Existing Lighting Conditions at Princeton's Campus

Report by Gáspár Bakos, Department of Astrophysics

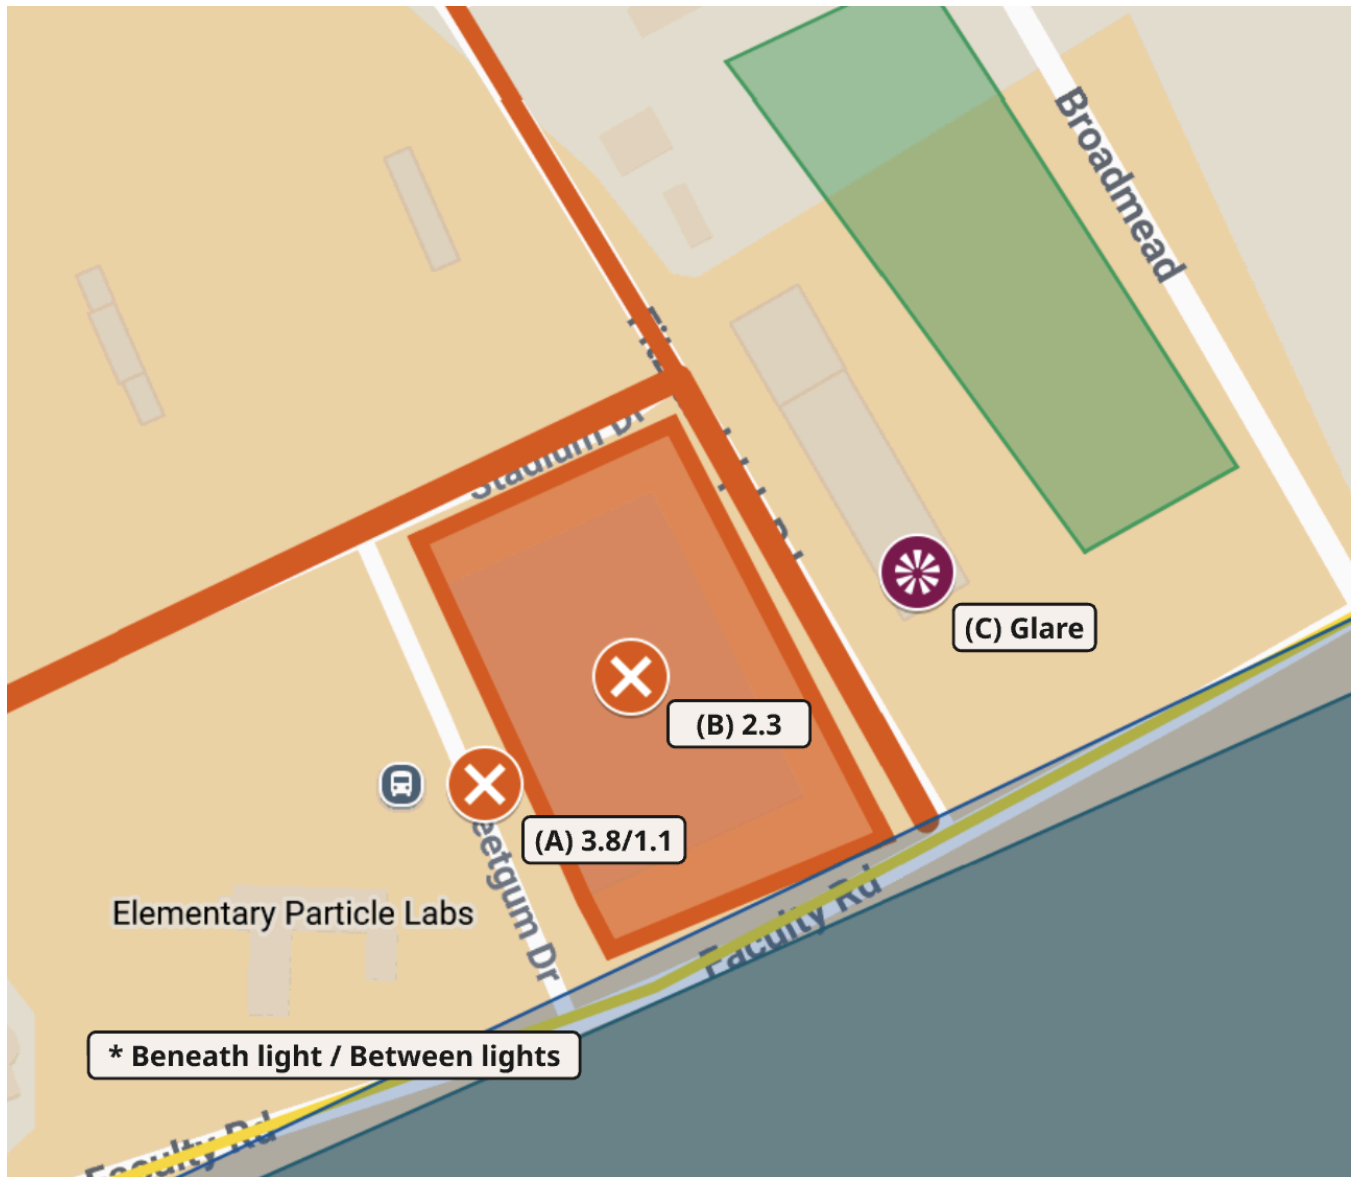
Stadium Drive Garage map. Illuminance is 3.8/1.1 FC (under/between lights). Compare this to the desired 0.3 FC horizontal illuminance for local/interior roadways from Table 12-2 of RP-8-22. The area is overlit by a factor of 3-10x.

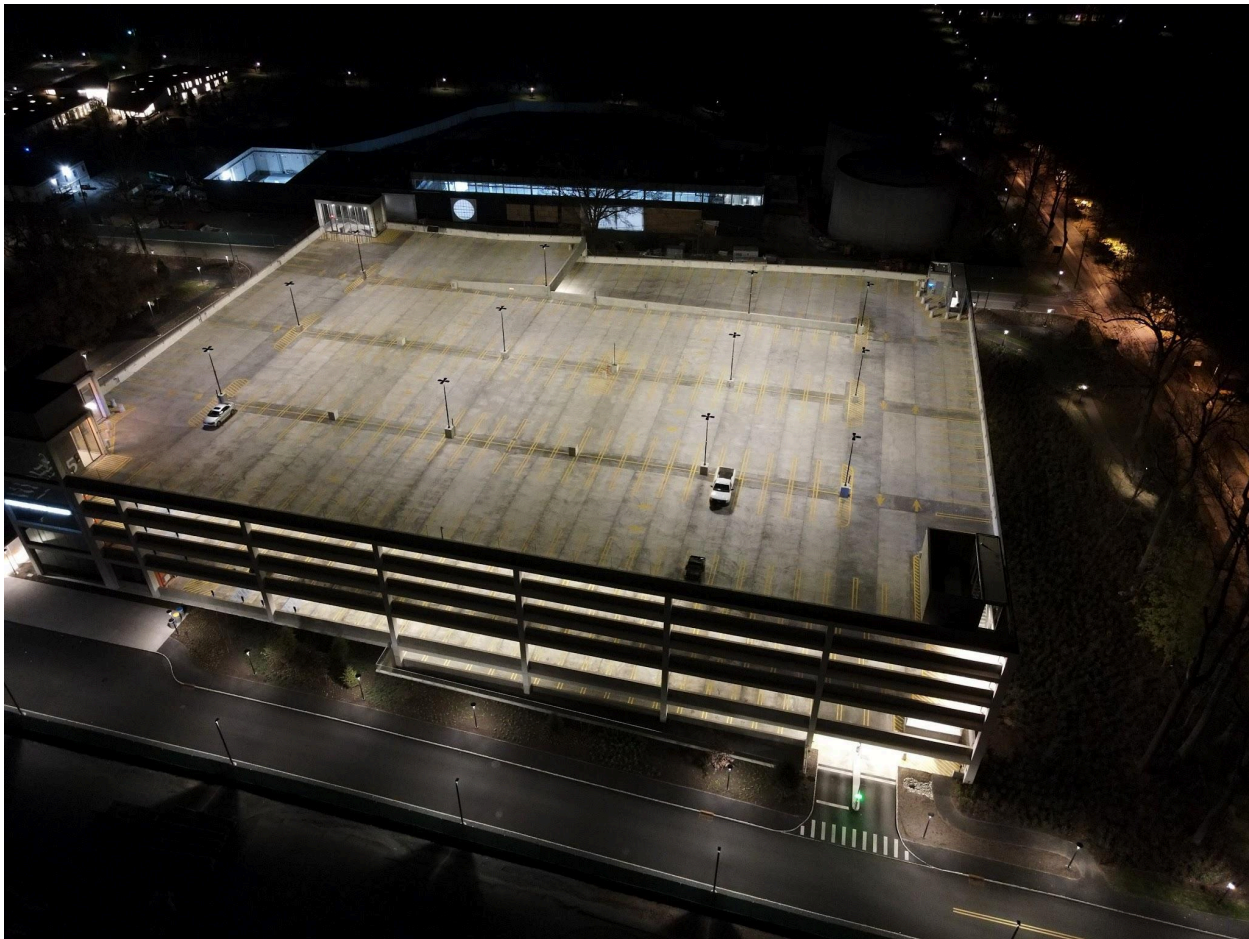
Stadium Drive Garage. Note the very high illuminance with respect to e.g., the pedestrian walkways and the adjacent Faculty Road. The direct illuminance is 2.3 FC. This is independent of the high albedo of the garage.

Light levels were measured under the poles and halfway between the poles. **Under the pole, the horizontal illuminance is 2.3 FC, and in between poles (darkest areas) is 1.6 FC. These values are many times the recommended values for LZ2.** No dimming and no motion sensors control the lights. The amount of light pollution is exacerbated by the reflective concrete, although we stress that the problem is primarily with the overlighting of the surface. The garage roof will be converted to solar panels.

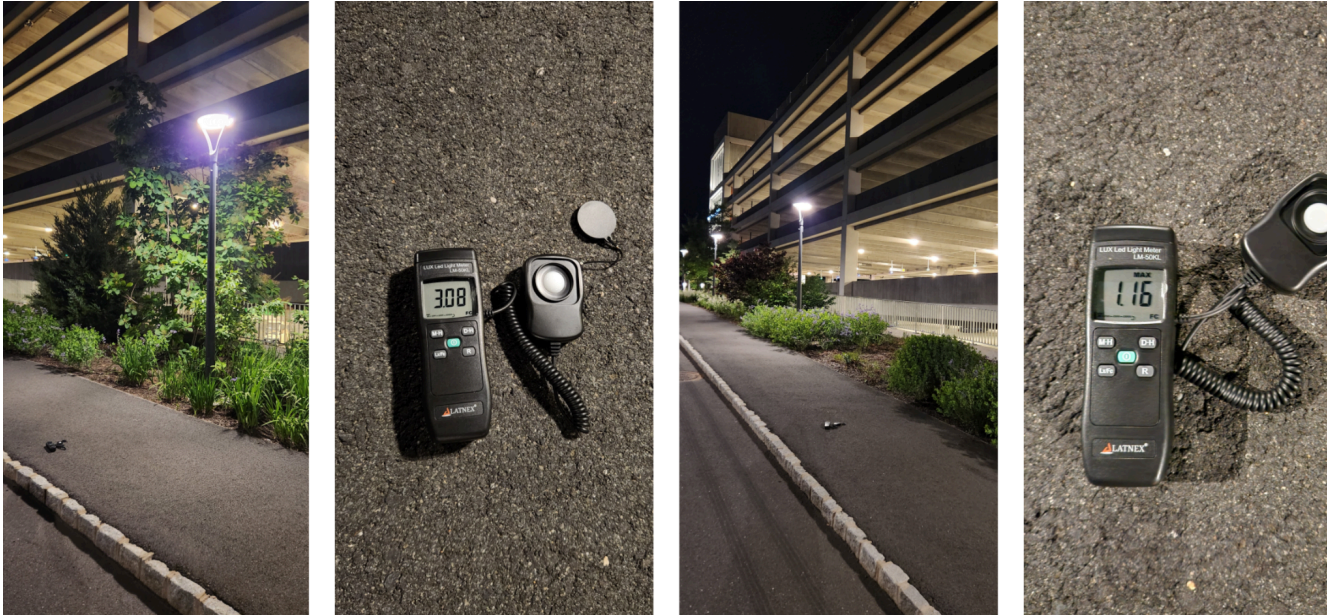
(A) Light measurements beneath & between poles on the walkway near Stadium Garage, 3.08 & 1.16 FC respectively.

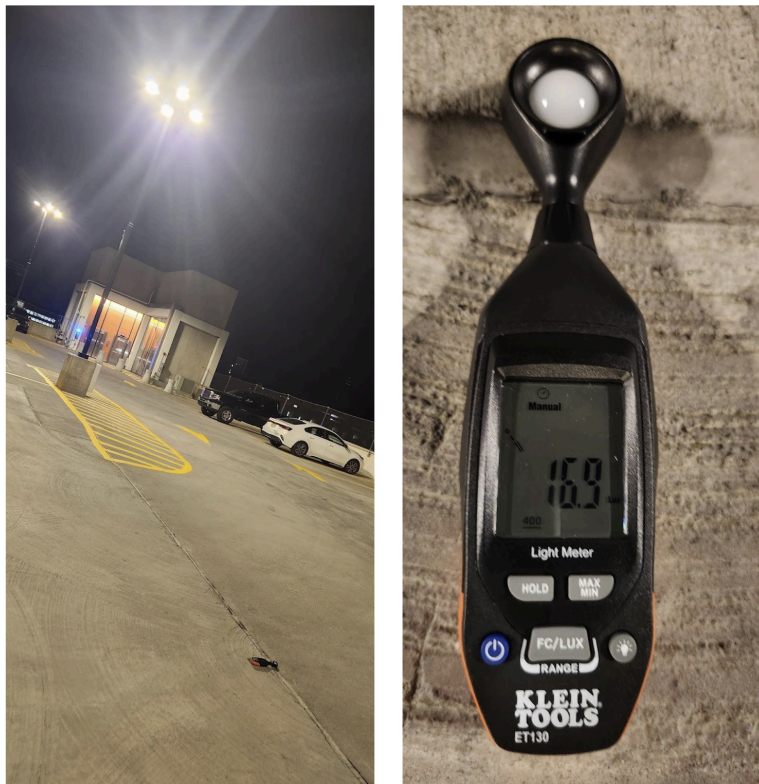
(B) Measurements of the horizontal illuminance on the roof of the Stadium Drive Garage, halfway between lamp posts. In this measurement, the light meter was set to “Lux” units, where 1 Lux is approx 0.1 FC; thus, the readings should be divided by 10 to get values in FC.

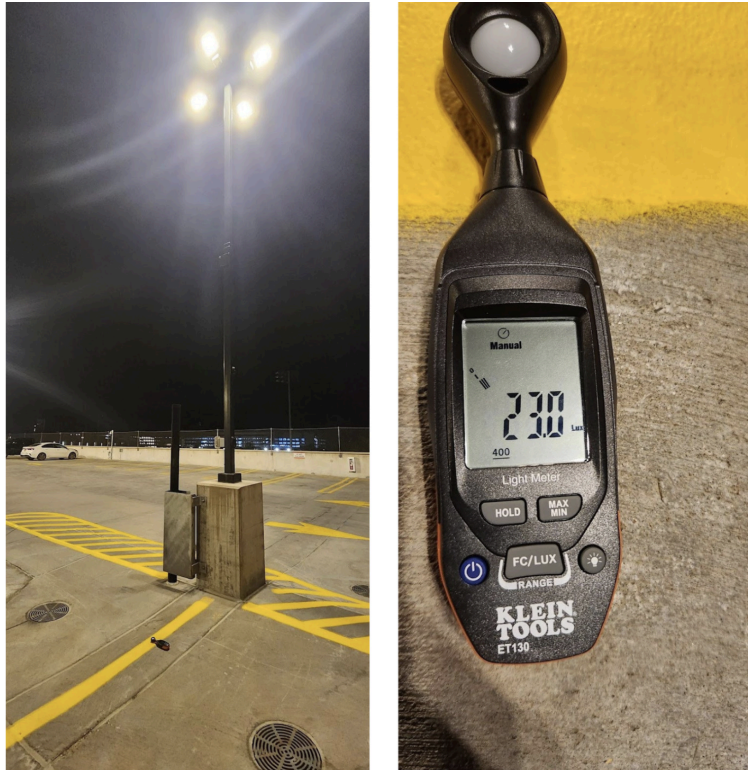
(B) Roof of Stadium Garage, directly beneath pole, 2.3 FC reading (convert from lux).

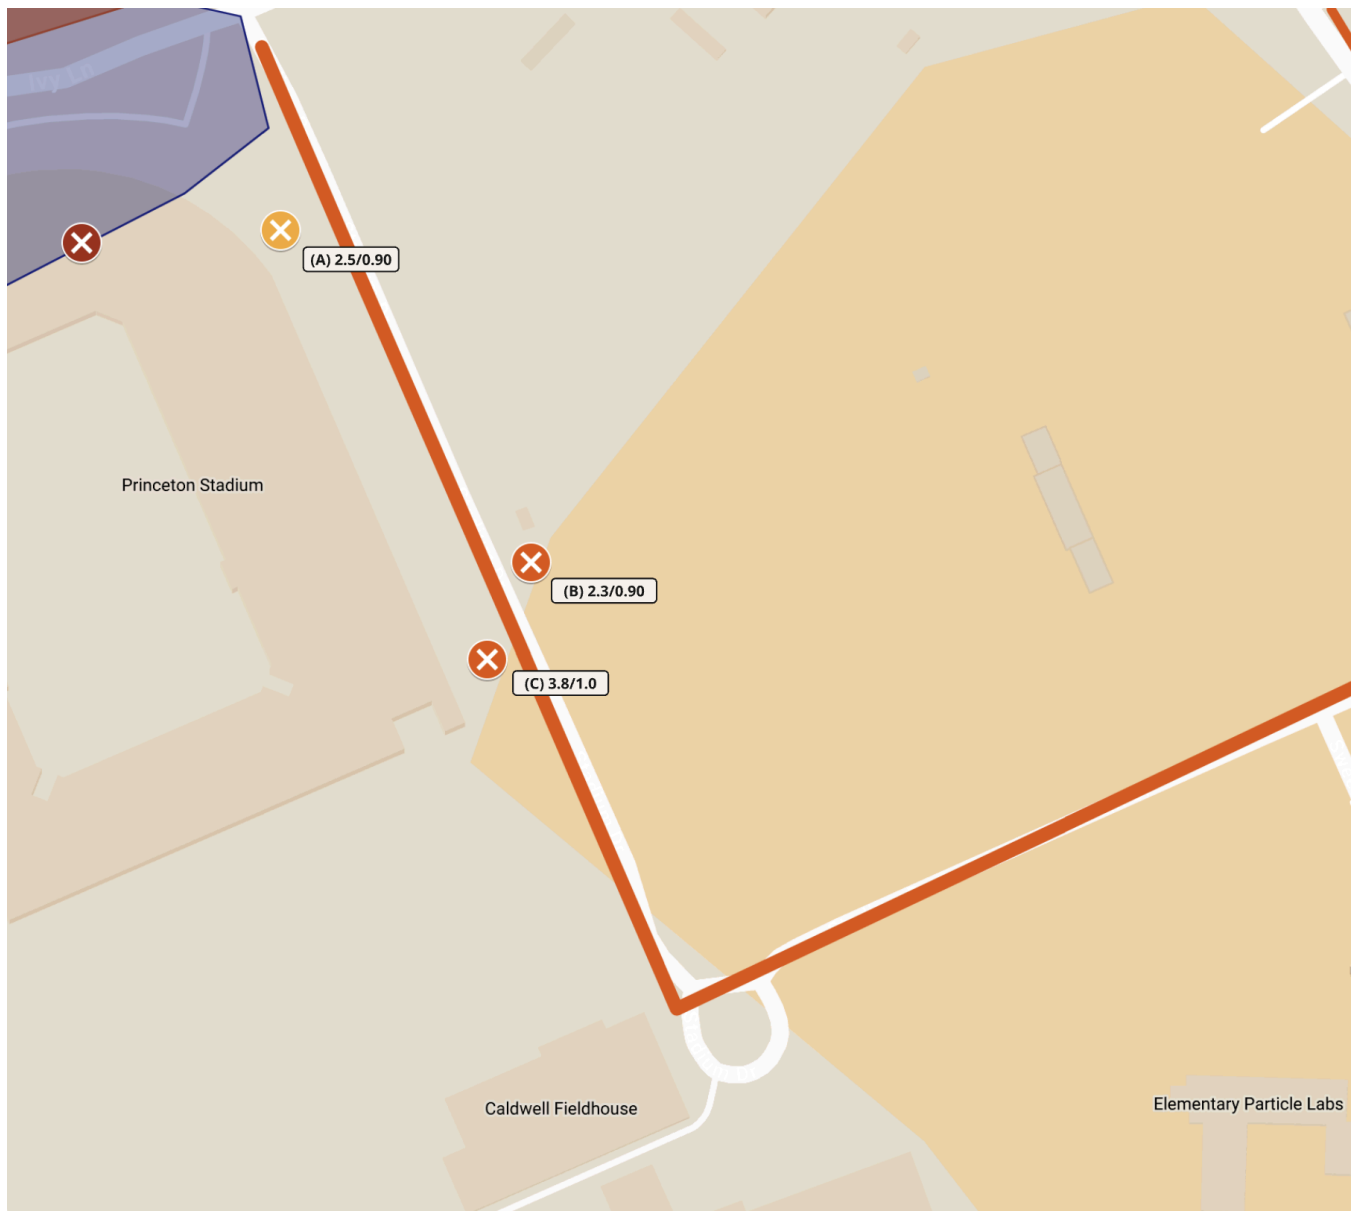
Stadium drive, including both the roadway and the pedestrian pathway received new lighting around 2024. The pedestrian pathway fixtures are BEGA 84121. The roadway fixtures are Bega 99516.

Direct illuminance was measured on multiple nights and at multiple locations. The roadway illuminance is in the range of 0.8 FC (halfway between the poles) to 1.66 FC (under the pole). The pedestrian walkway illuminance is in the range of 1 FC (halfway between poles) to 3.9 FC (under the pole). **These values are many times the recommended LZ1/LZ2 median values; the stadium drive is overlit by a factor of 3 to 10. There are no motion sensors or dimming.** The pedestrian walkway poles are sensor-ready with a provision for a field-installable occupancy sensor, but such sensors were not installed.

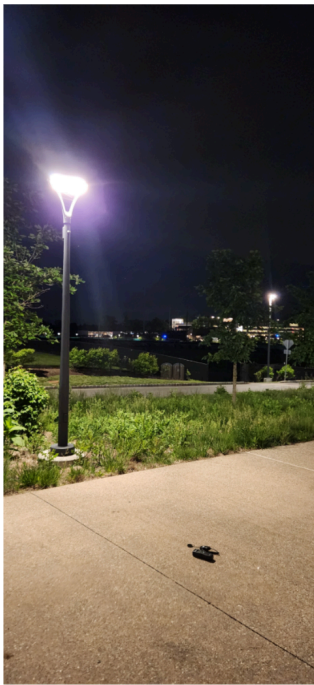
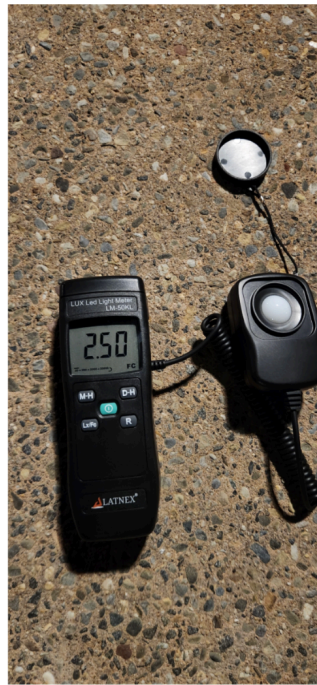
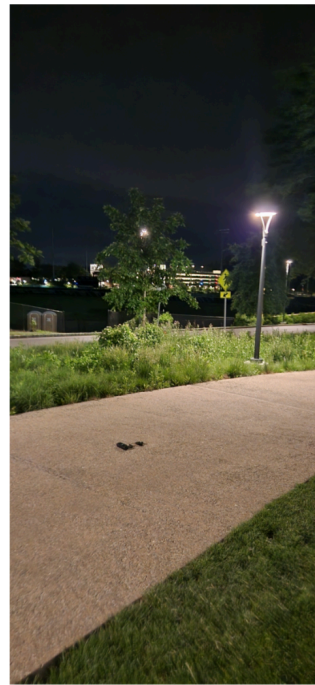
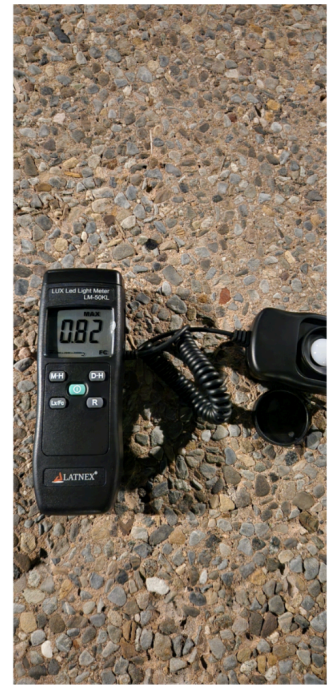
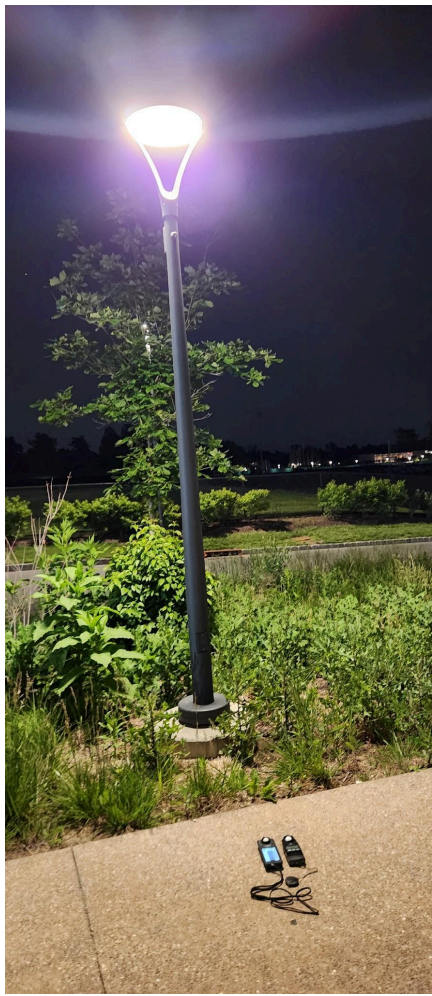
Illuminance measurements on the sidewalk at Stadium Drive, under the fixture, comparing the Sekonic C-800 with the Minolta illuminance meter. The two meters measure illuminance to within 4%.

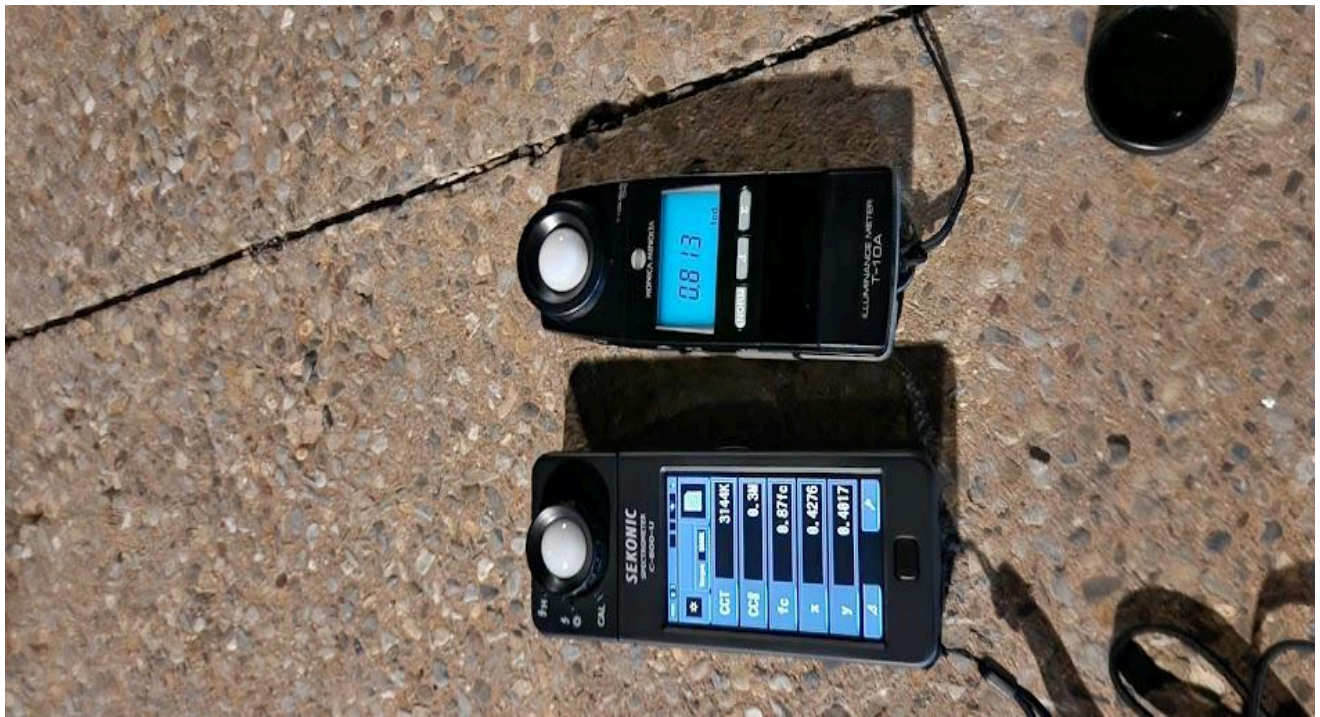
Illuminance measurements halfway between the sidewalk fixtures, comparing the Sekonic and the Minolta meters. They are consistent to within 5%.

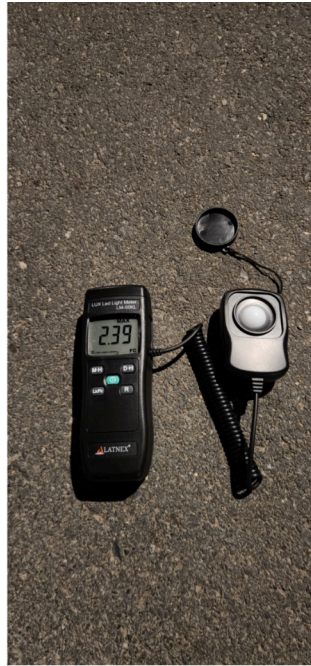
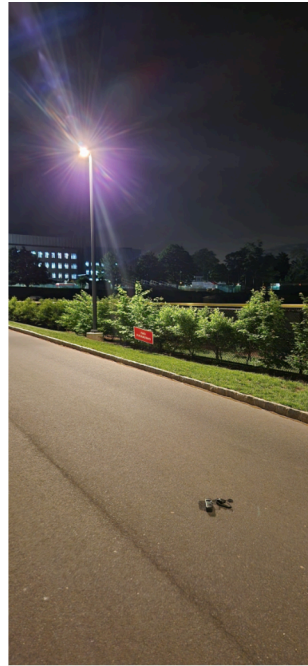
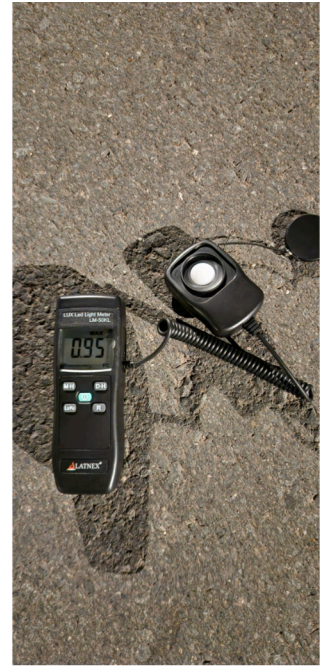
(B) Stadium Drive road between Peyton Hall and Stadium Garage, measurement taken directly under the pole and between poles, 2.39 FC and 0.95 FC, respectively (desired value: 0.3 FC). Independent measurements with the Klein Tools meter were consistent.

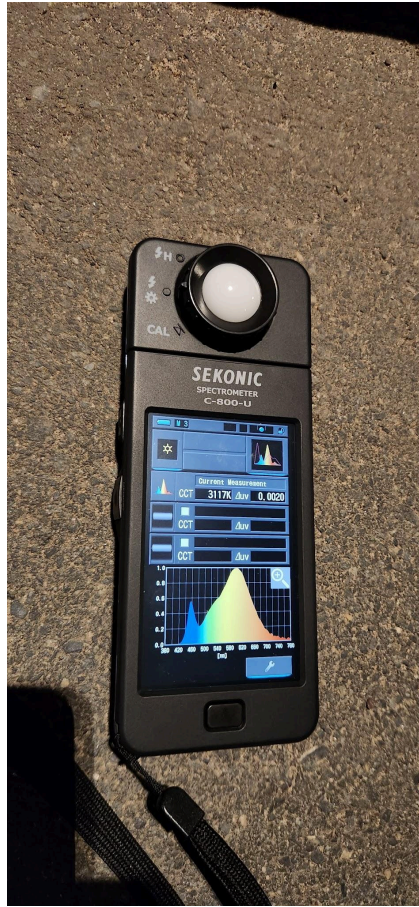
Spectrum of the roadway light. Peaks at 590nm, with a significant blue peak at 400nm.

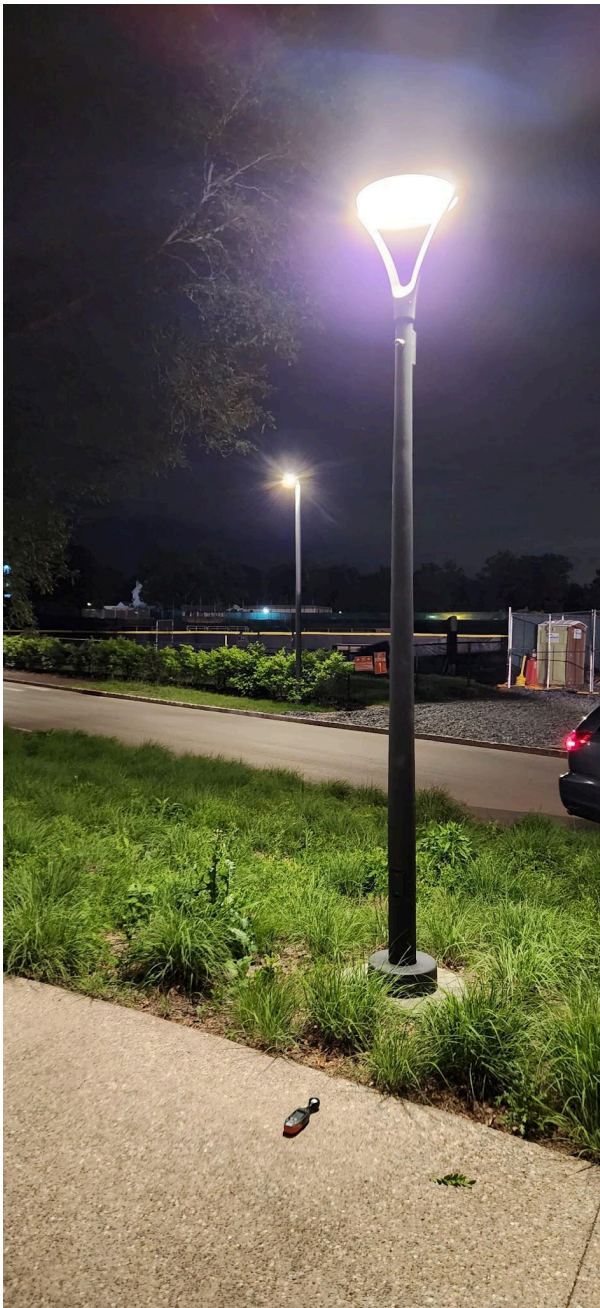
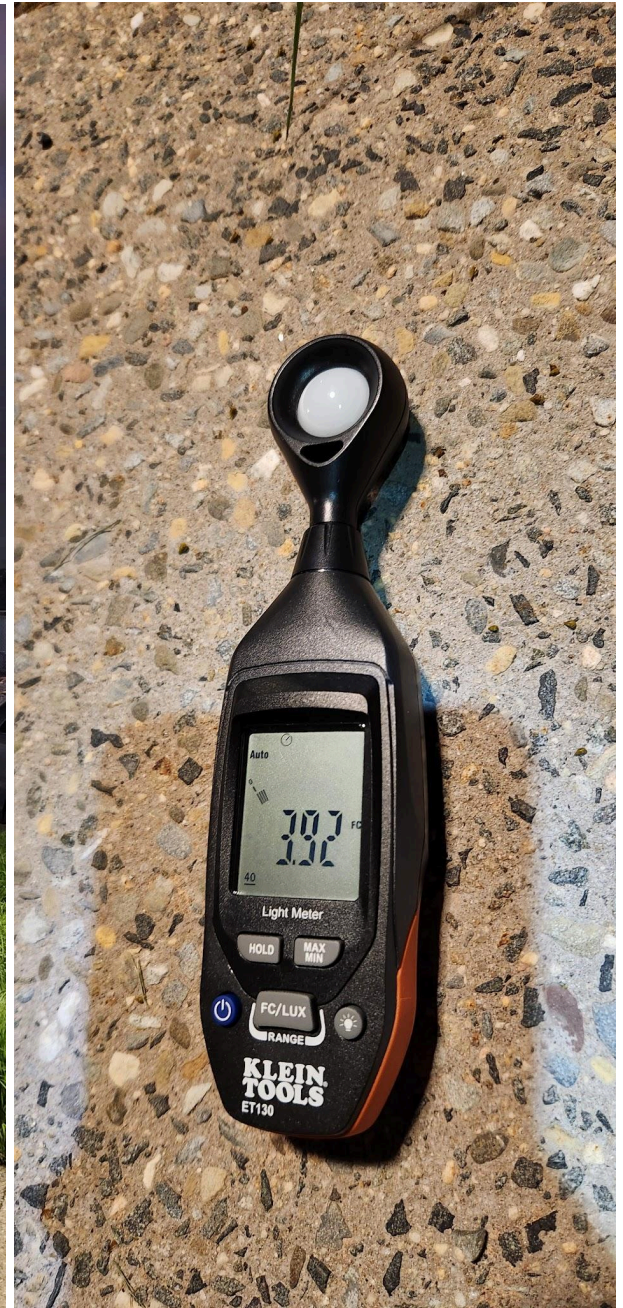
(C) Illuminance measurements on Stadium Drive's walkway under the light fixture. The reading is 3.92 FC; the walkway is overlit by factors of many.

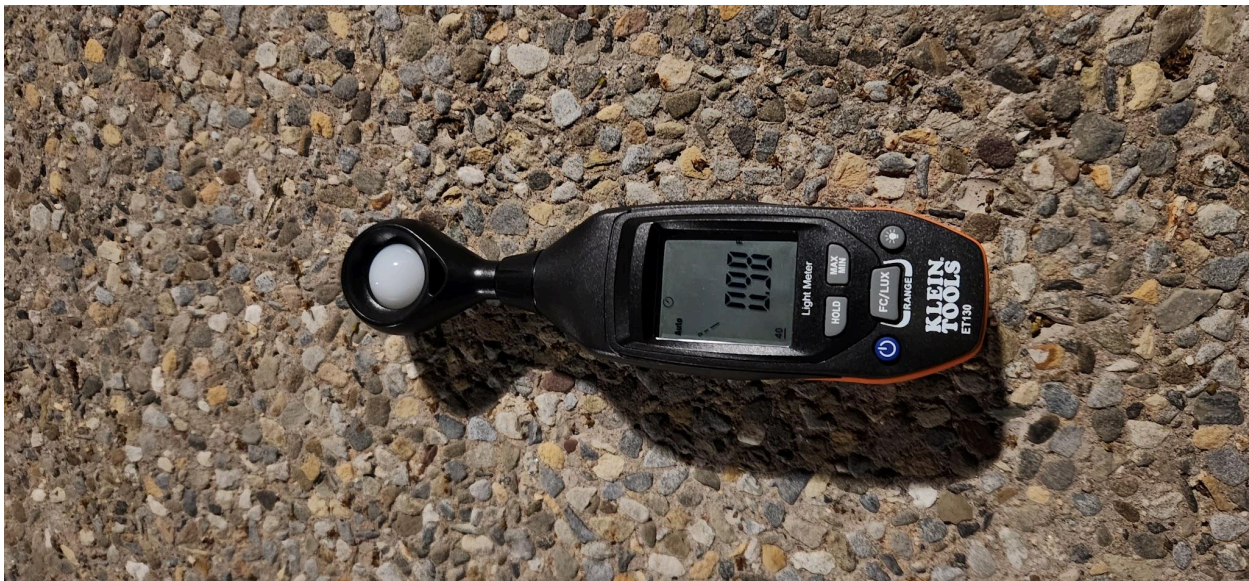
(C) Illuminance measurements on Stadium Drive's walkway, halfway between light fixtures. The reading is 0.98 FC.

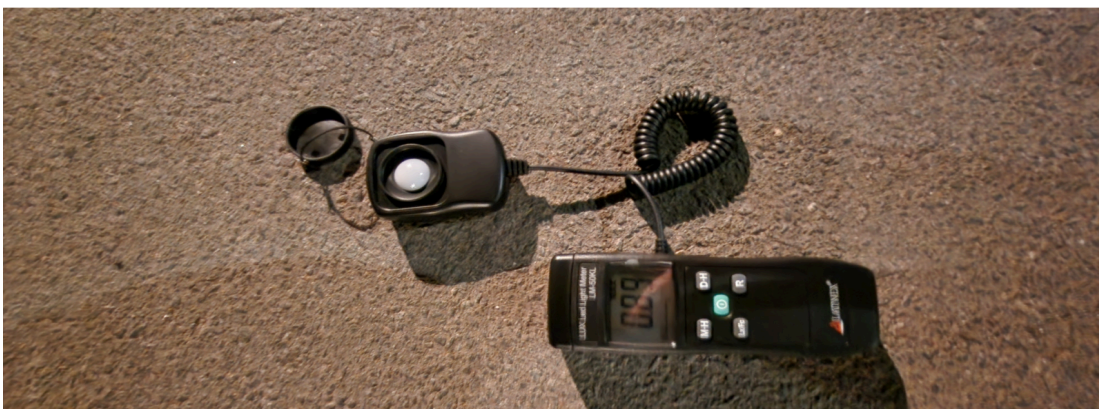
(A) Southside of Peyton Hall, measurement taken between two lamps, 0.89FC reading

(A) cont. Southside of Peyton Hall, directly beneath the lamp. Measurement of 3.46 FC (target 0.3 FC).

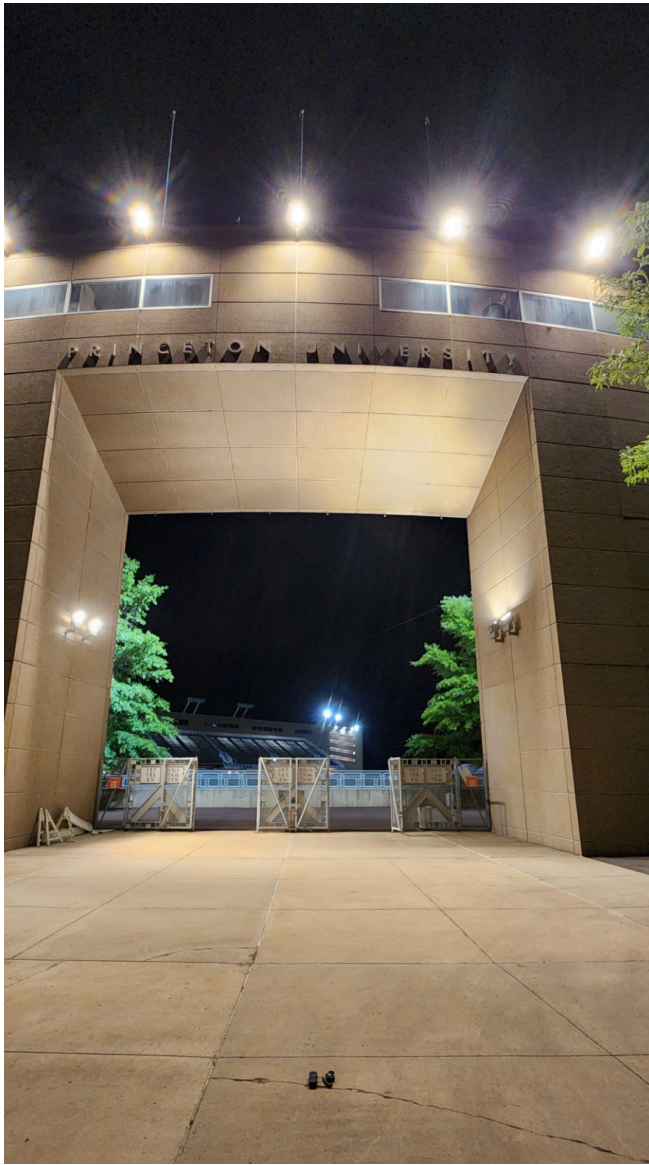
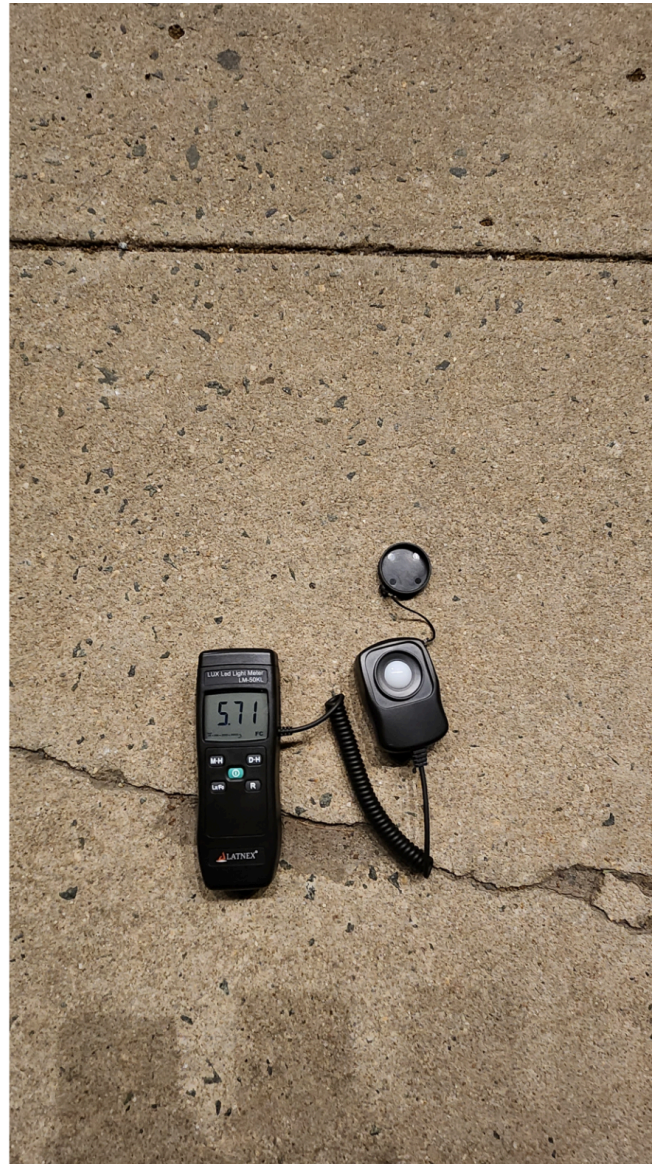
(B) Stadium archway, adjacent to Peyton Hall. Measurement of 5.71 FC (desired value 0.3 FC).

Overall illuminance under the archway lights is 5.9 FC, whereas the recommended values for this lighting zone are roughly at 0.2 – 0.3 FC. The glare from the overlighting is a safety concern, as other areas are clearly far less lit. Pedestrians walking through this area are losing their dark adaptation. This area is in front of Peyton Hall, which is a sensitive area for night time lighting.

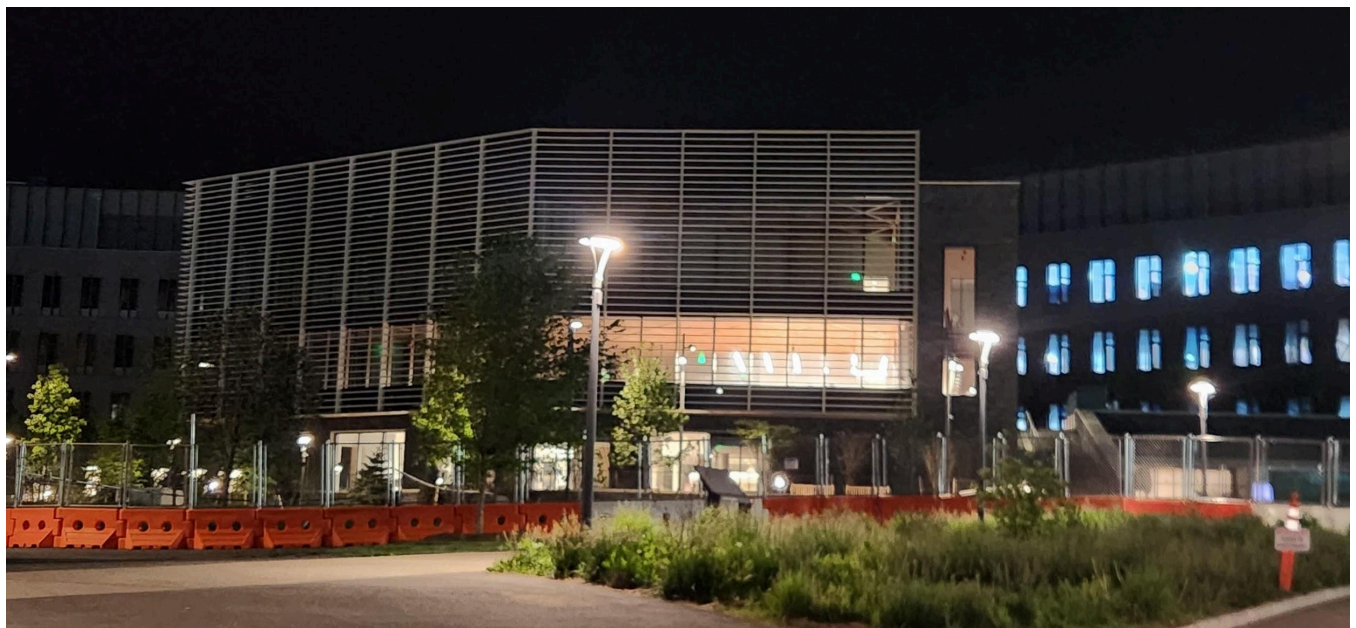
ES+SEAS Front area/park, very overlit with glare/direct light from buildings.

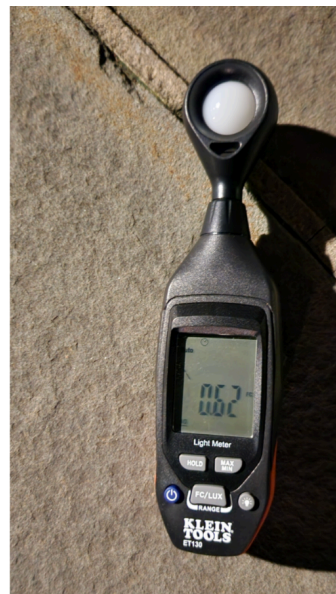
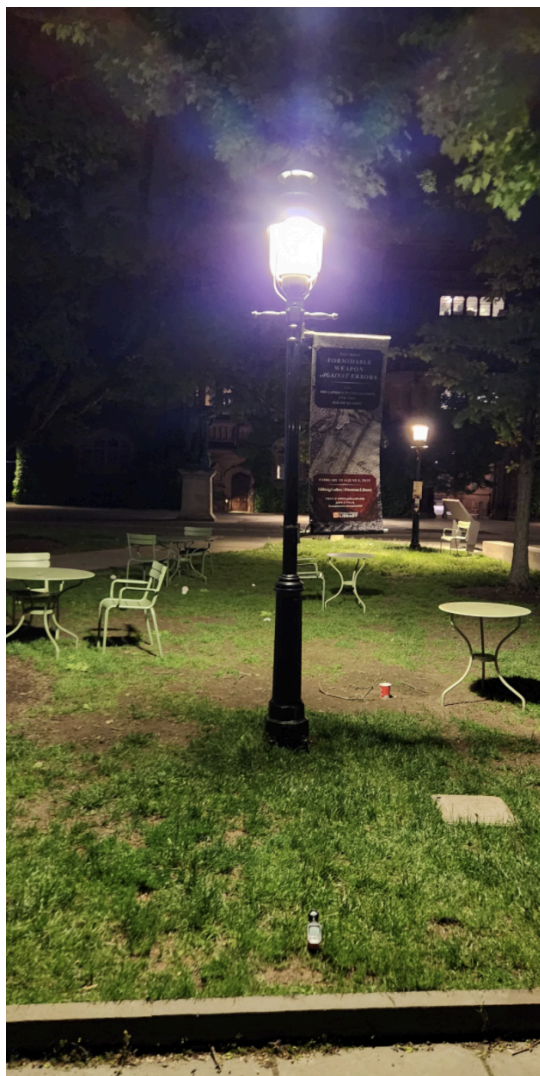
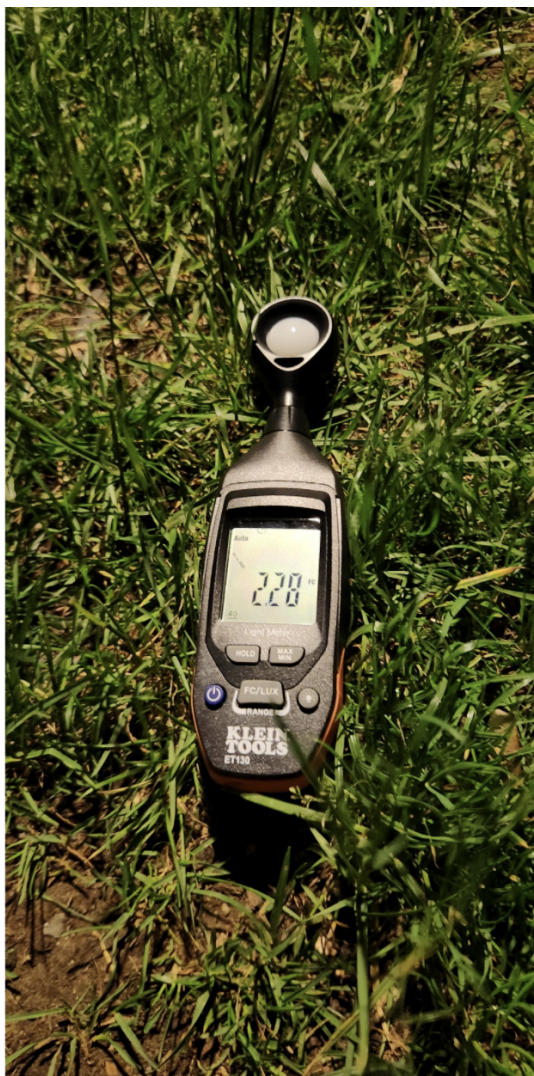
(A) cont. Penn globes, measured at 0.62 FC between poles and 2.28 FC beneath the pole, respectively. (Desired value 0.3 FC).

Penn Globes – The aesthetically pleasing “classy” Penn globes provide a moderate level of lighting, broadly compatible with the desire of a “park-themed aesthetic” of the campus. There is a variation between penn globes; some are better shielded, some produce more glare, depending on the vertical positioning of the bulb. There is also variation in terms of the top cover; some have translucent top covers, leading to huge uplight (McCosh walk). With the 60 ft spacing, they have dark areas in between the poles, which was noted in the 2015 master plan: *“To preserve the park-like nighttime aesthetics of the campus, sparsely locate pole lights along walkways. This applies to walkways that are adjacent to and distant from roadways. Note that very low light levels between poles are to be expected”*. This feature is good for those looking for a “romantic” stroll while enjoying the park-like ambiance, even looking up at the sky when they are in between poles. This feature is bad for those looking for a city-center feeling with homogeneous illumination.

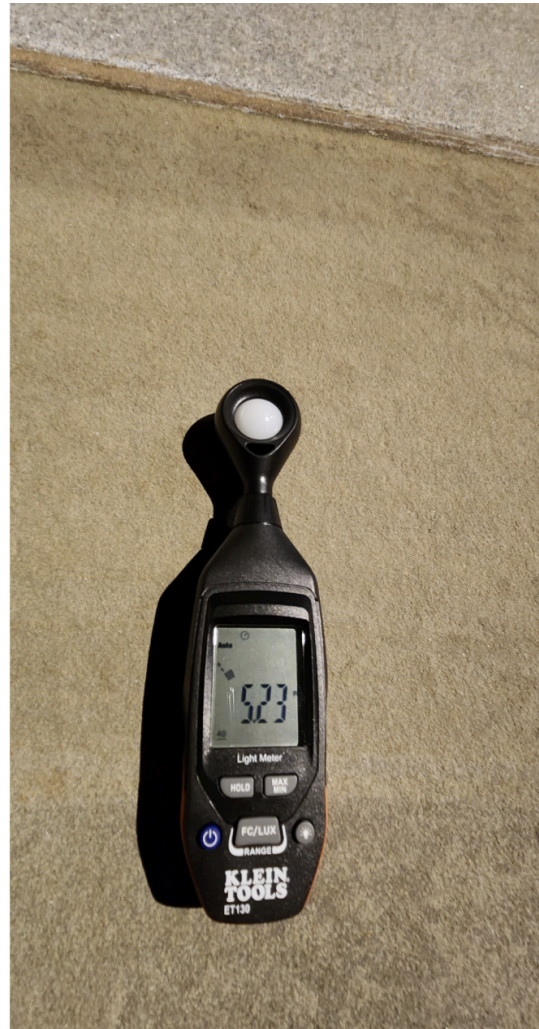
(B) Stairway at the Princeton Chapel. (Desired value 1-2 FC).

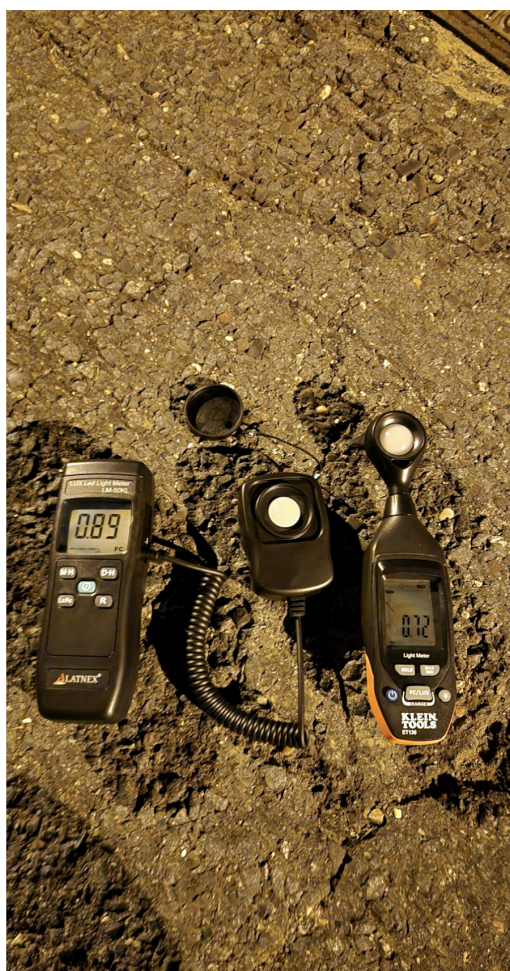
(B) College road, roadway lighting, sodium, lower estimate. 5.7 FC under post, 0.9 FC between posts. (Desired: 0.3–0.6 FC)

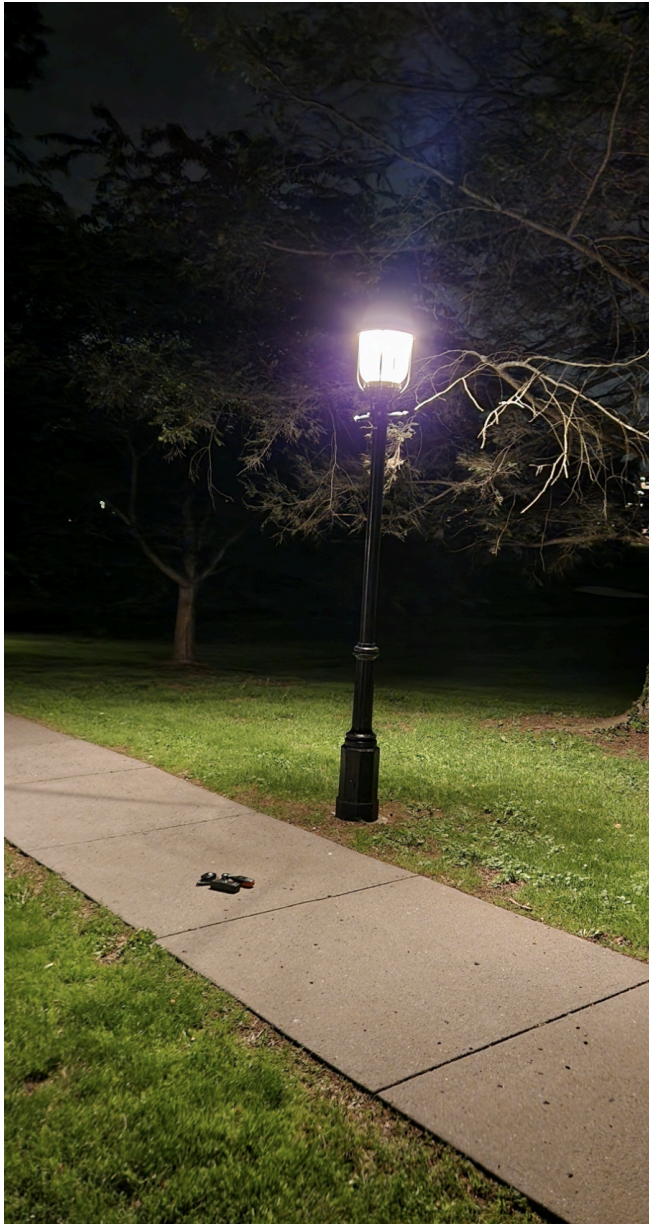
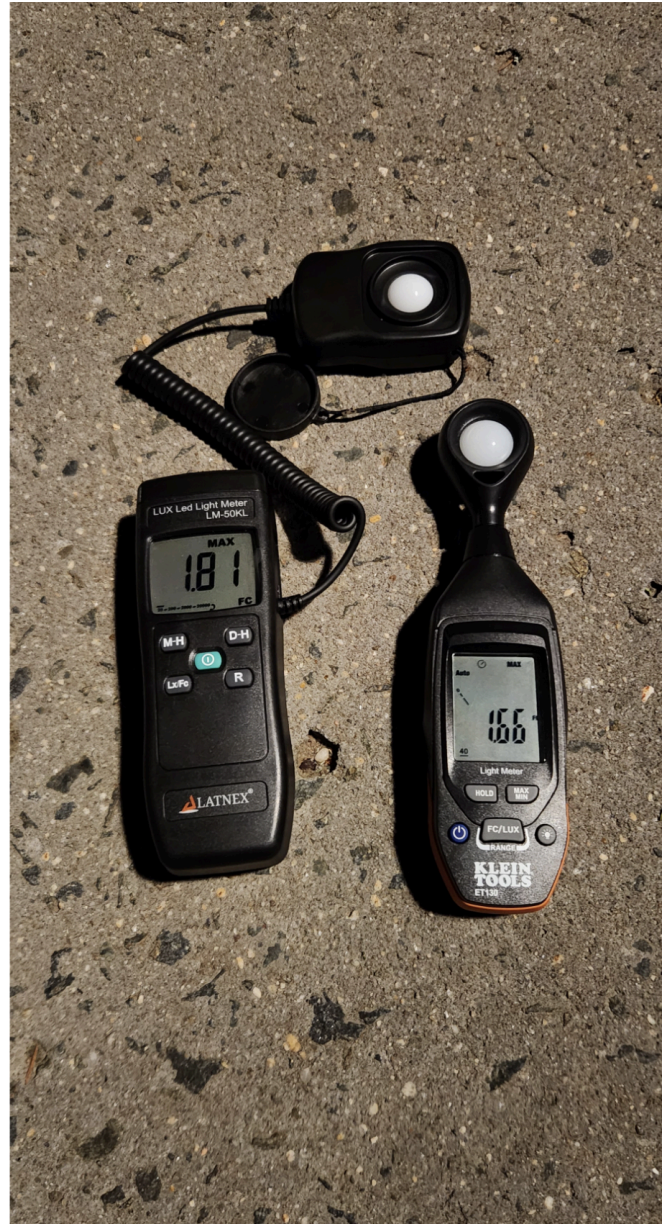
(C) Path from parking lot to graduate college, Penn globes, brighter beneath post, lower but still acceptable limit between posts. Light spills into the nature area. 1.81 FC & 1.66 FC measurements with two different detectors to check for consistency.

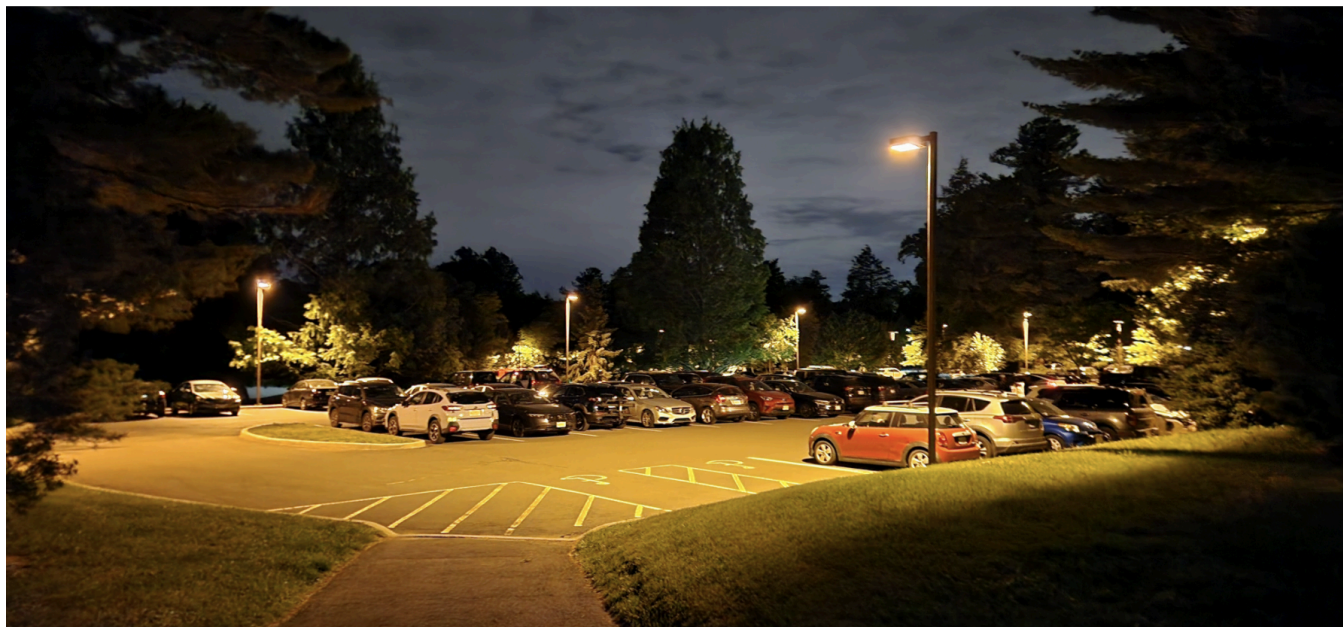
(D) Parking lot behind the Graduate College with sodium lights. Measurements underestimate the true value due to sodium. Overall not bad, but a little overlit.

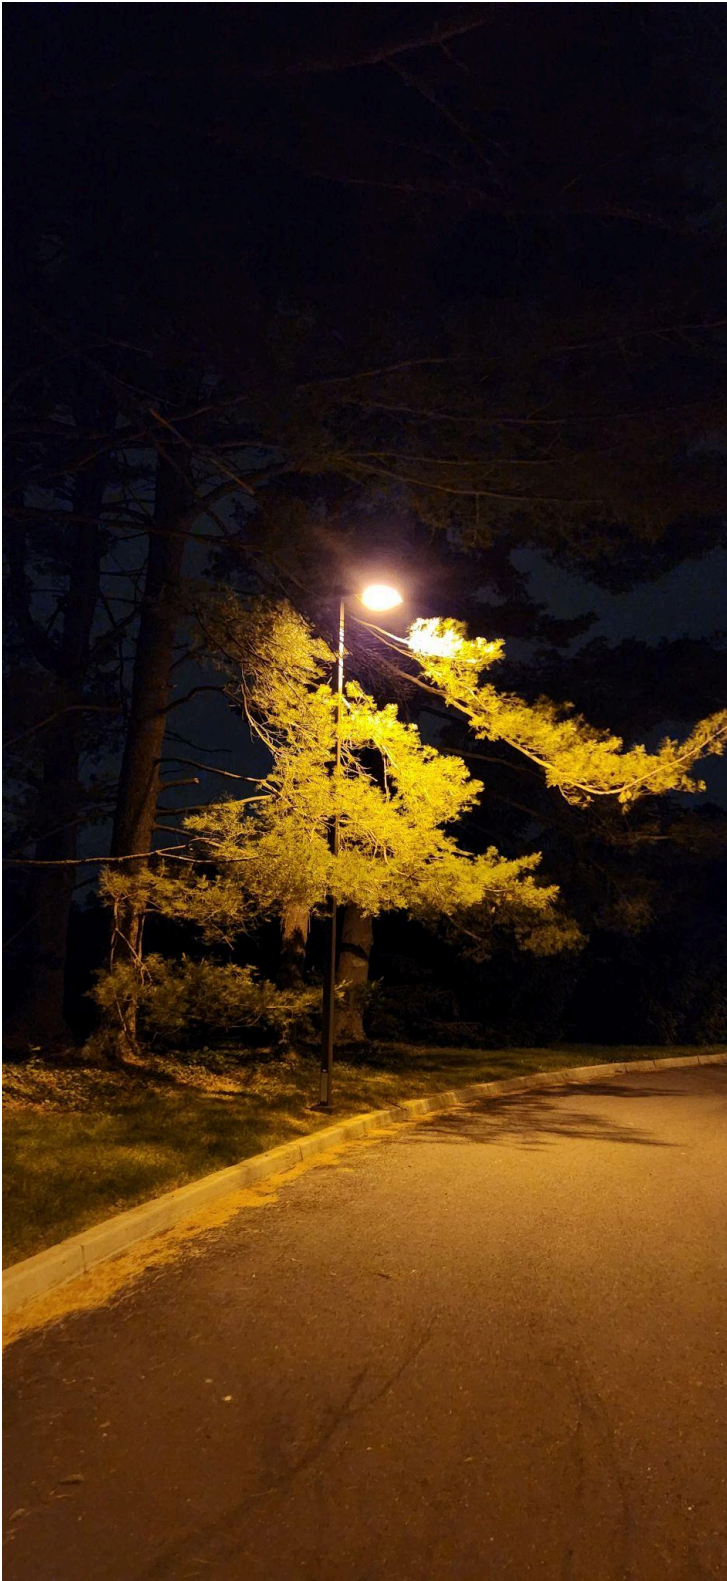
Some of the lights in the Graduate Parking Lot are shielded by trees.
