Existing Lighting Conditions at Princeton's Campus

Report by Gáspár Bakos, Department of Astrophysics

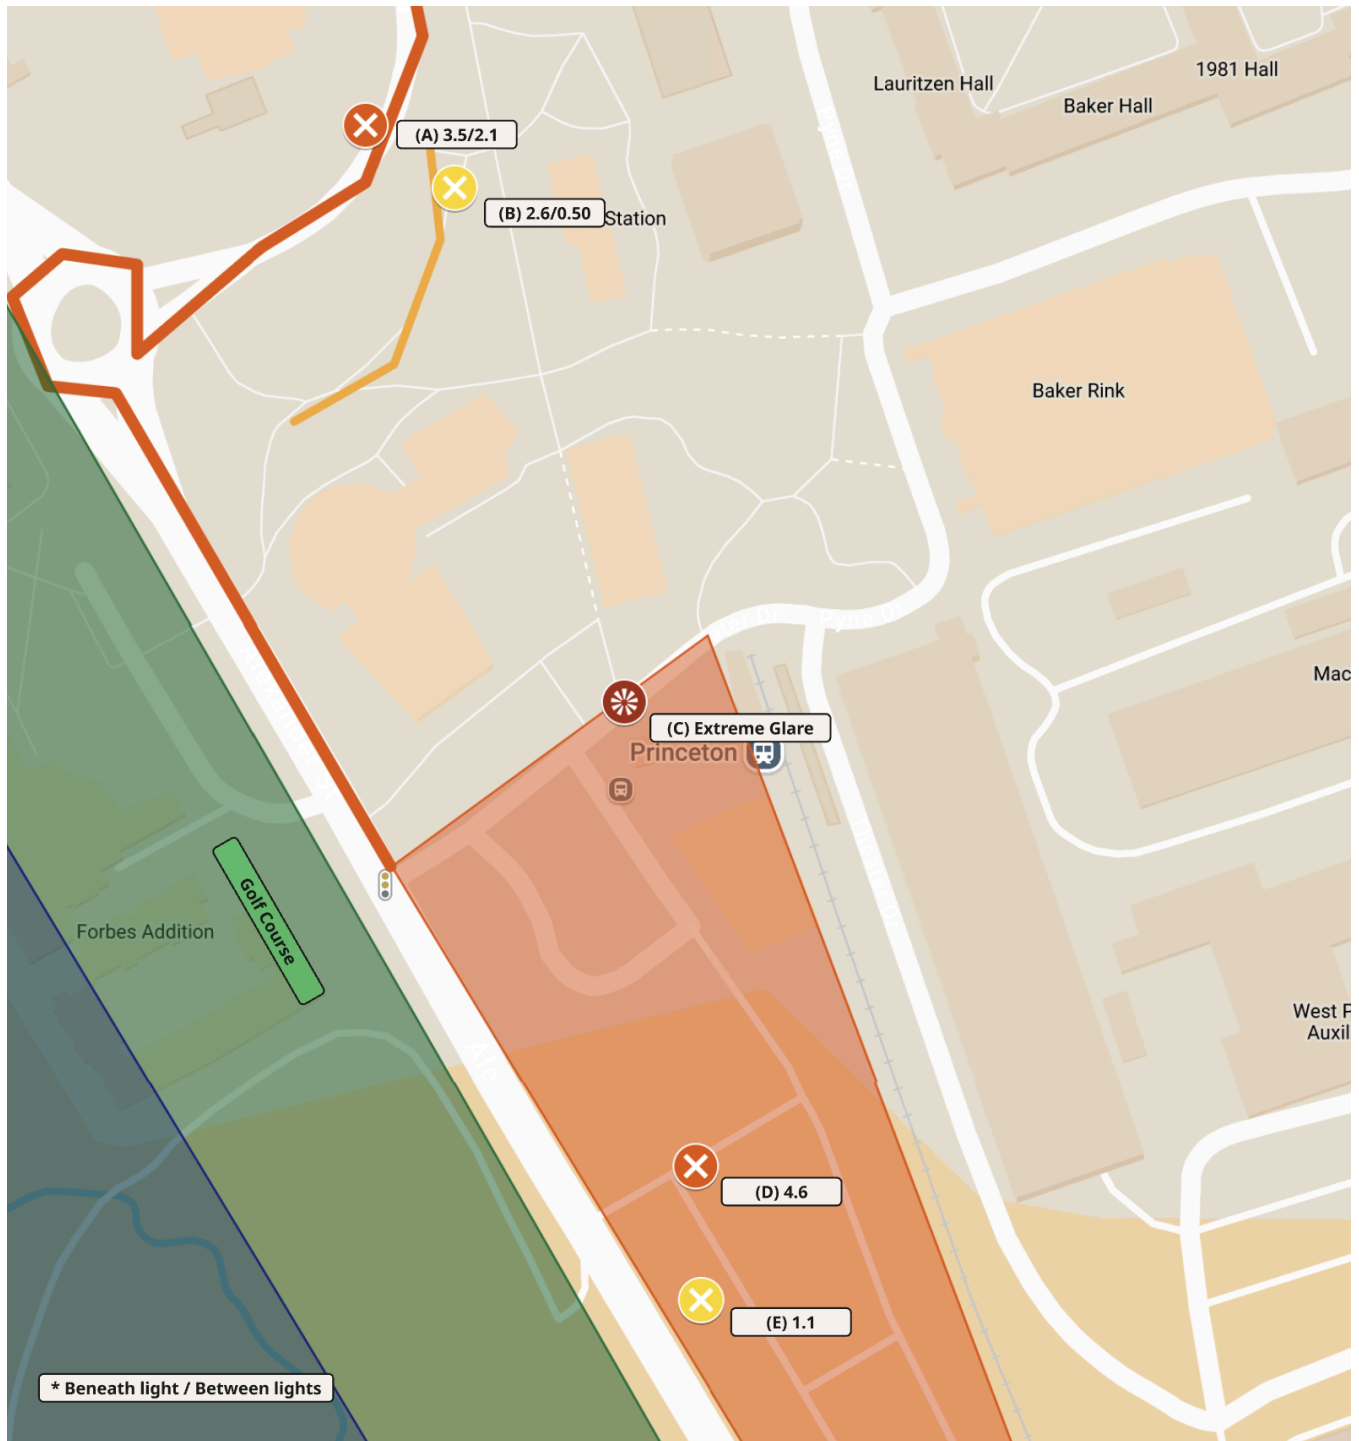
New South Hall to Dinky Station parking map. Overlit areas are indicated by orange. Areas that should be strongly protected are marked with green.

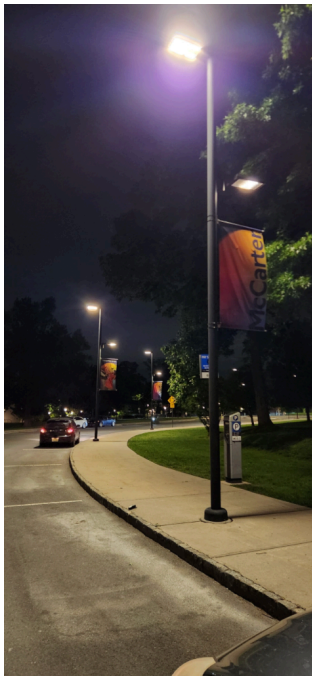
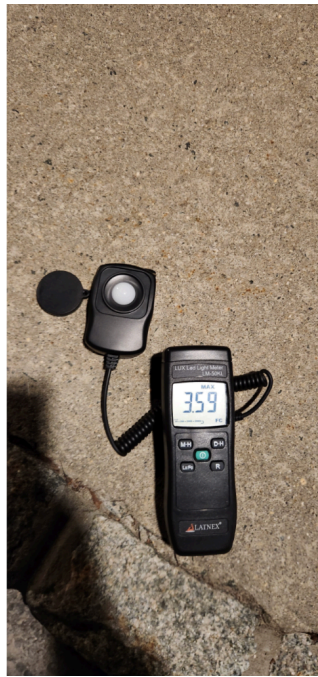
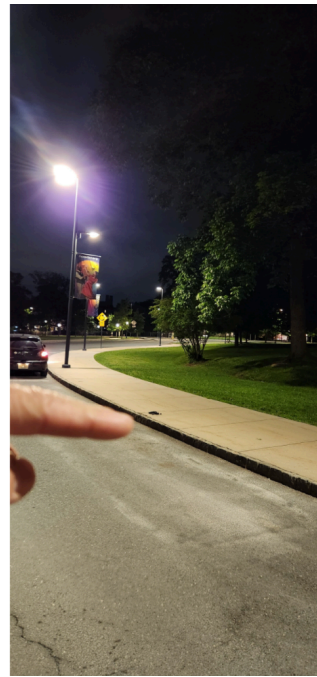
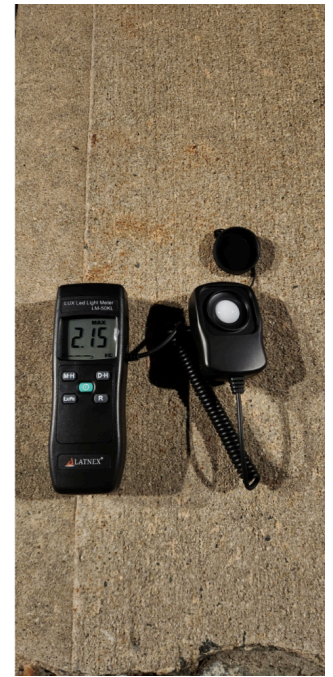
(A) Shoebox LEDs on high poles. Generally overlit, and the lighting is homogenous due to the high poles. 3.59 FC directly beneath the pole and 2.15 FC between the poles, respectively. (Desired value 0.3 FC).

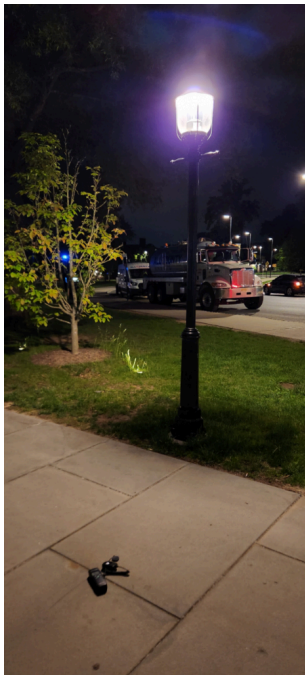
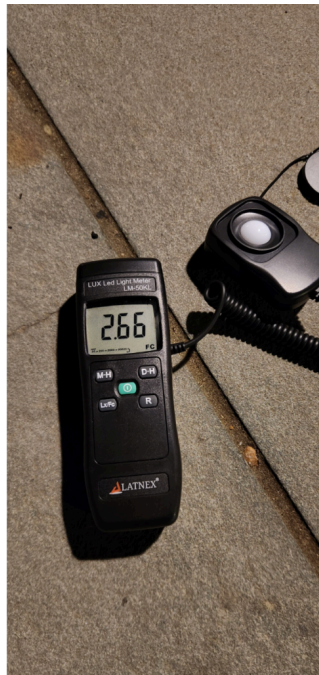
(B) Overall, slightly overlit area. 2.6 FC directly beneath the pole, 0.47 FC between the poles, respectively. (Desired 0.3 FC).

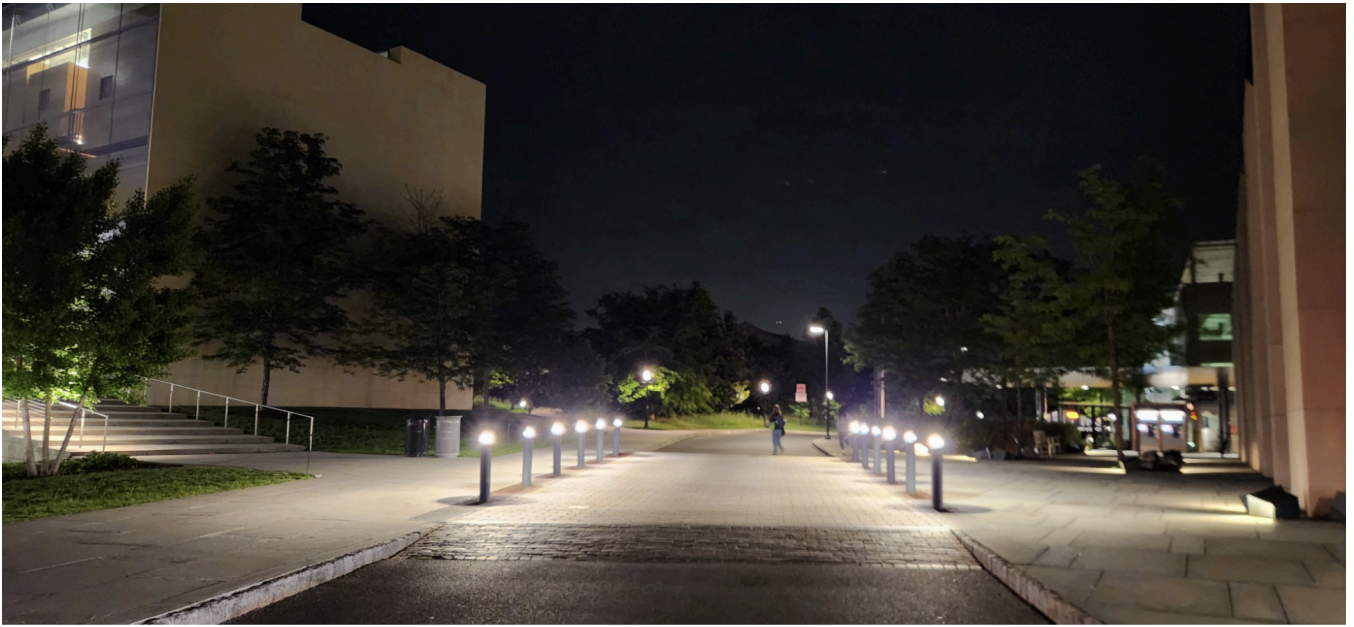
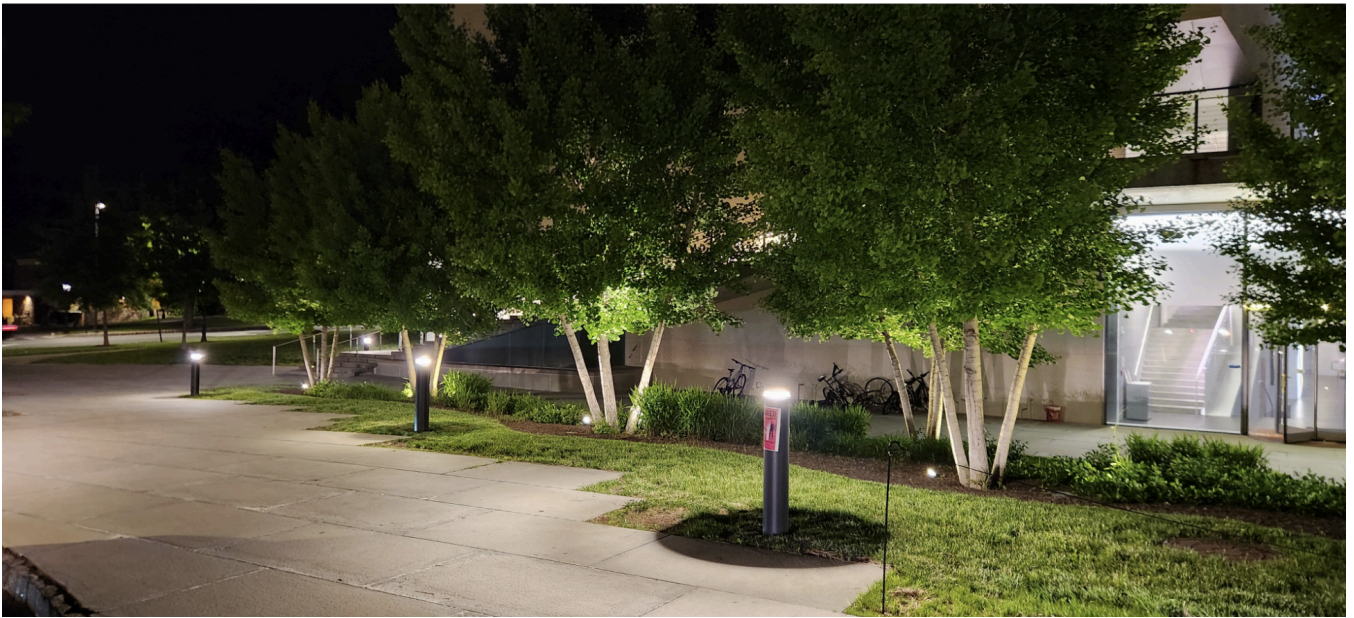
(C) Sharp white glare from a large cluster of unshielded bollards shining directly in the eye, next to Princeton Station.

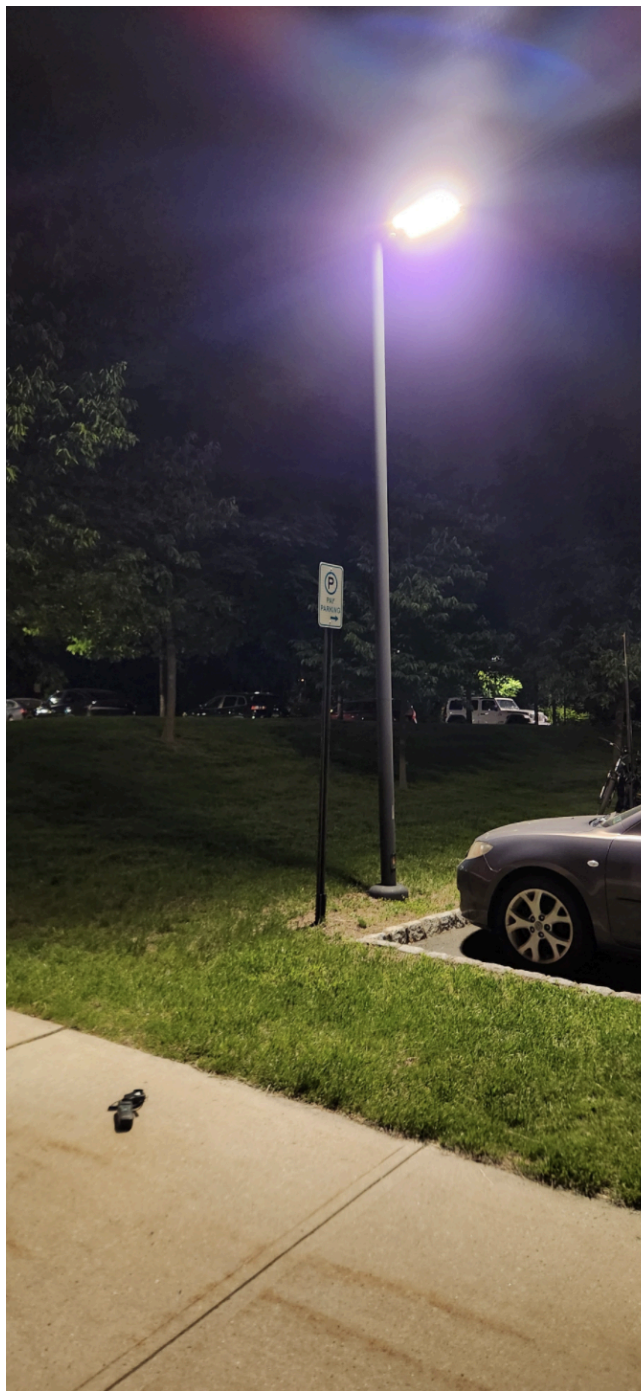
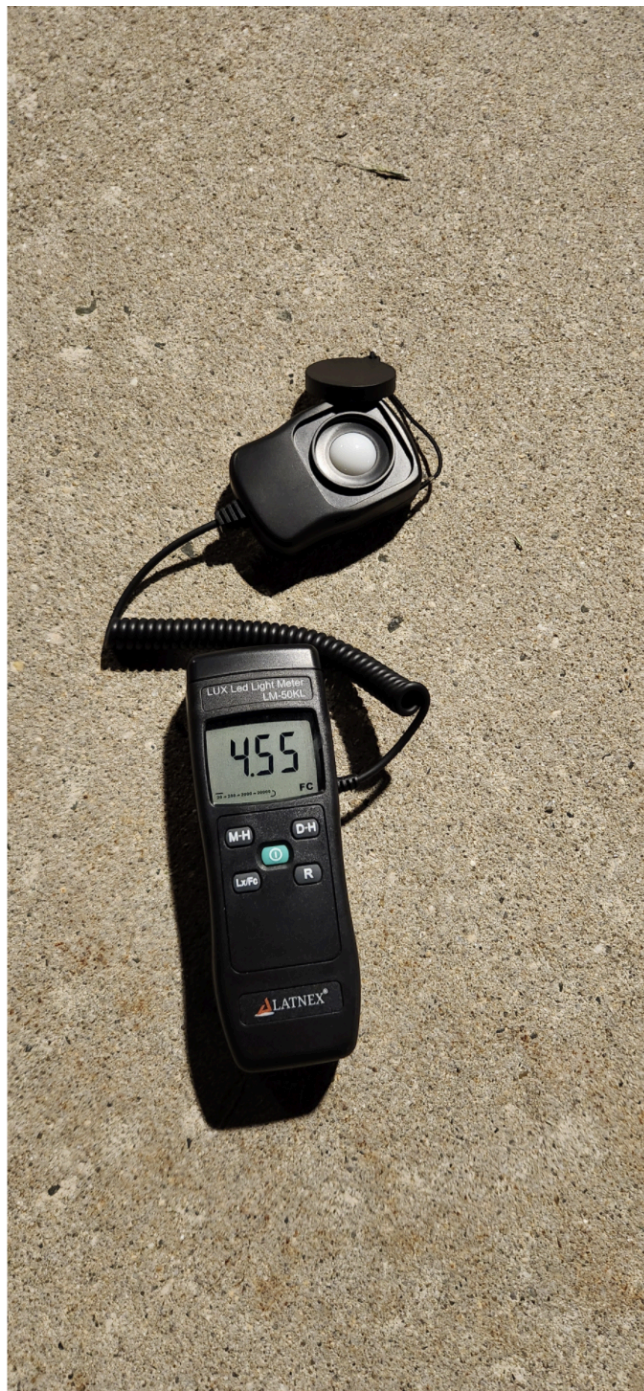
(D) Dinky parking lot walkway, seriously overlit, 4.55 FC measured.

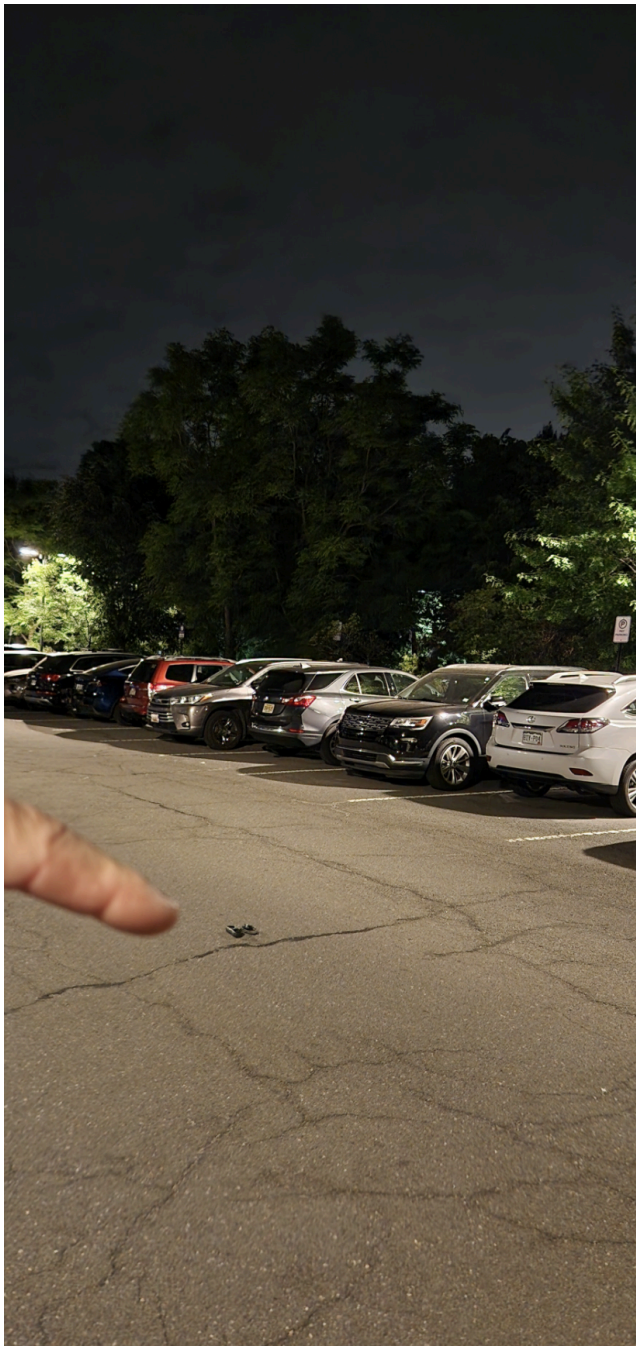
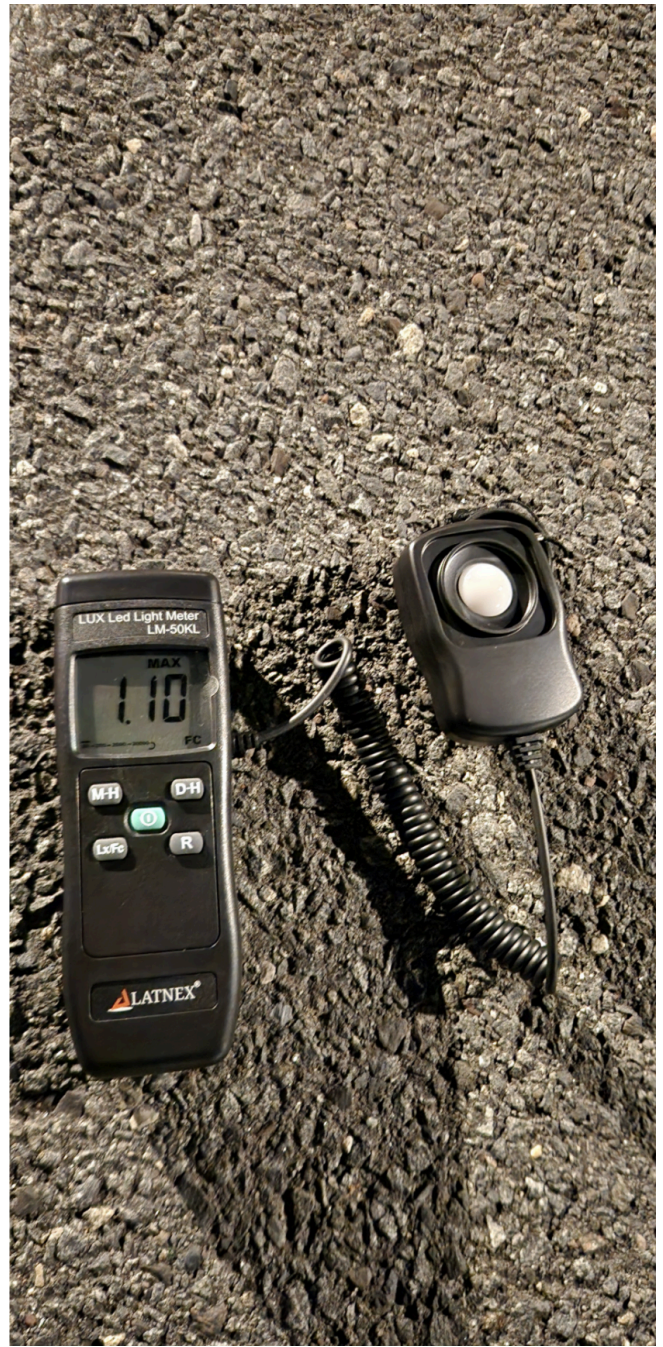
(E) Dimmest point of the dinky parking lot, point furthest from all poles, 1.1 FC measured.

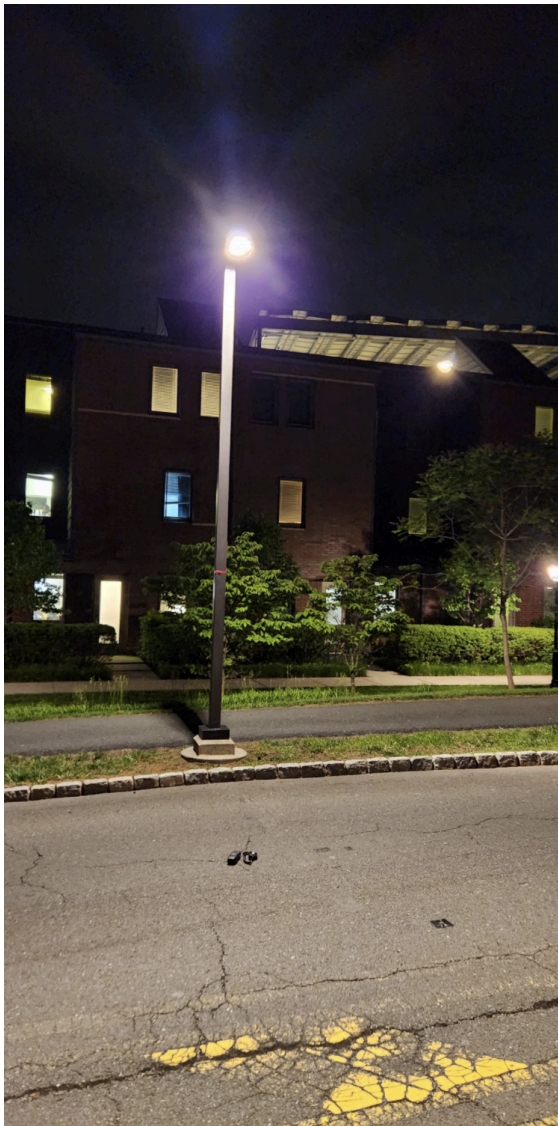
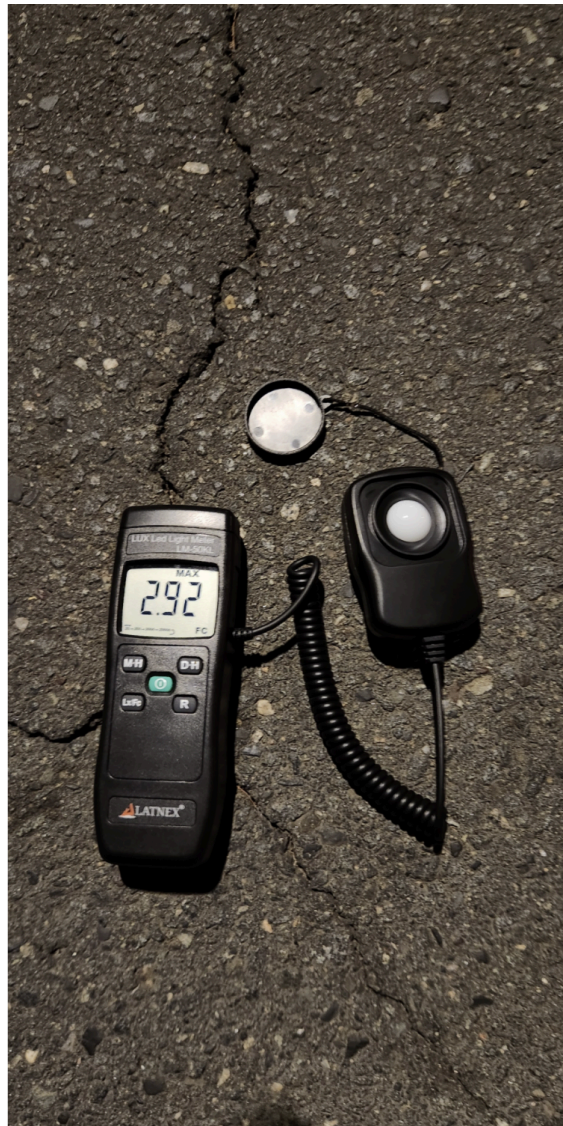
(A) These are low post LEDs with ~3000K light, 2.92 FC directly beneath pole, 1.6 FC between poles at the center of the street. (Desired value 0.3 FC).

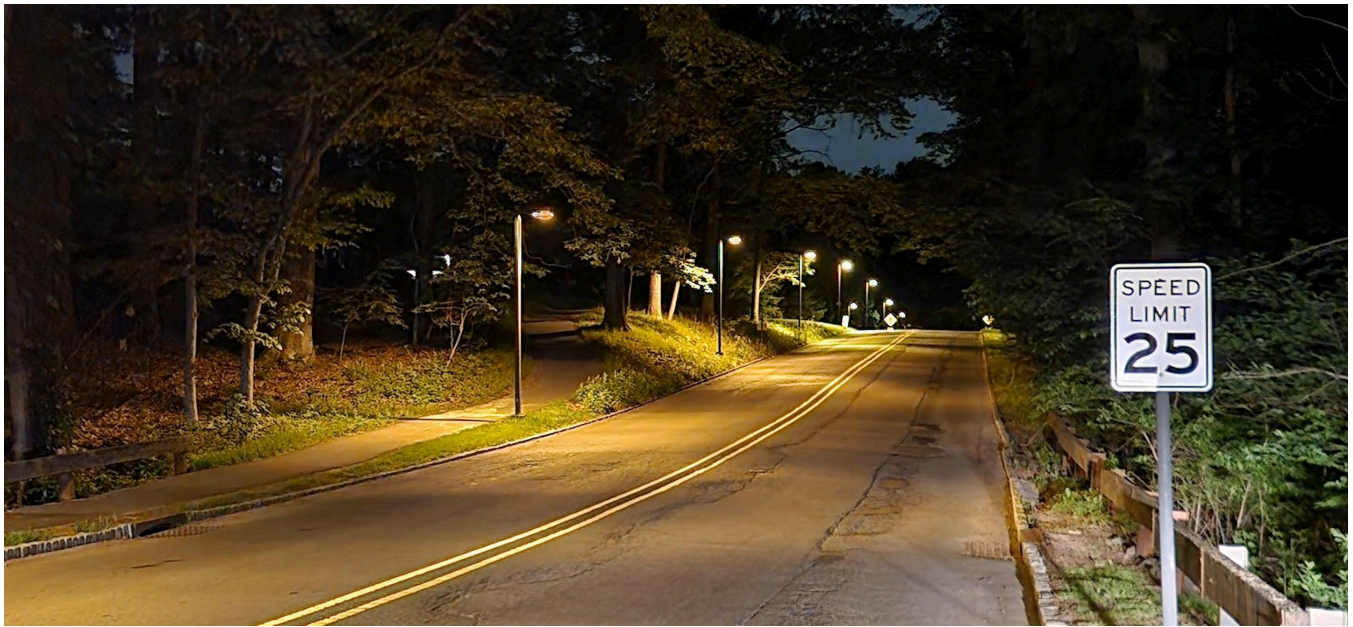
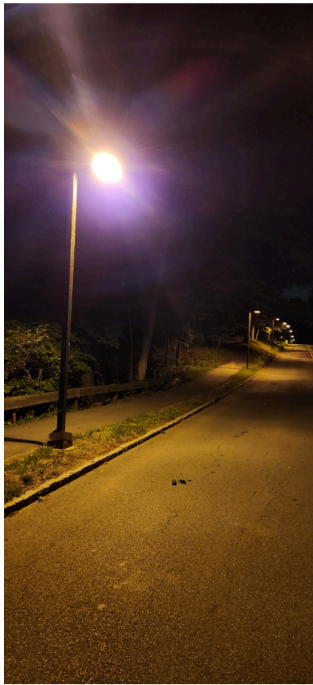
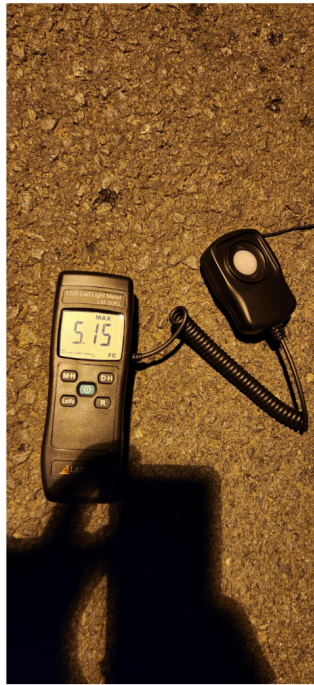
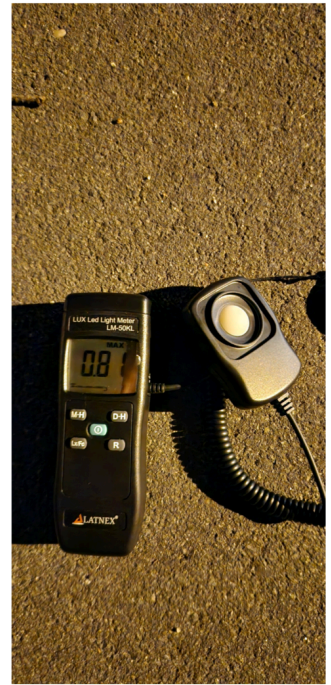
(B) Low post shoebox sodium, very well shielded, slightly overlit. *One of the best lighting on campus, even though the backlight is not desirable at other parts of Faculty Rd. Closer to Broadmead. 5.15 FC directly beneath pole, 0.81 FC between poles, respectively.*

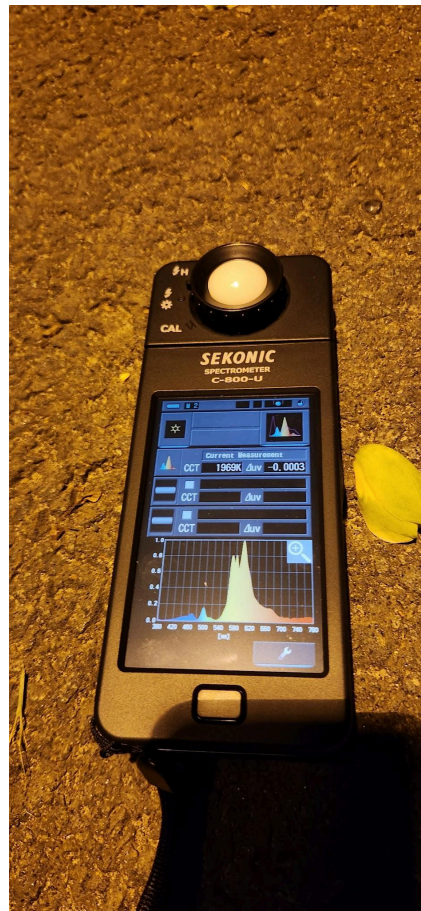
The spectrum peaks around 610nm, corresponding to a color temperature of 1970K.

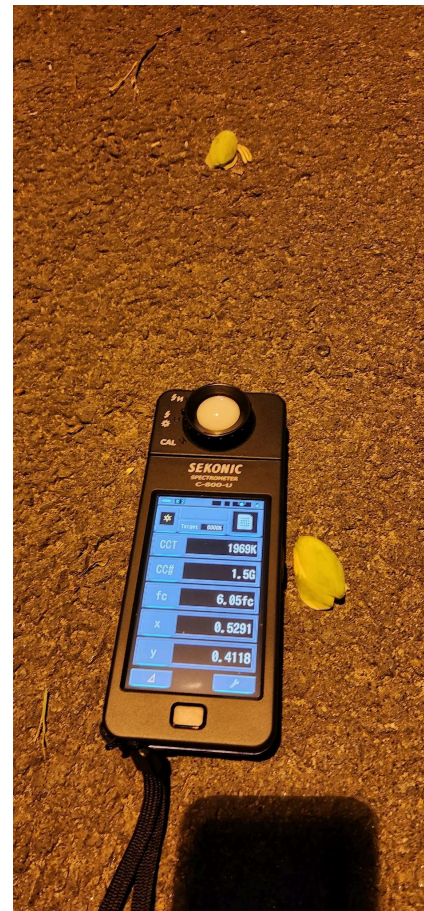
Lighting level under the fixture is 6FC.

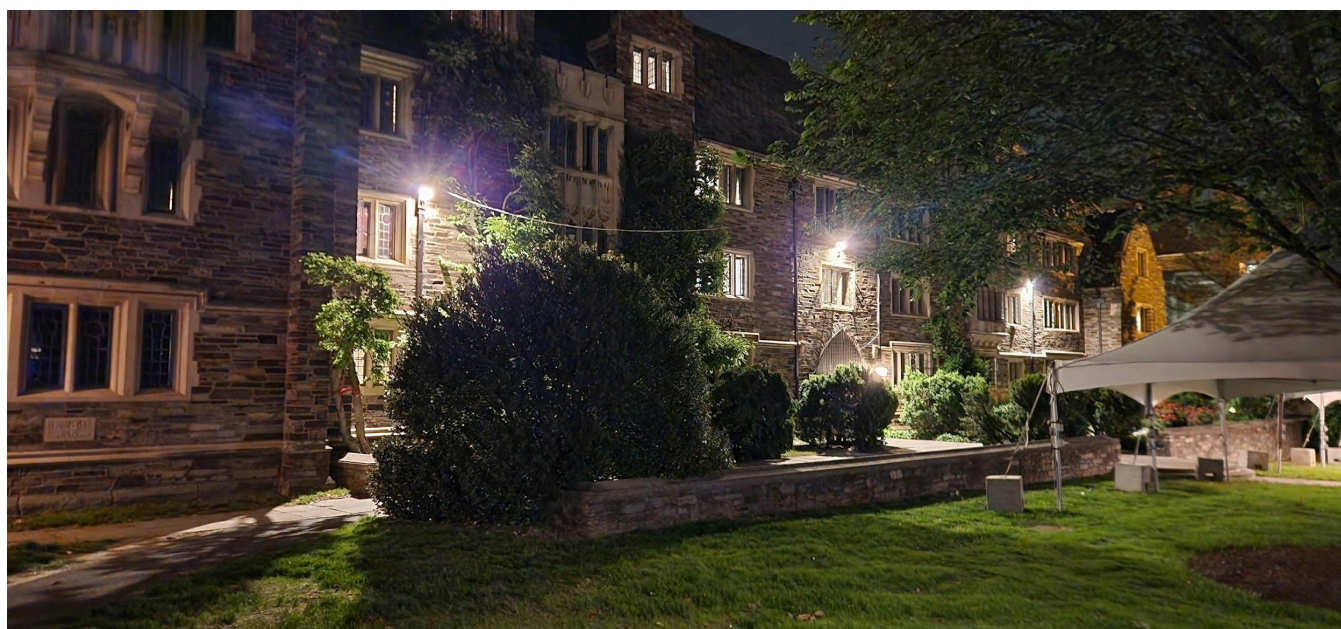
(A) LED area lights on the wall of the building, some right above the windows of the students.

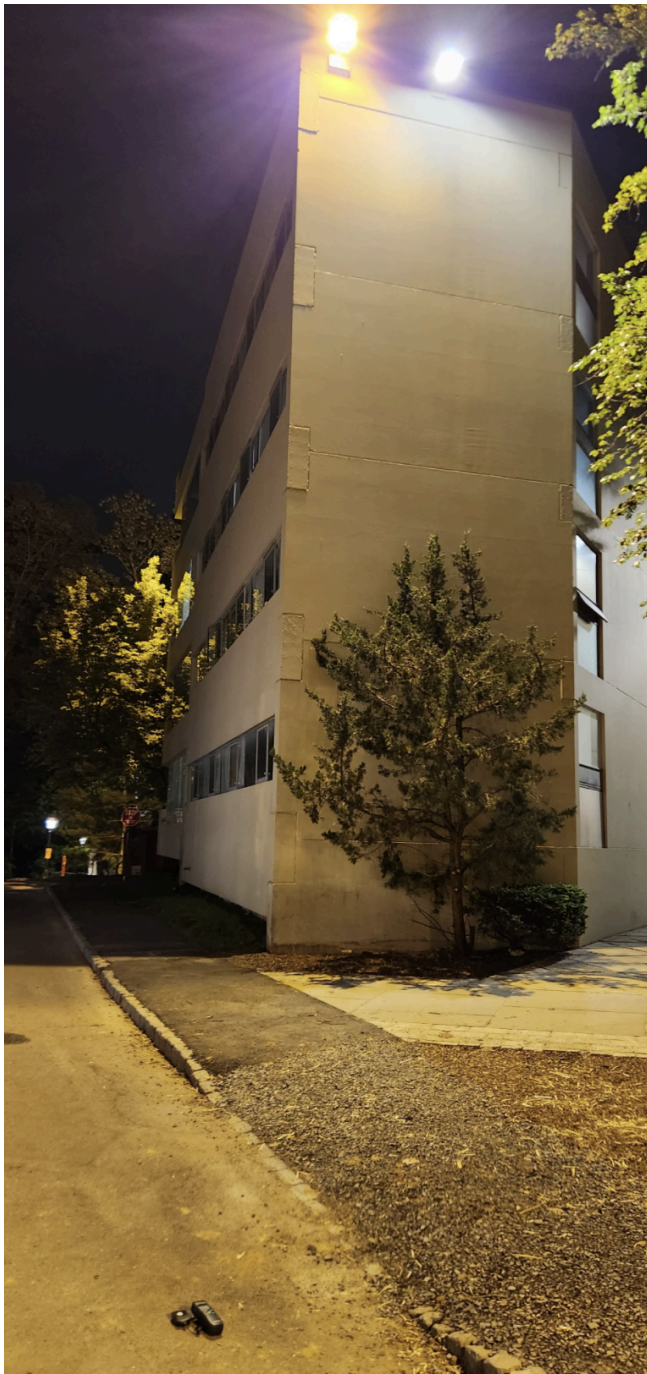
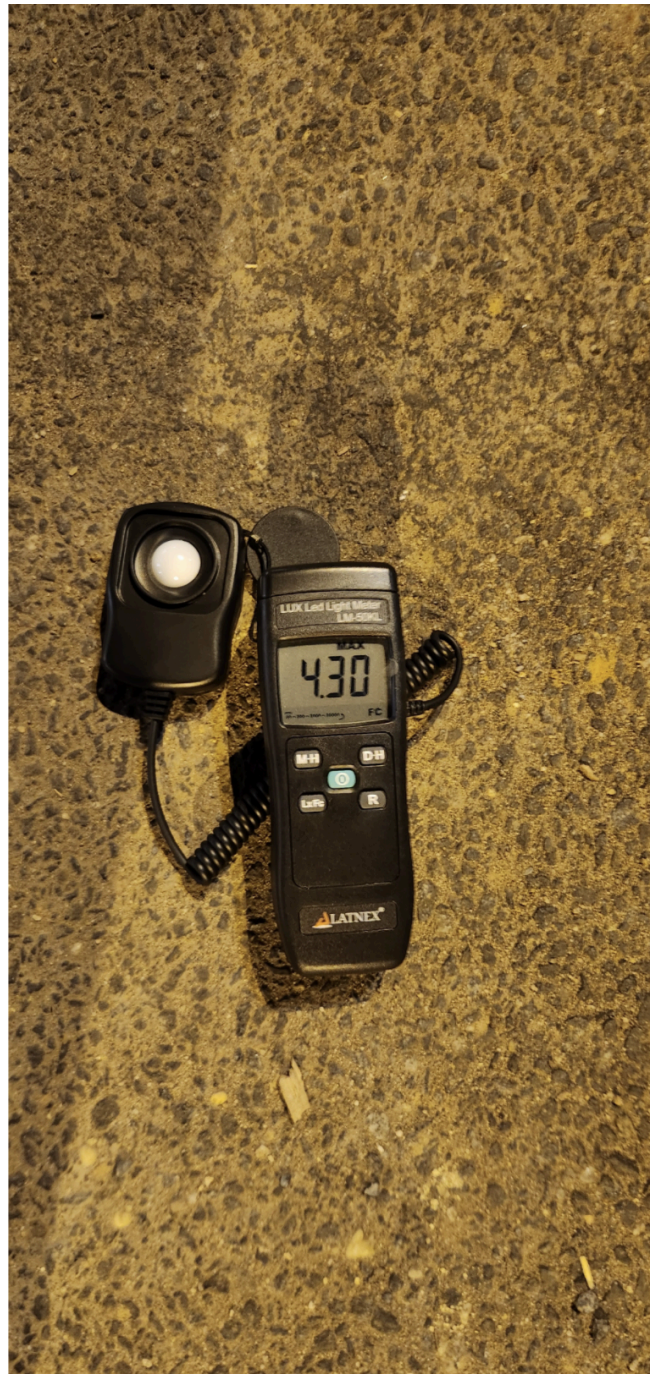
(B) Strong area lights from the top of the building, causing glare and overlighting, 4.3 FC measured. (Desired value 0.3 FC).

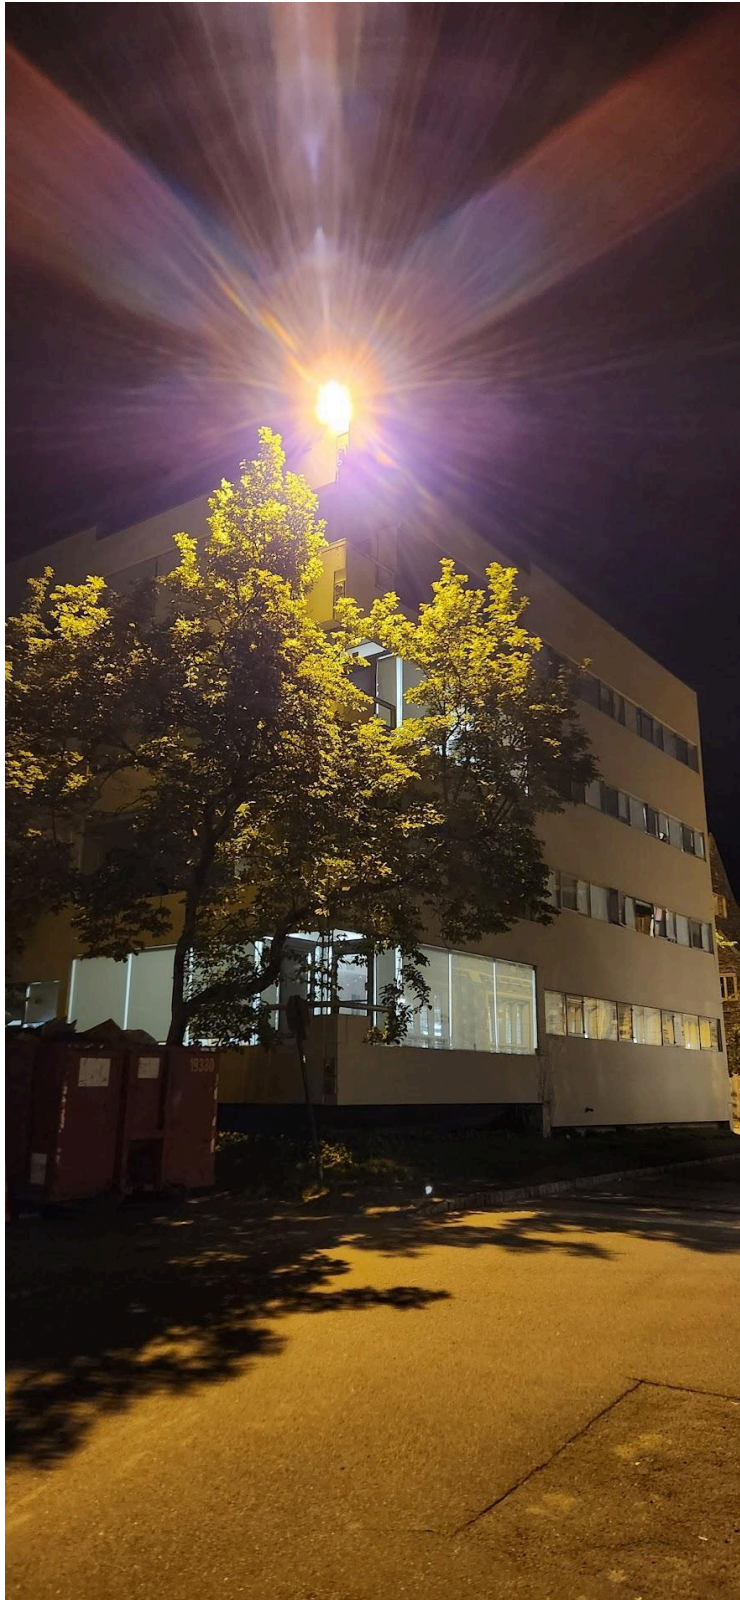
(C) Strong spotlight glare from top of building, majority of light being blocked by top of tree, creating dark patches beneath and blinding passersby.

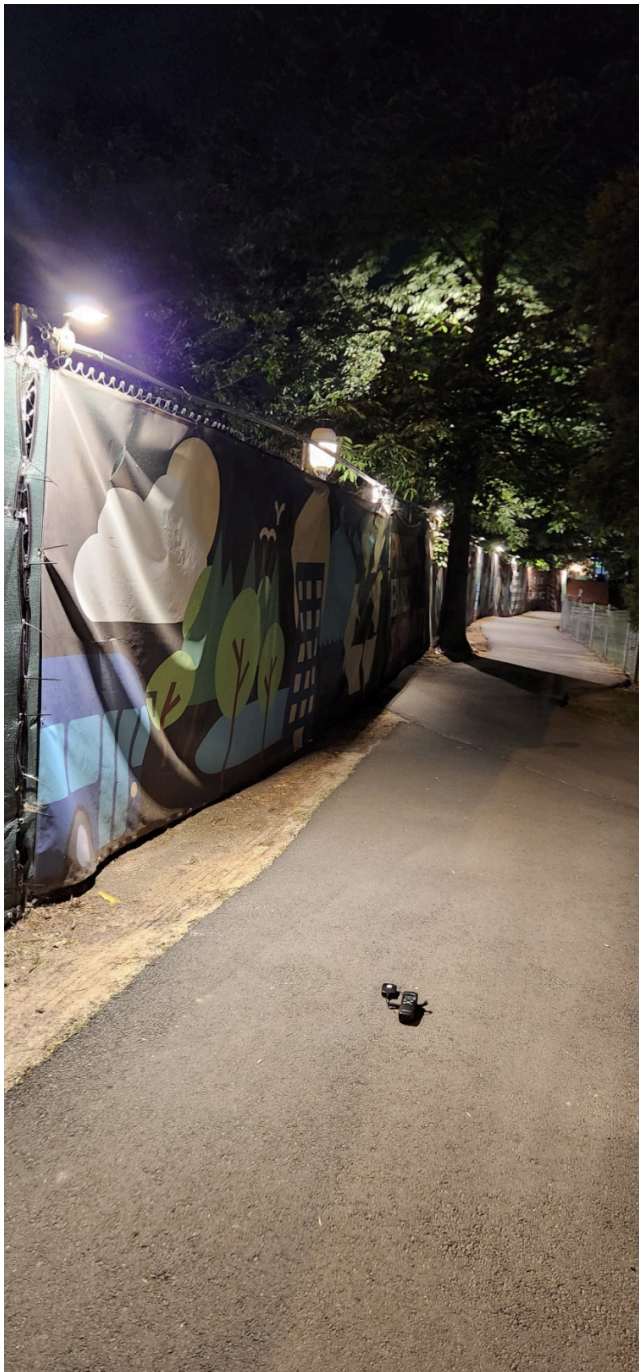
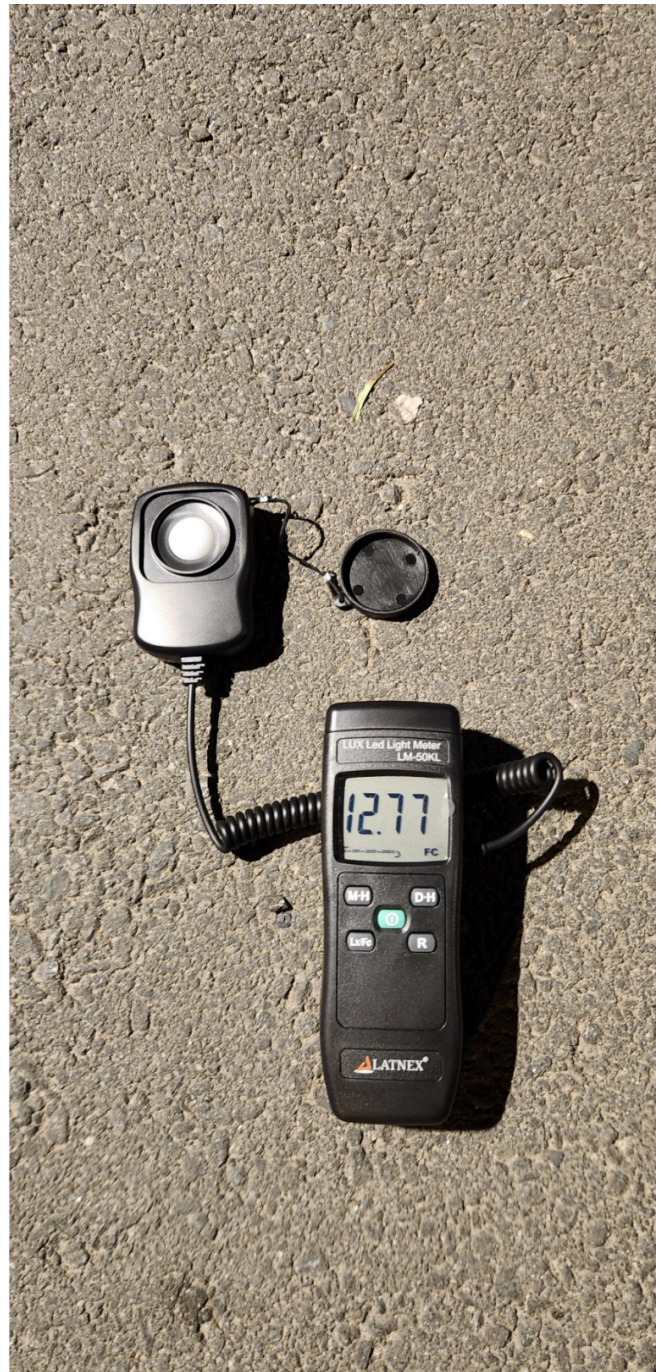
(D) Makeshift LEDs for the walkway. Extremely bright, causing the loss of dark adaptation for other areas that are ~ 10x less lit, 12.77 FC measured.

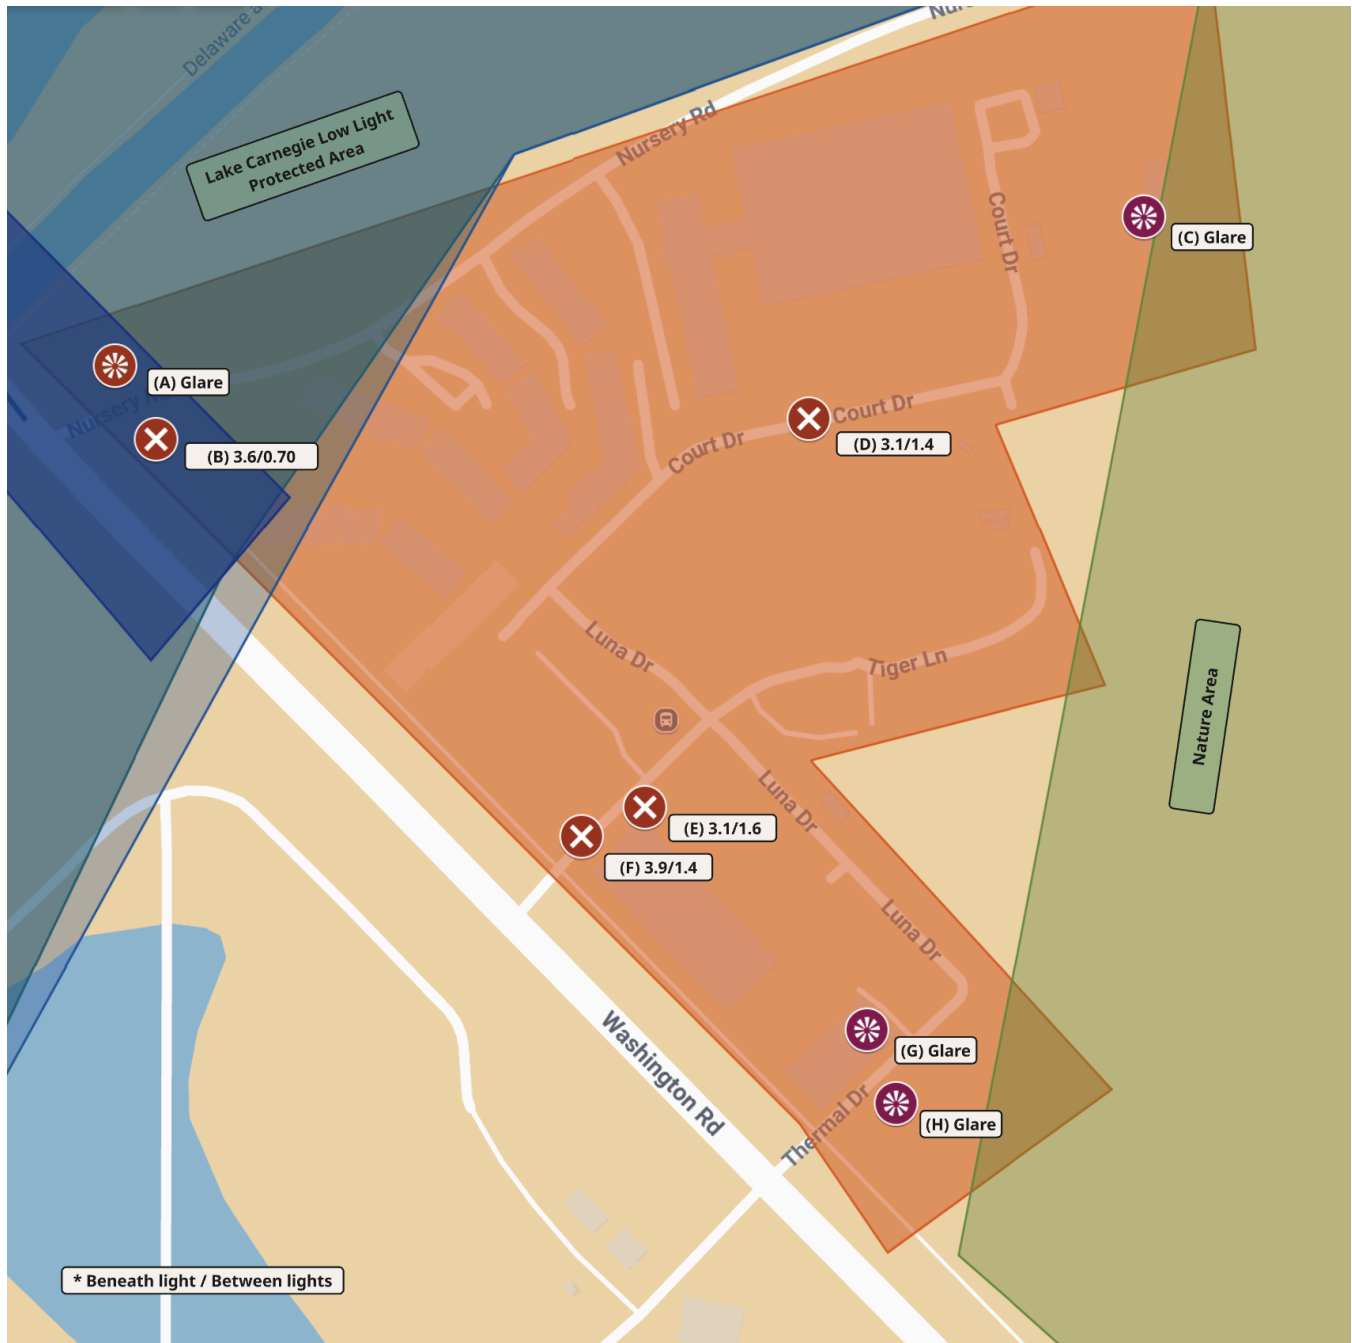
Lake Campus map. Orange shade indicates the current area of the Lake Campus, all of which is overlit. The area borders the natural area of Lake Carnegie and the Canal Park, and the large open grassland extending to Harrison Street and Route 1.

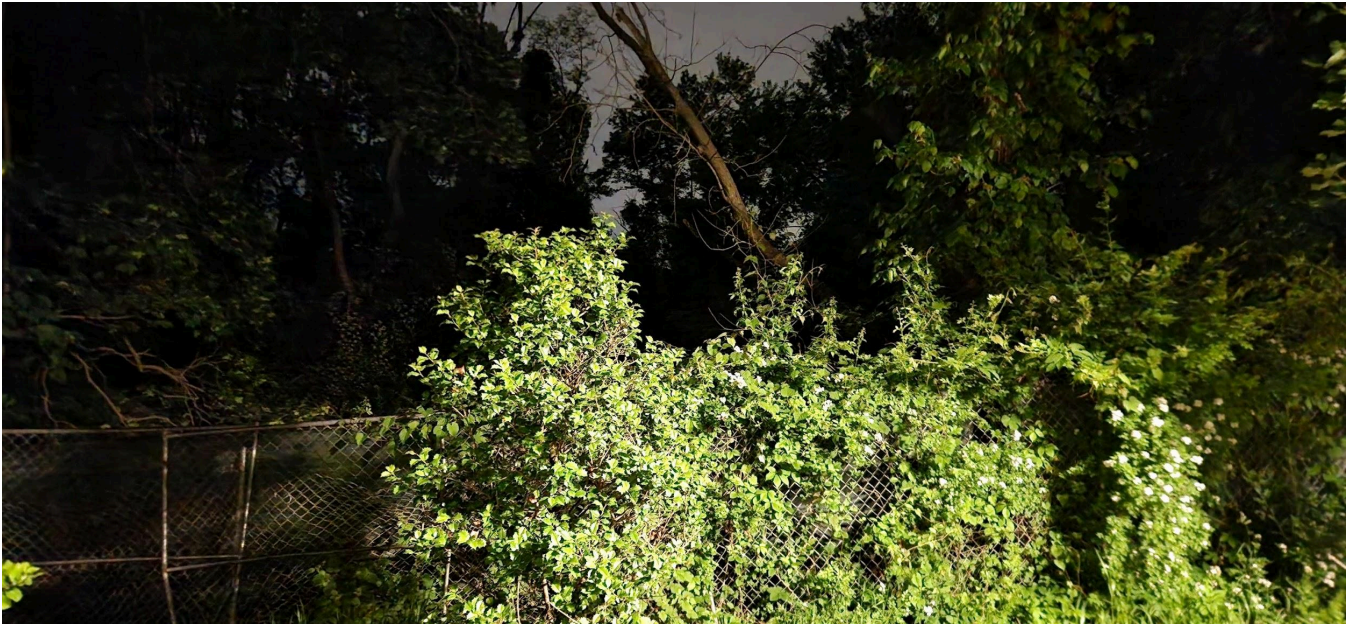
(A) Glare directly into the LZ0 area. Such glare could be avoided with back shielding the Bega 84 fixtures and dimming them.*

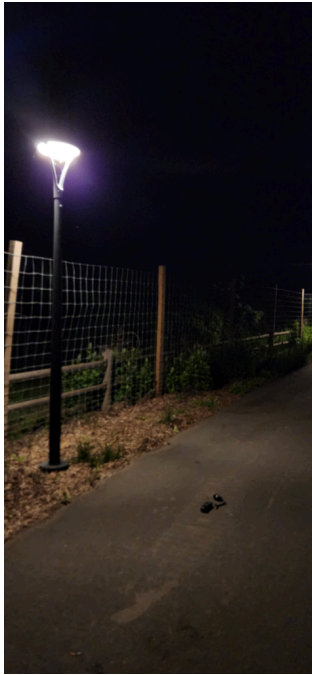
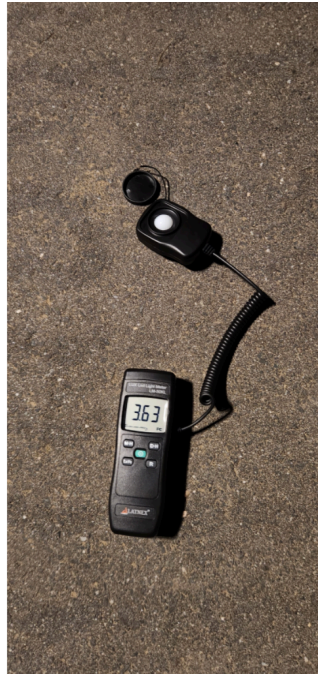
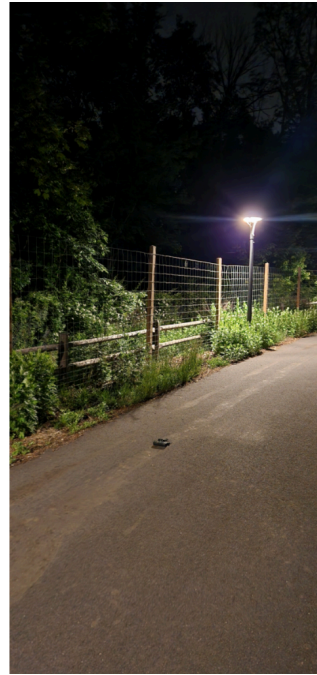
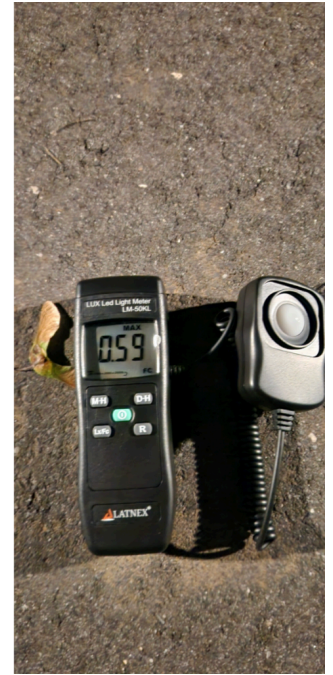
(B) cont. 3.63 FC beneath pole, 0.59 FC between poles, respectively. (Desired: 0.3 FC).

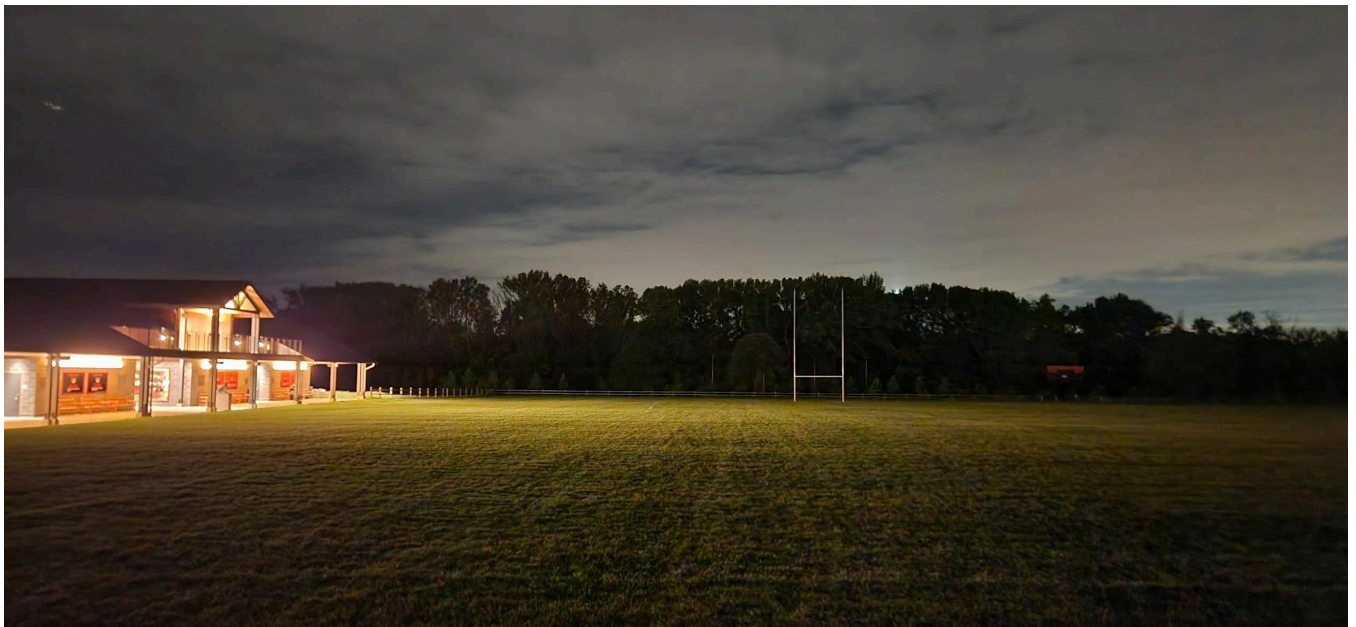
(C) This building at the East edge of the Lake Campus has strong facade illumination all night, flooding the field with light.
