Existing Lighting Conditions at Princeton's Campus

Report by Gáspár Bakos, Department of Astrophysics

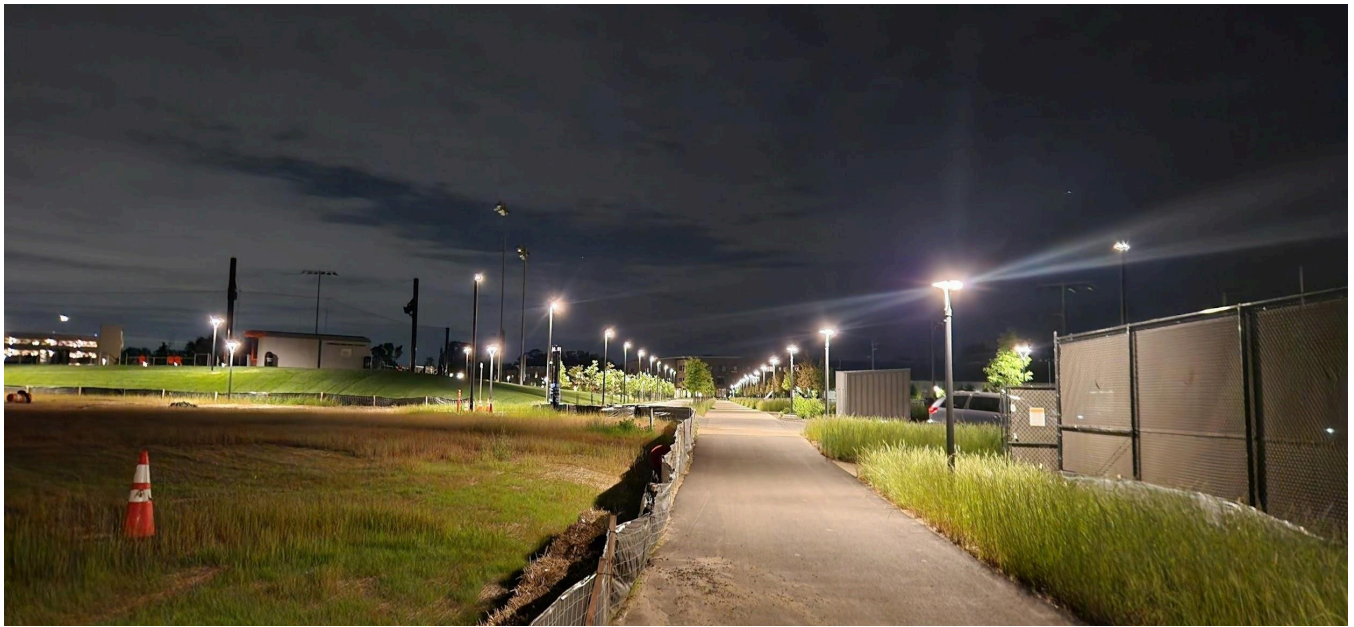
(D) Overall glare at the Lake Campus. This entire area used to be a dark field.

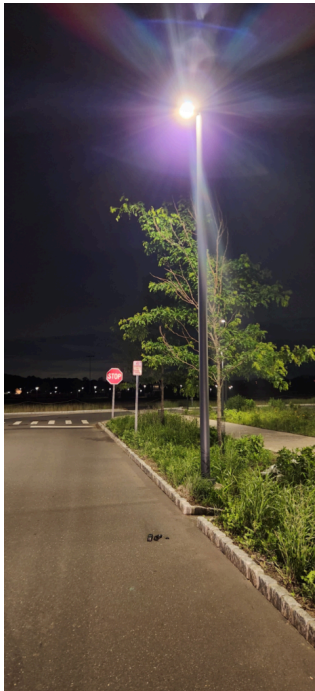
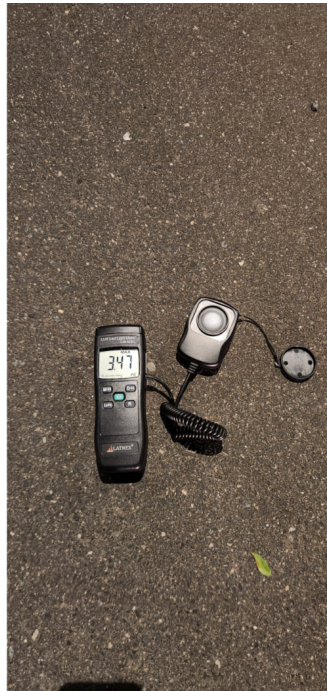
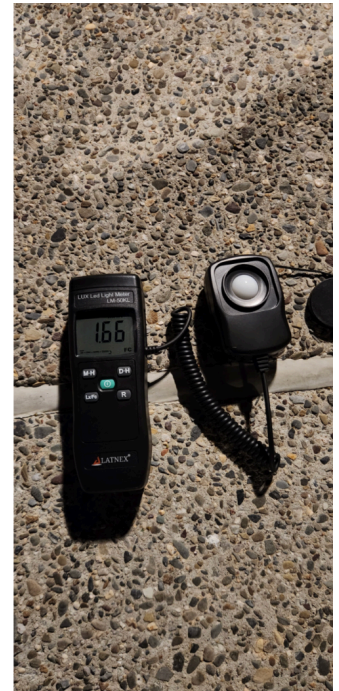
(E) The walkway is excessively illuminated, with both roadway and sidewalk fixtures operating at light levels far higher than necessary, 3.47 FC beneath the pole and 1.66 FC between poles, respectively. (Desired 0.3 FC).

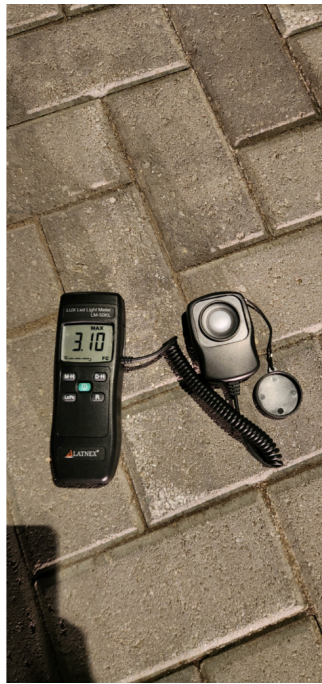
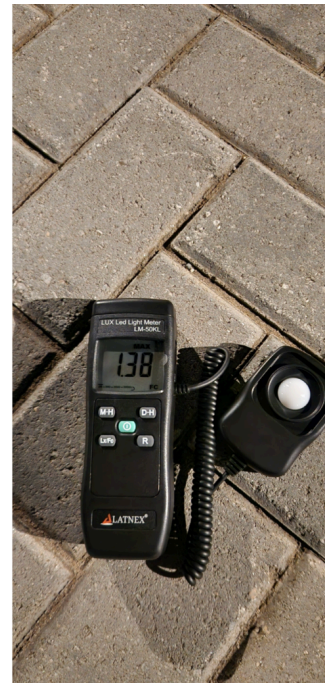
(F) Bright white streetlights, overlit by factors of many, 3.10 FC beneath the pole and 1.38 FC between poles, respectively.

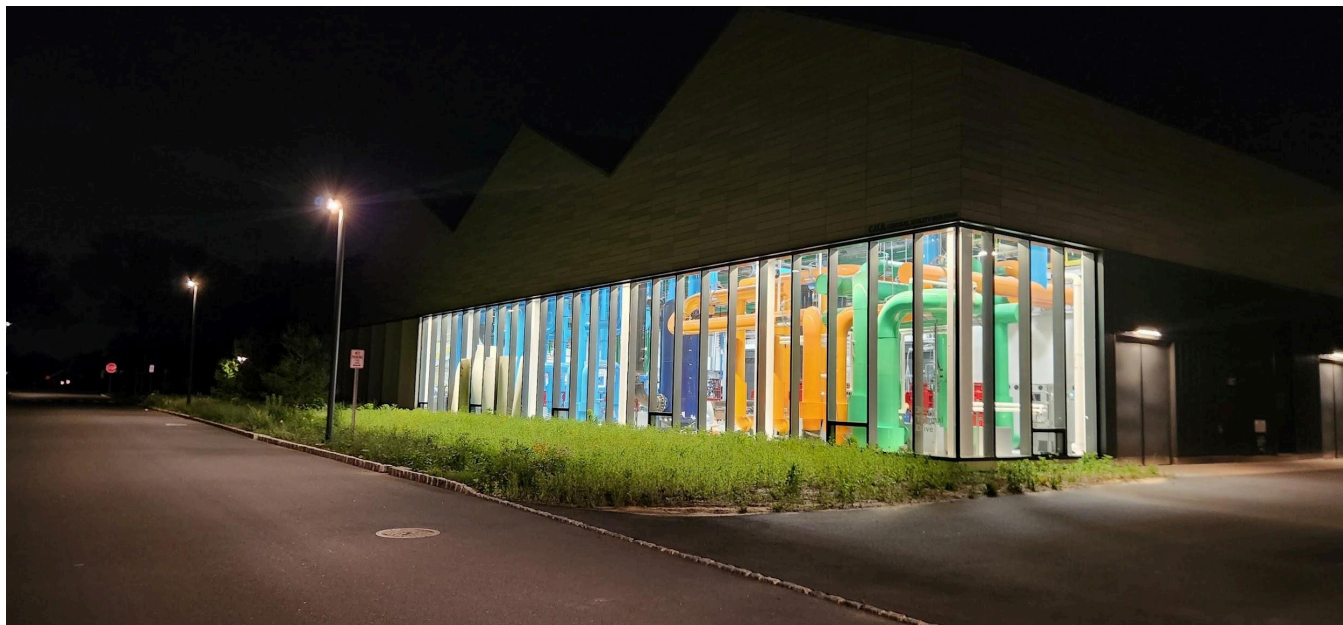
(G) Strong, bright lights floodlight the fields from the thermal facility.

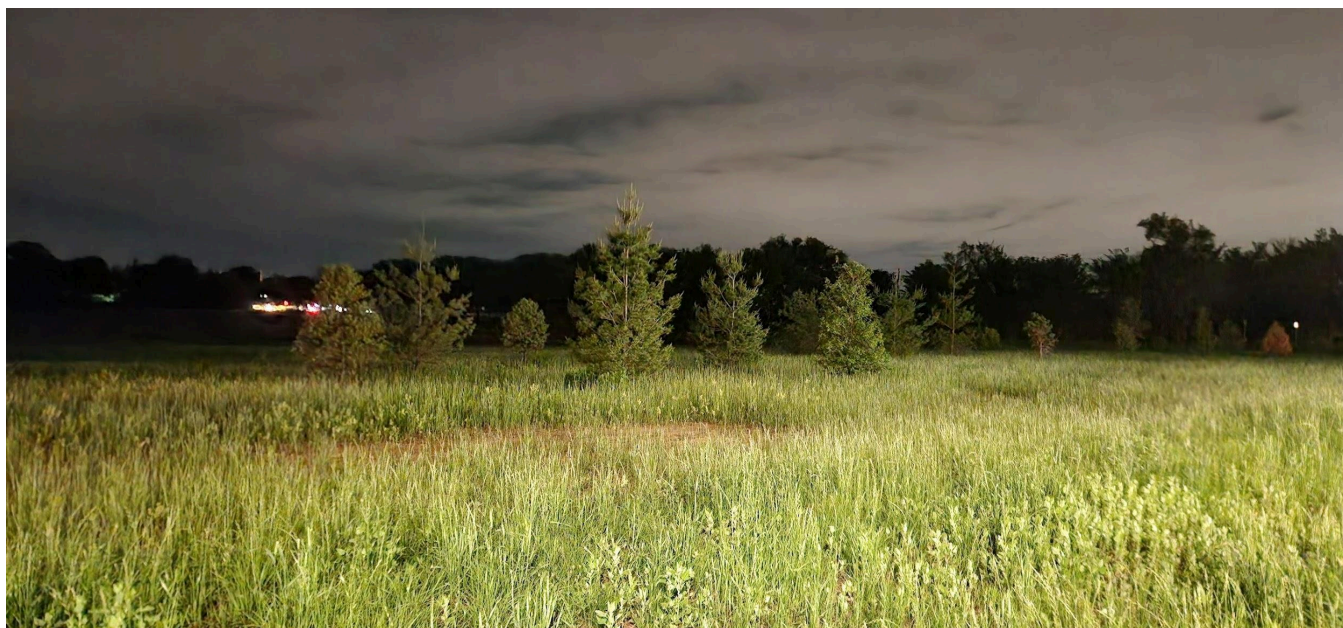
(H) The field is illuminated by the thermal facility. A band with a width of hundreds of meters is lit up.

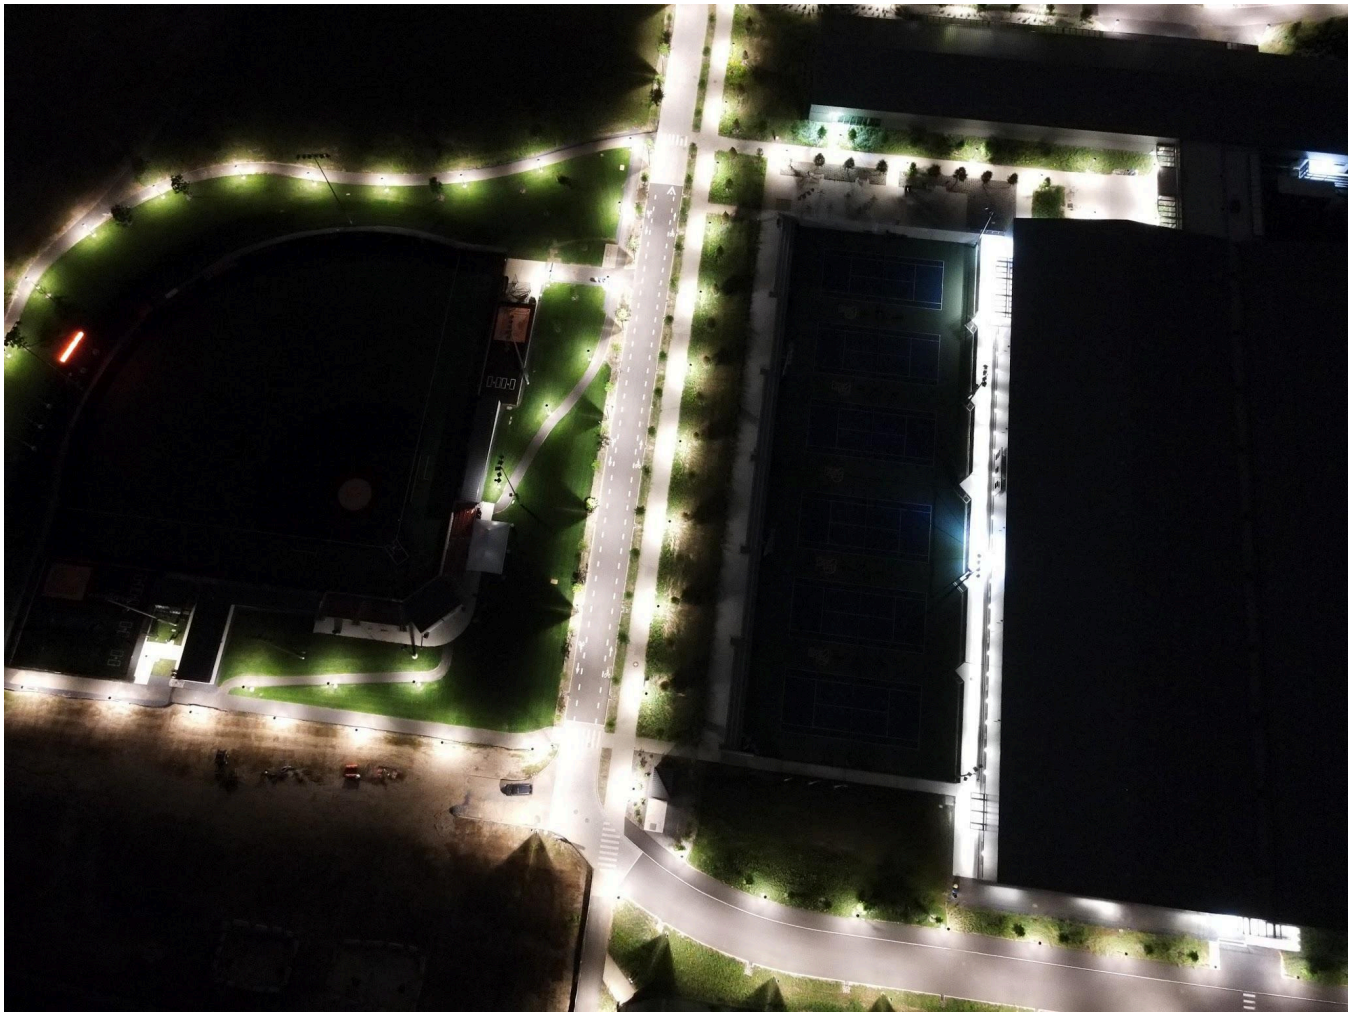
The central alley of the Lake Campus with sidewalk and roadway lights combined, yielding an overlighting of a factor of ~5. Lighting on the edge of the tennis courts with strong vertical light leakage.

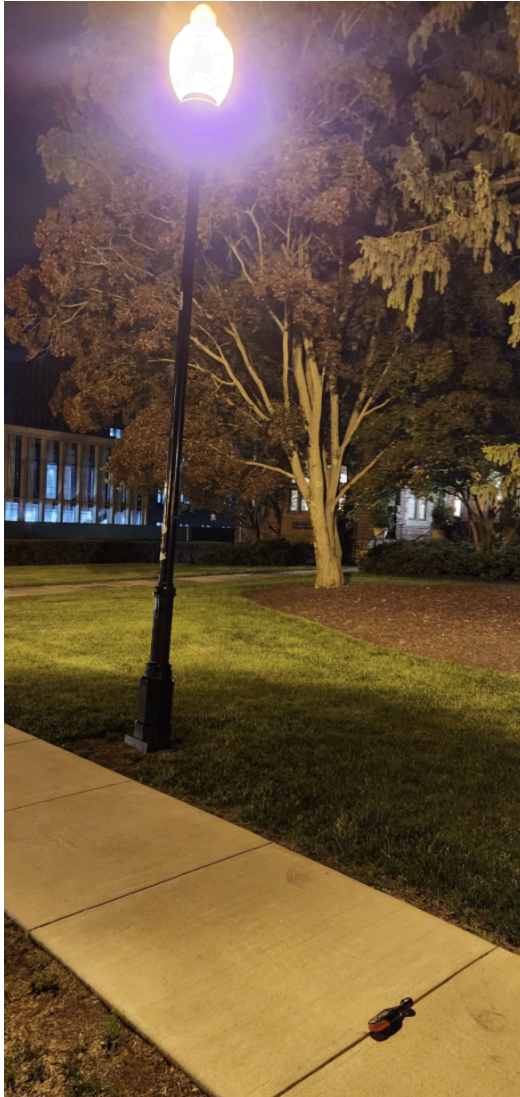
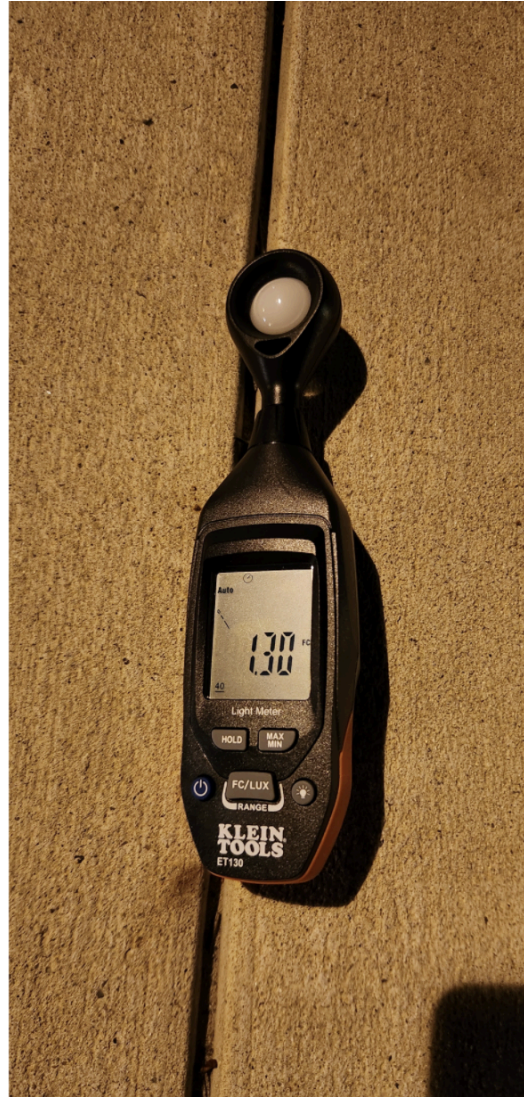
(B) Municipality sodium globes, 1.30 FC measured.

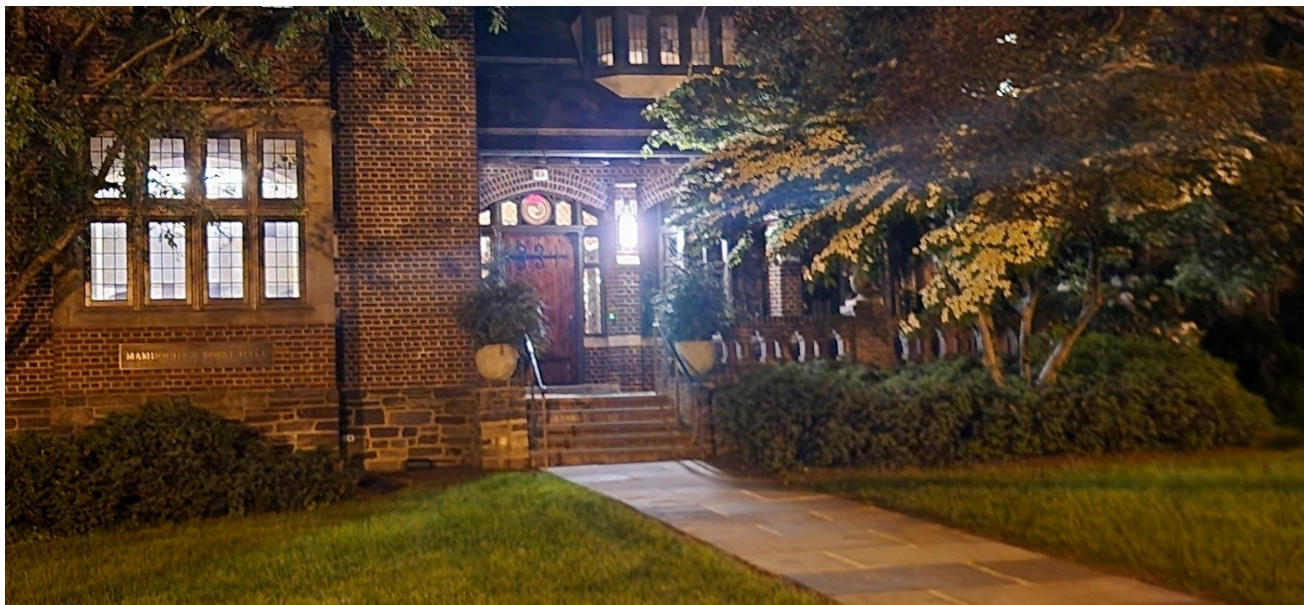
(C) Bobst Hall, a very bright and blinding area light.

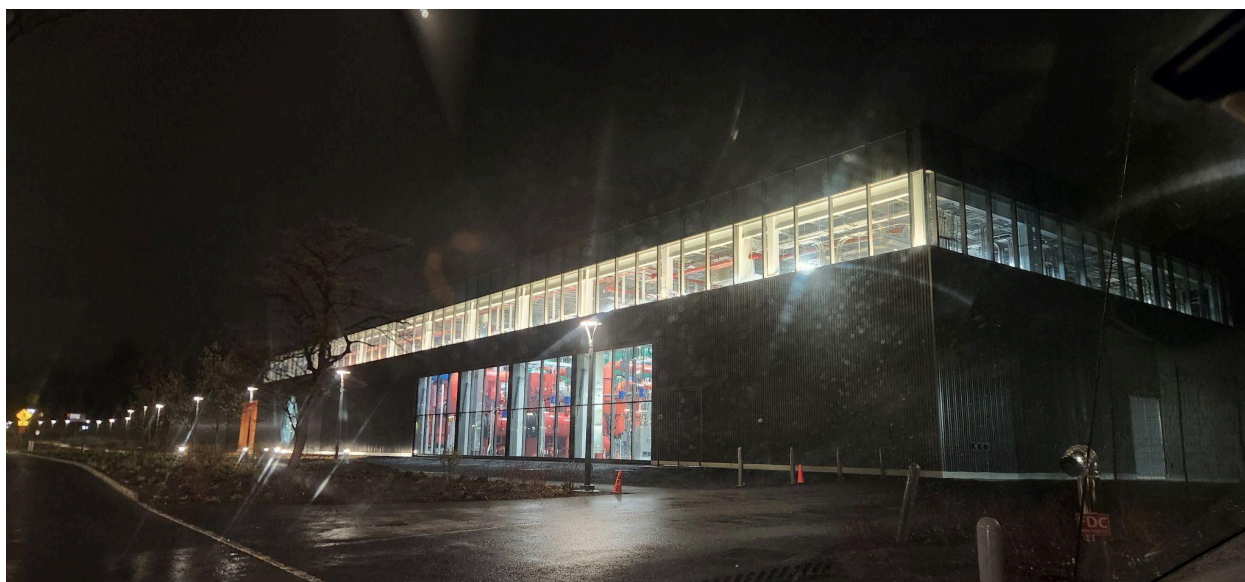
Lights from the geoexchange building from the direction of the lakeside woods (Faculty drive). These lights are on all night, extremely bright and blue, 30-40% of the emission going straight up in the sky, another fraction spilling into the lakeside woods.

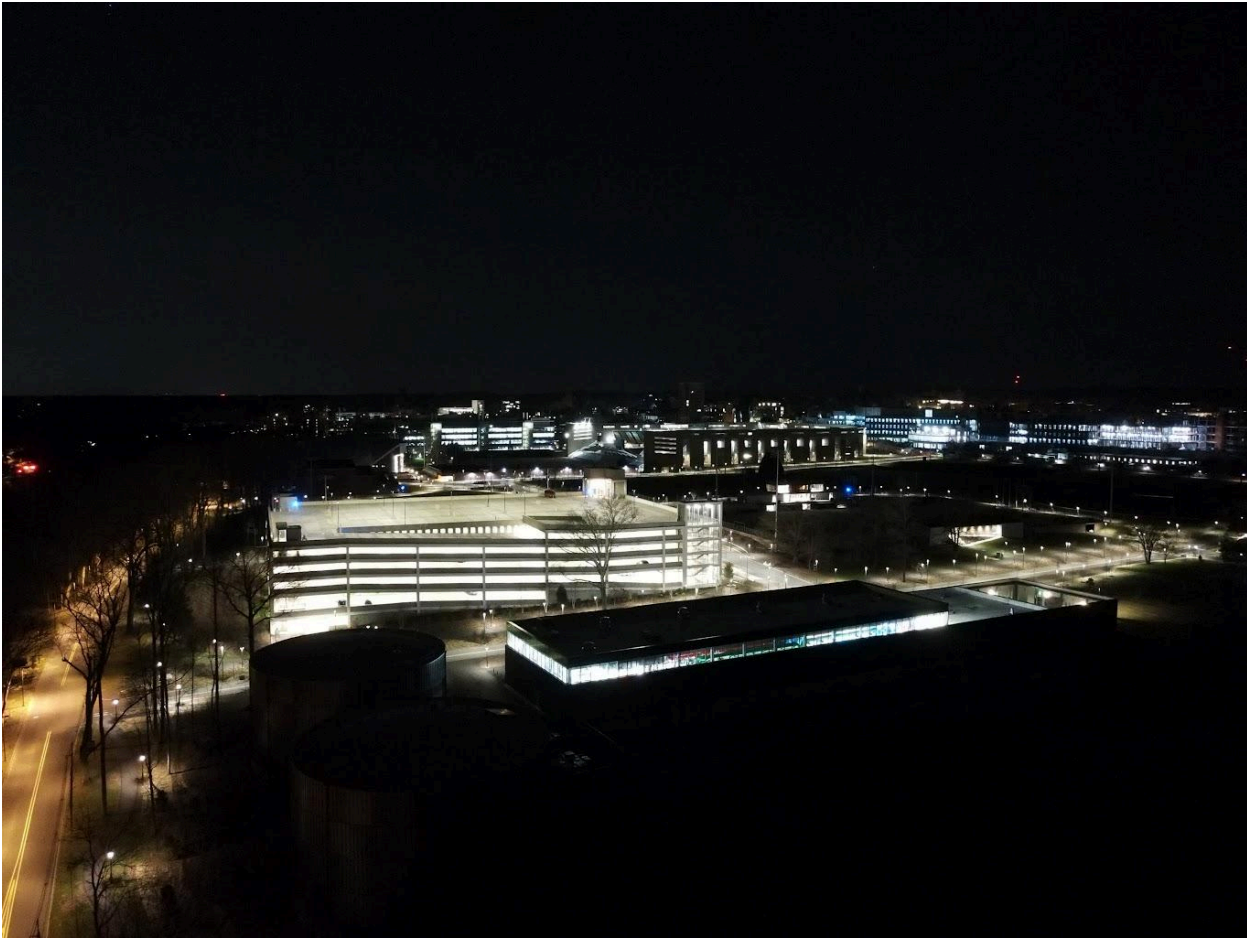
Stadium drive garage and its light spill to Lake Carnegie's woods. This image was taken by a drone, not showing the effect in its entirety. The light spill, as seen from the woods, is much stronger.

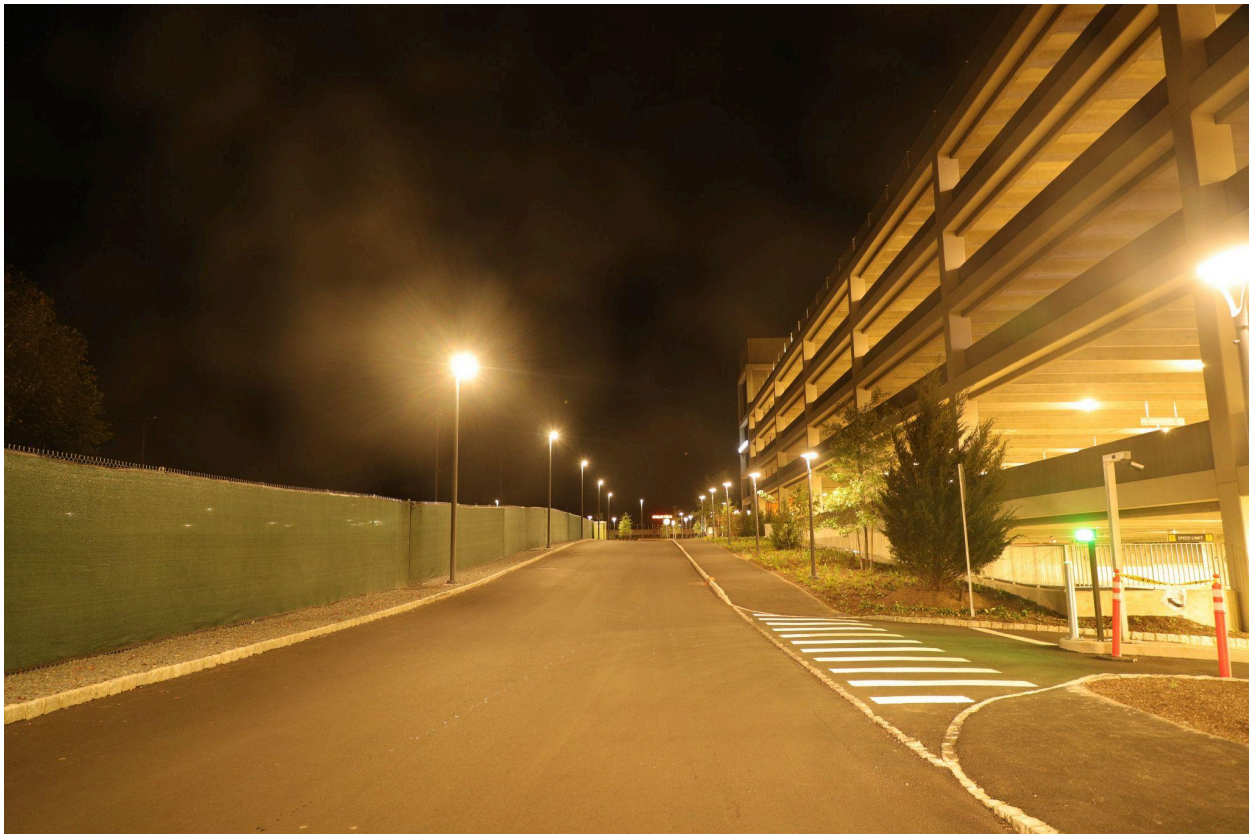
Overlighting and > BUG-0-0-0 fixtures on Stadium Drive spill light in the lakeside woods. See the next image.

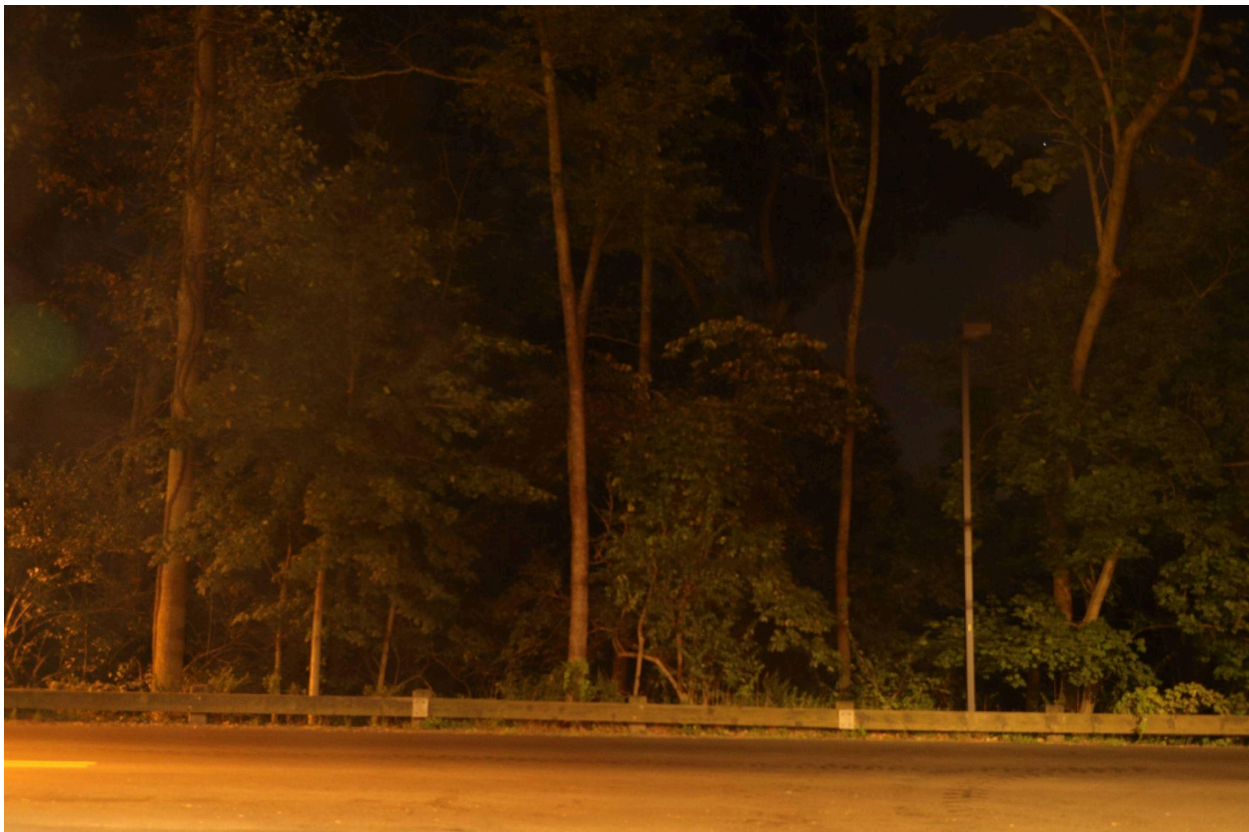
The lakeside woods as illuminated by the lights of Stadium Drive. The standard sodium shoebox streetlight was off during the exposure.

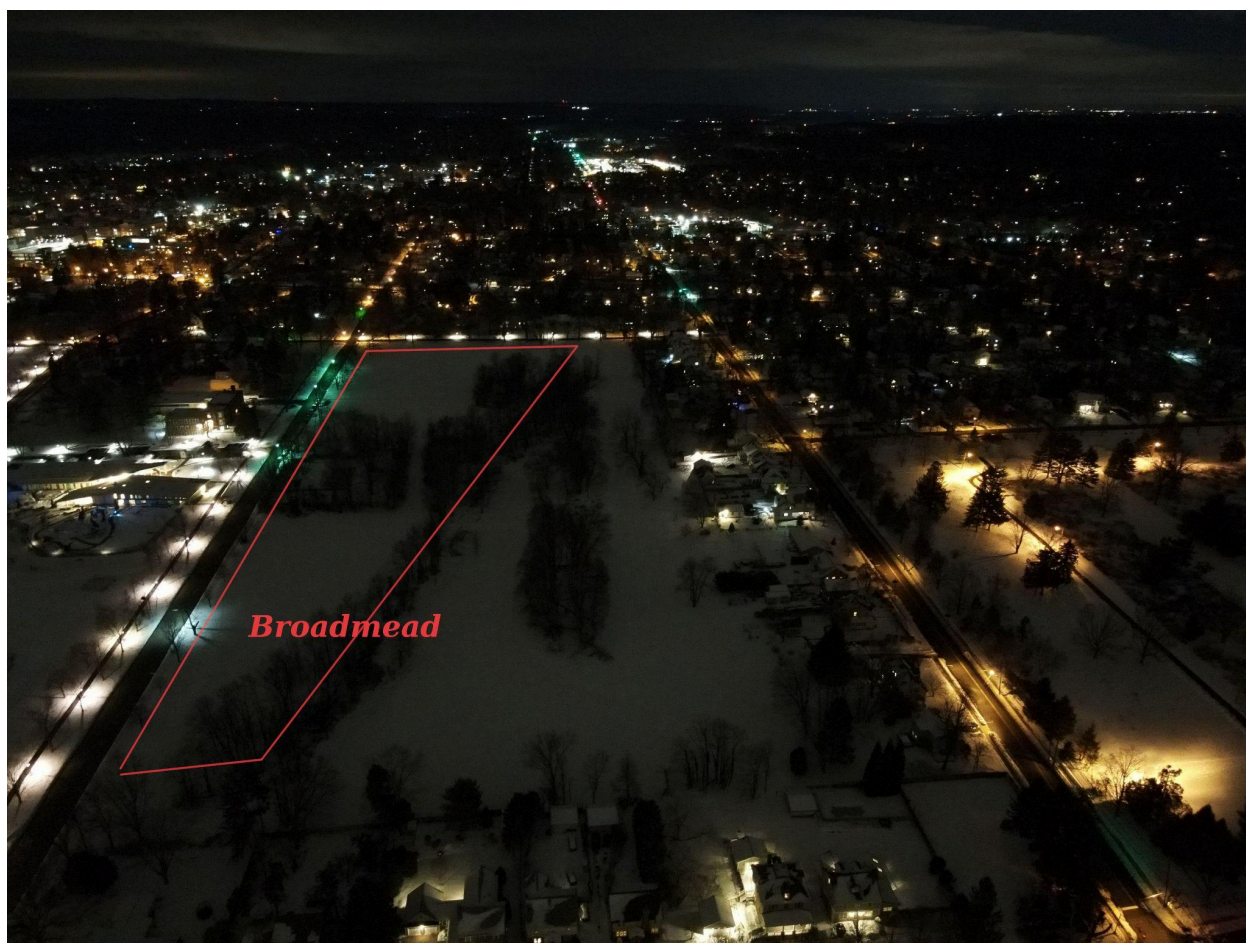
Broadmead with light spill from Broadmead st and Western Way and the Unow nursery.

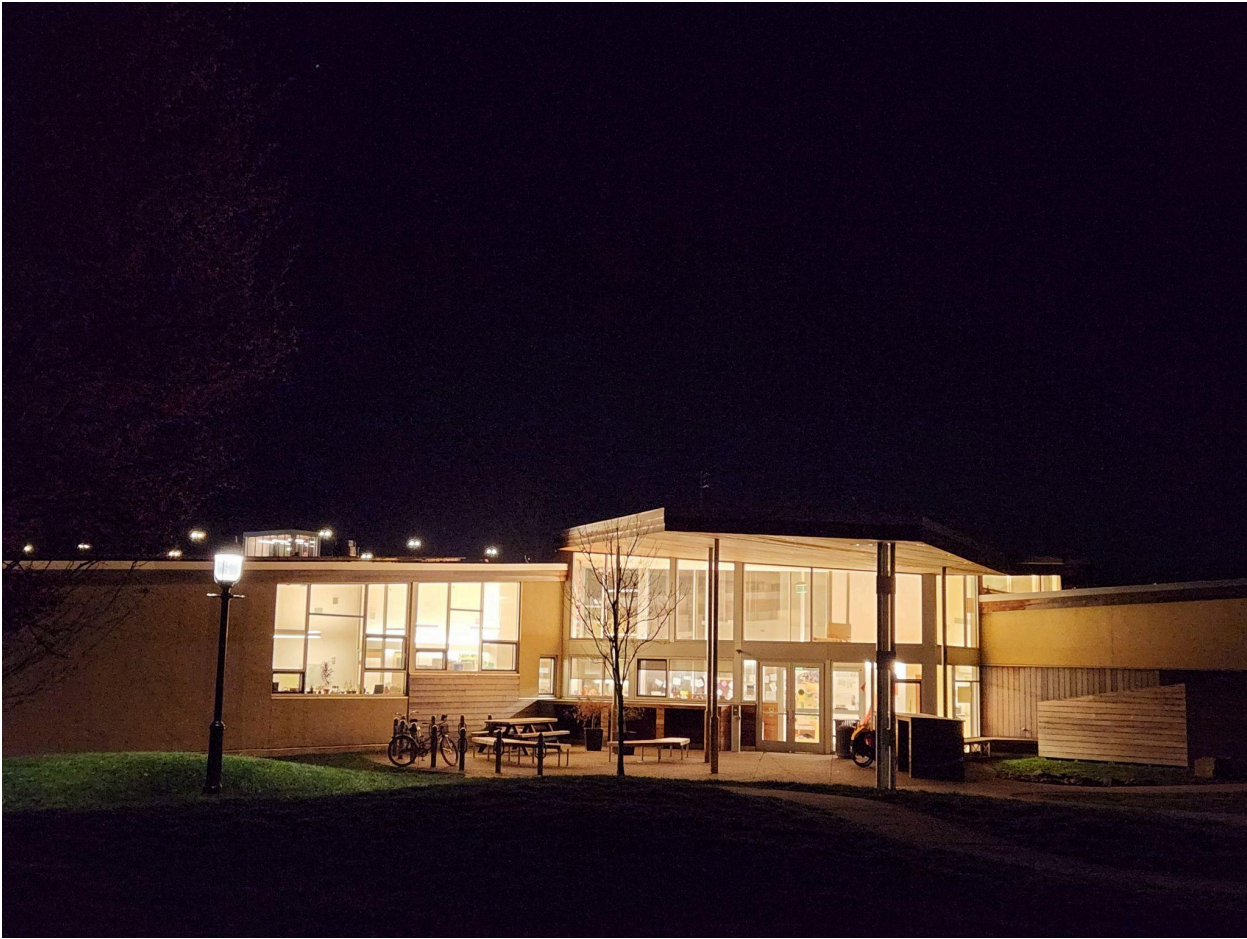
The Unow kindergarten at midnight on an average day. The strong lights spill over to Broadmead.

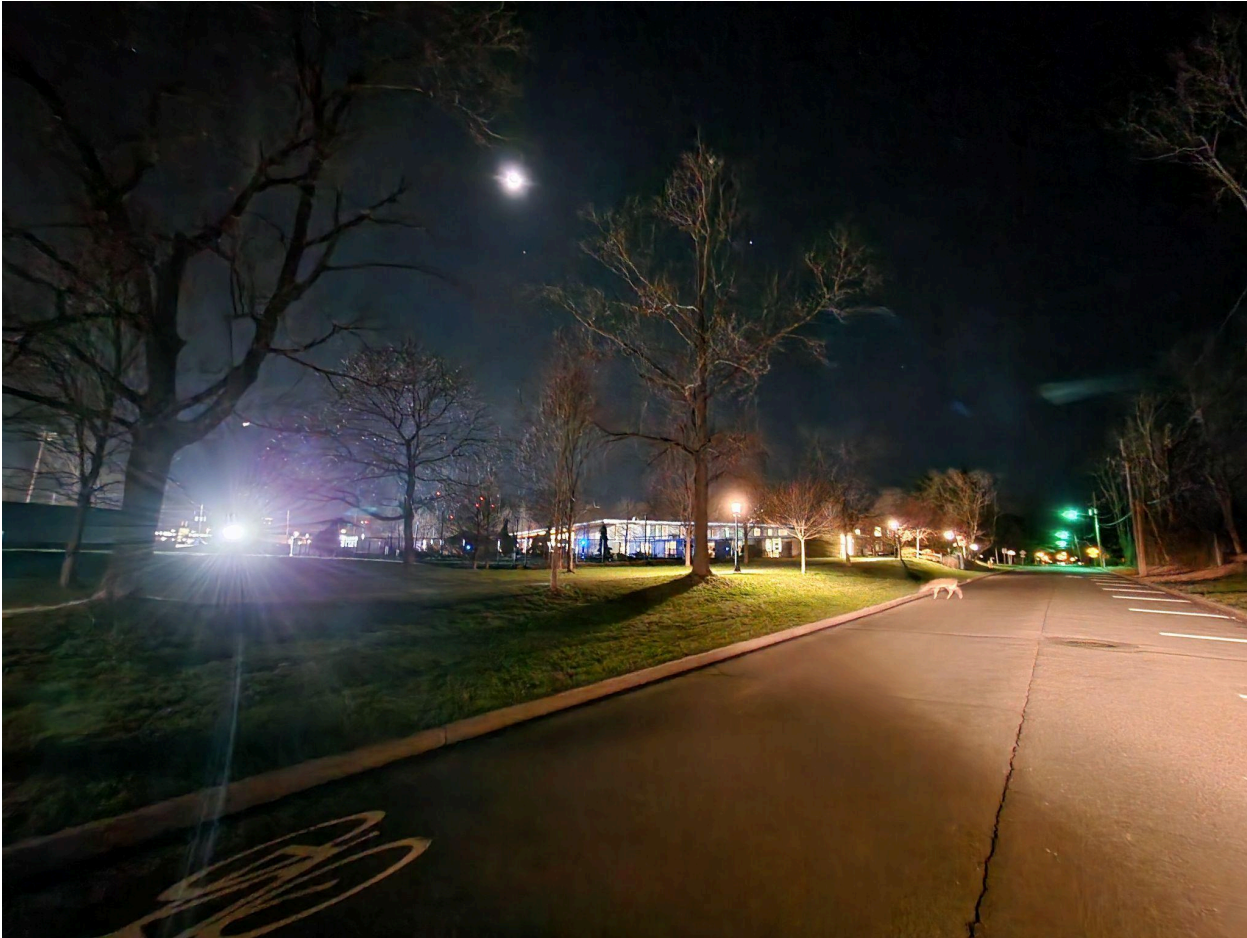
The area between the Geoexchange building and Unow. This ecosystem is essentially lost due to the light spill from the two facilities. This nighttime image demonstrates the very sparse township-cobrahead lights with their blue color, the whiter color from the Penn globe lights, the Unow spill, and a crossing deer.

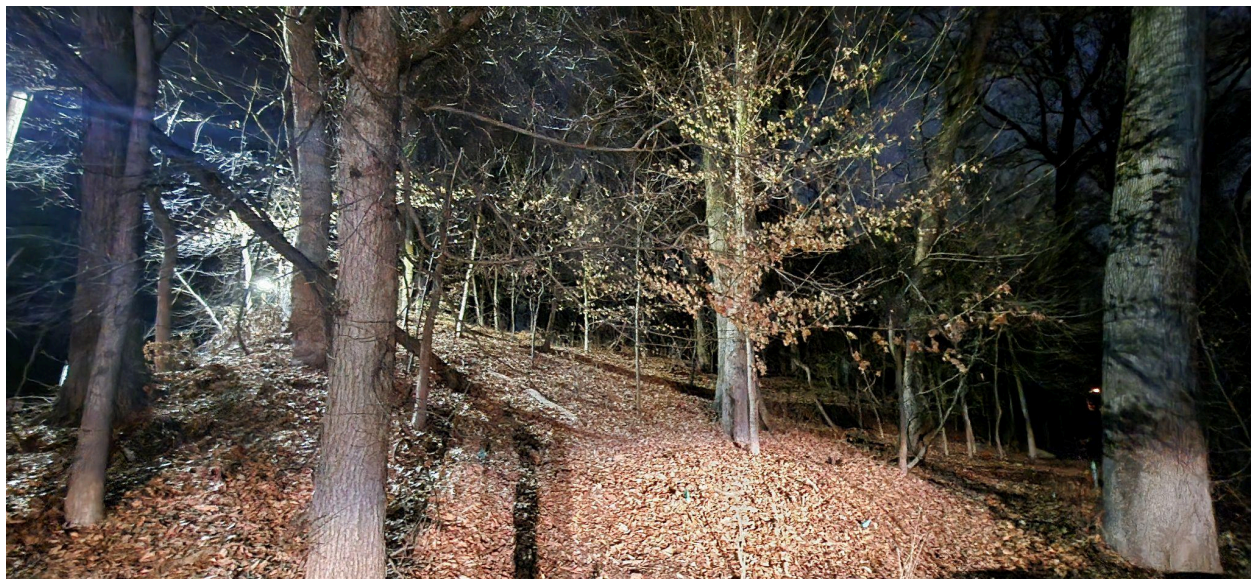
The wooded area on the East side of Washington Road, now lit up by poorly positioned area lights.

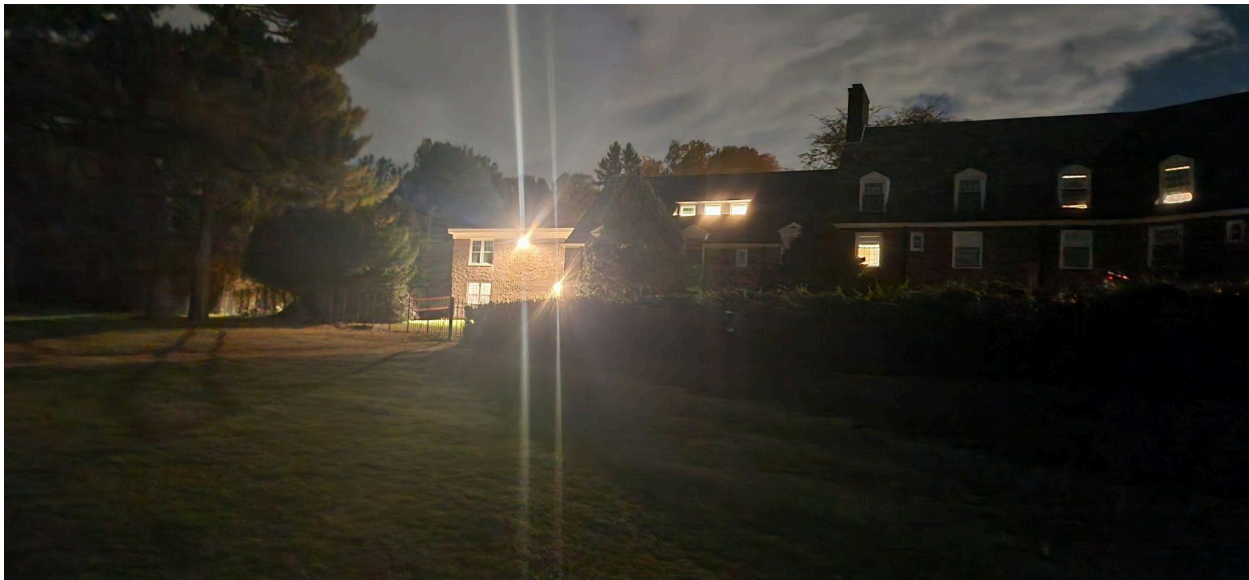
Light spills onto the golf course from two extremely bright and unshielded LED lights.

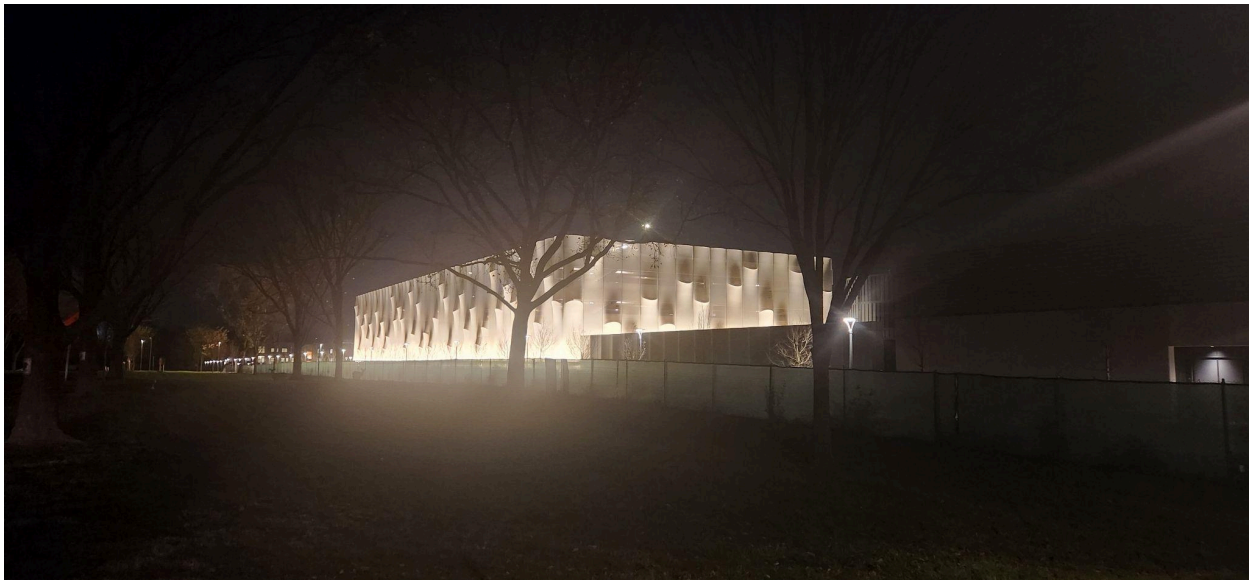
Lake Campus area from the south, approaching from Washington Rd. The facade has been dimmed since.

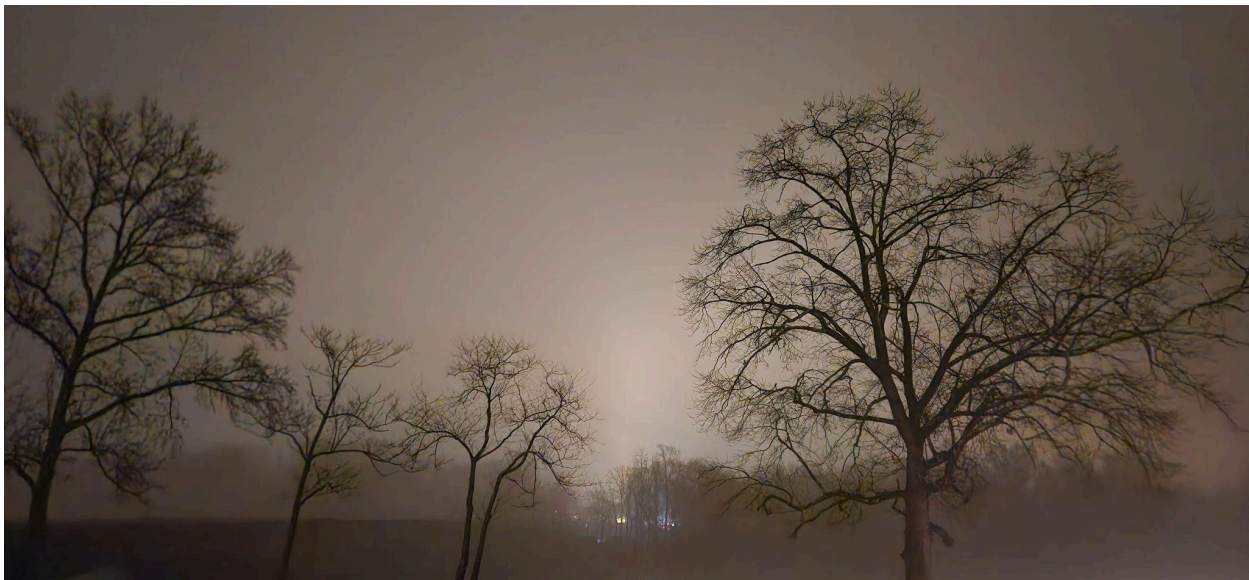
Light glow from the Lake Campus area, as seen from the other side of Lake Carnegie.

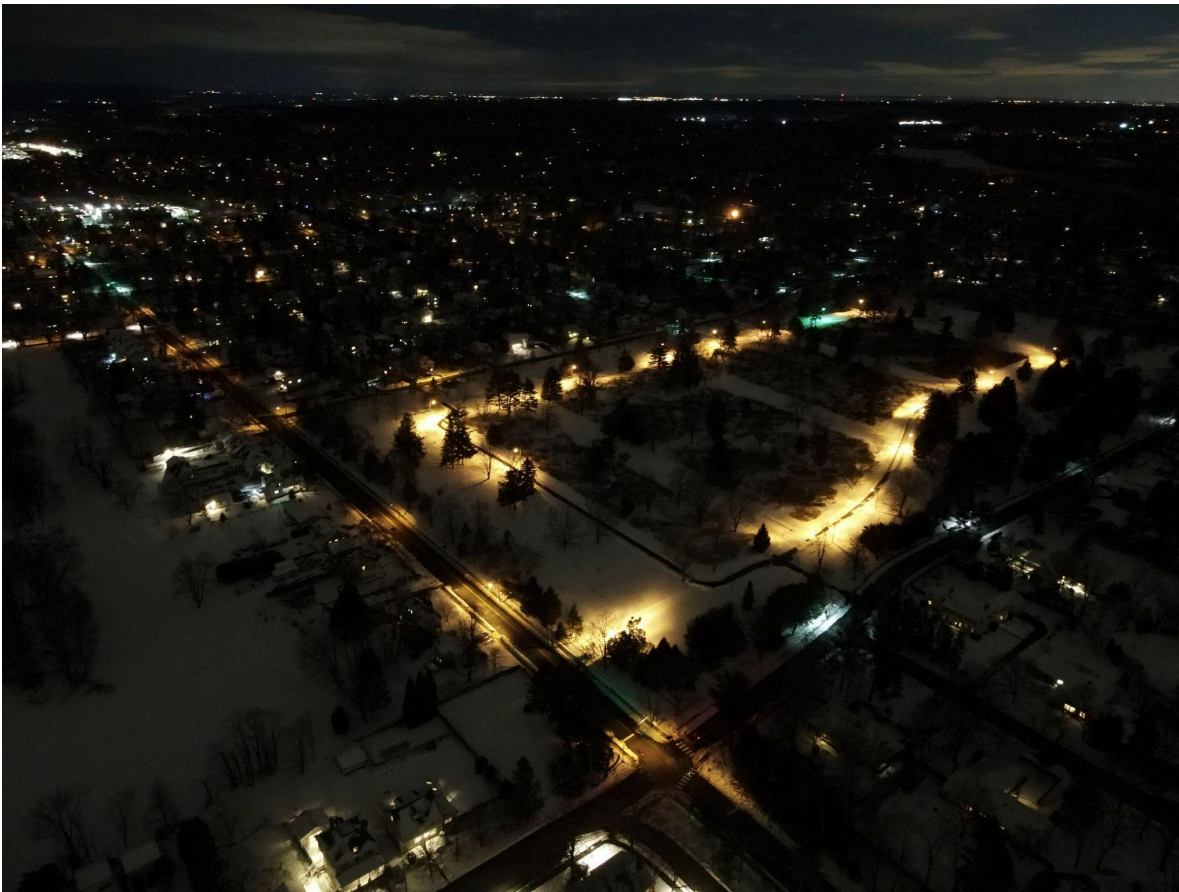
The Butler Tracts at night. Note the strong sodium lighting with the exception of a blue municipality cobrahead in the back.

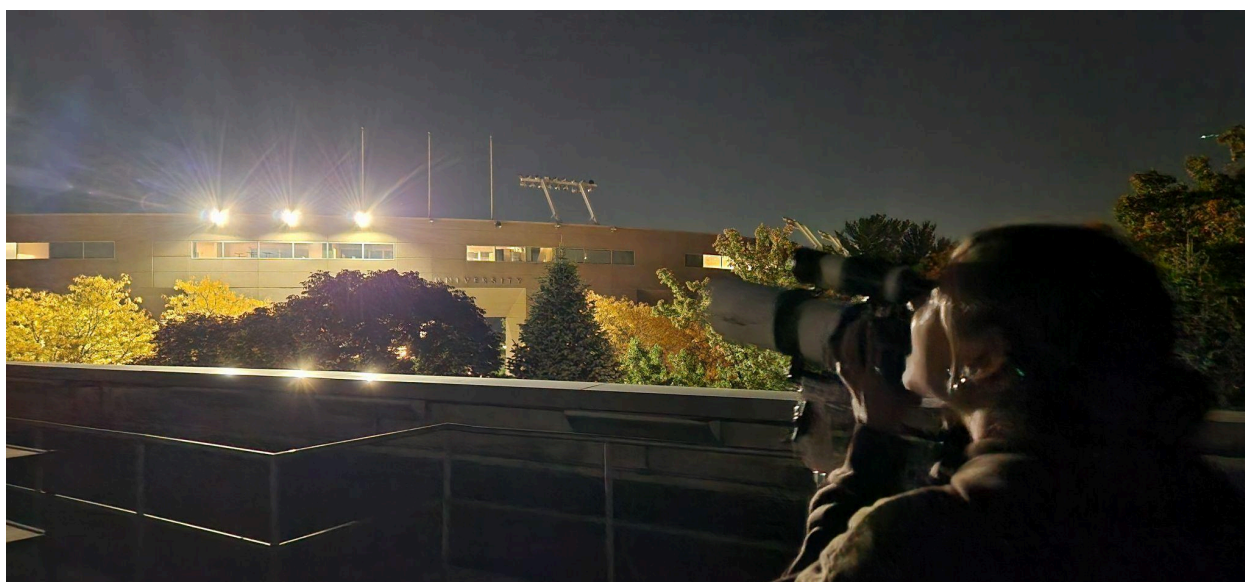
Stadium archway lights are oriented in the direction of Peyton Hall, disabling any telescopic observation. (The student in the picture is pretending to look through the telescope for reasons of demonstration).

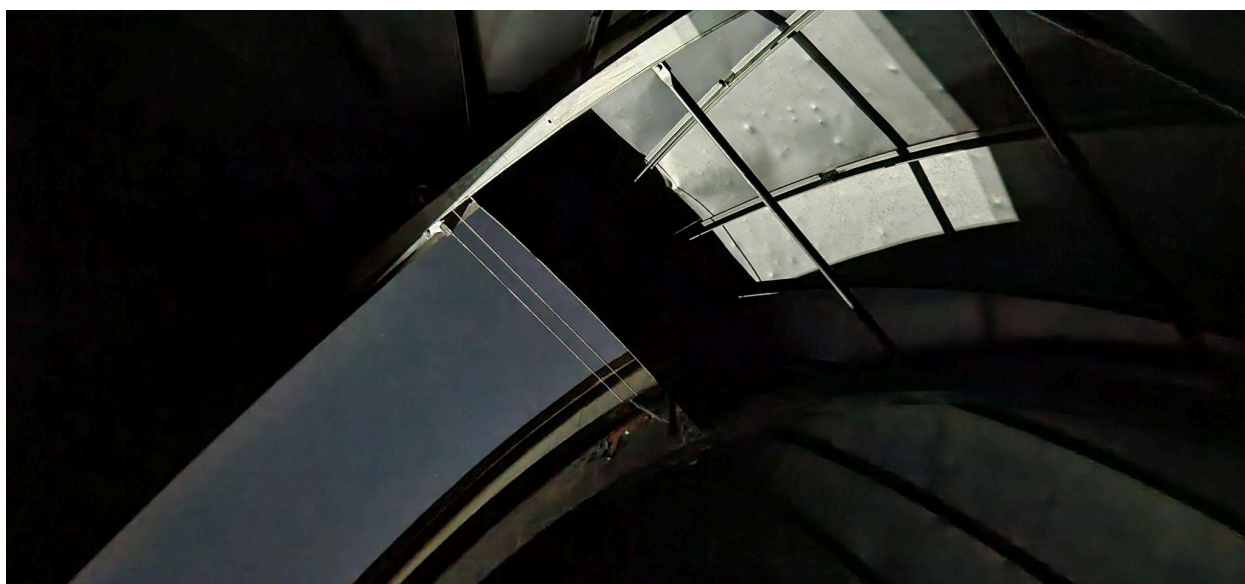
Lights inside the Peyton telescope dome.

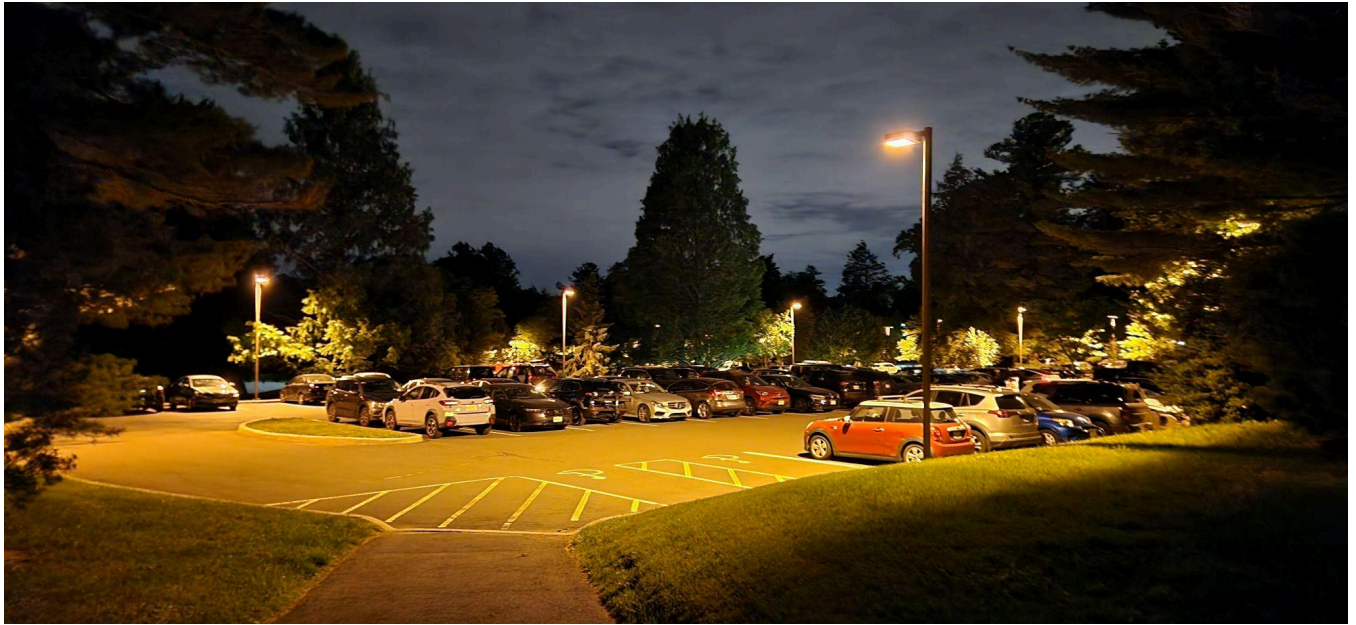
The Graduate School parking lot. Illumination levels are slightly above specs, but light spills out due to non-perfect shielding.

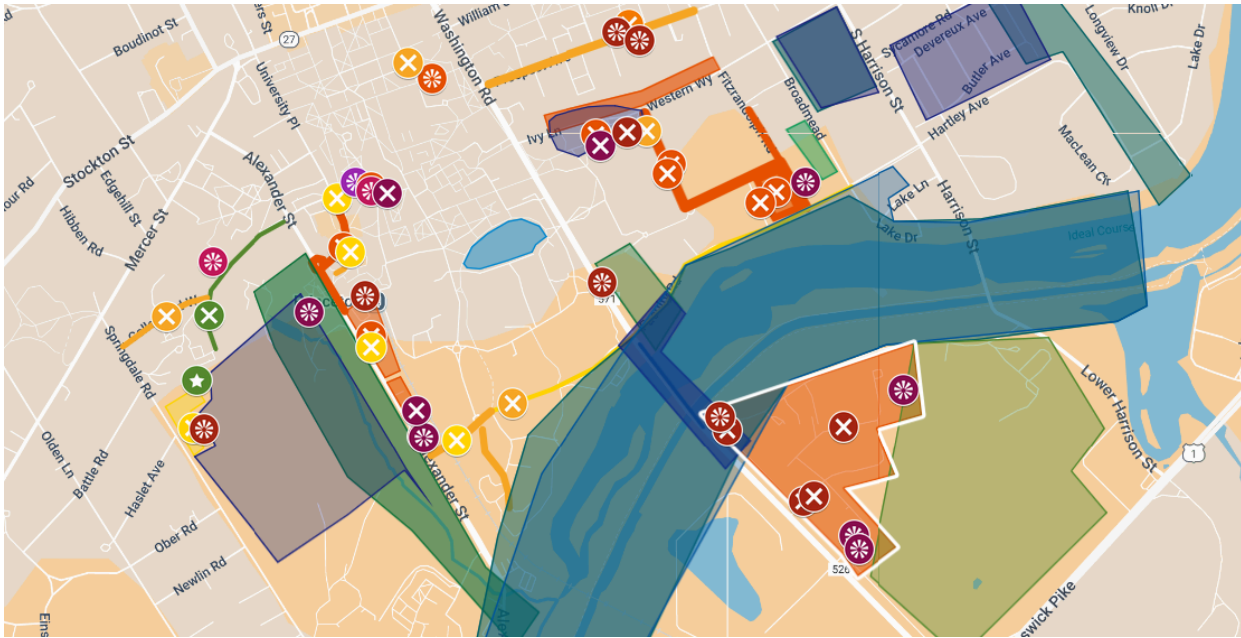
Locations with significant glare are marked with the “fireworks” symbols. This is by no means an extensive map, but it identifies a few significant occurrences.
