Existing Lighting Conditions at Princeton's Campus

Report by Gáspár Bakos, Department of Astrophysics

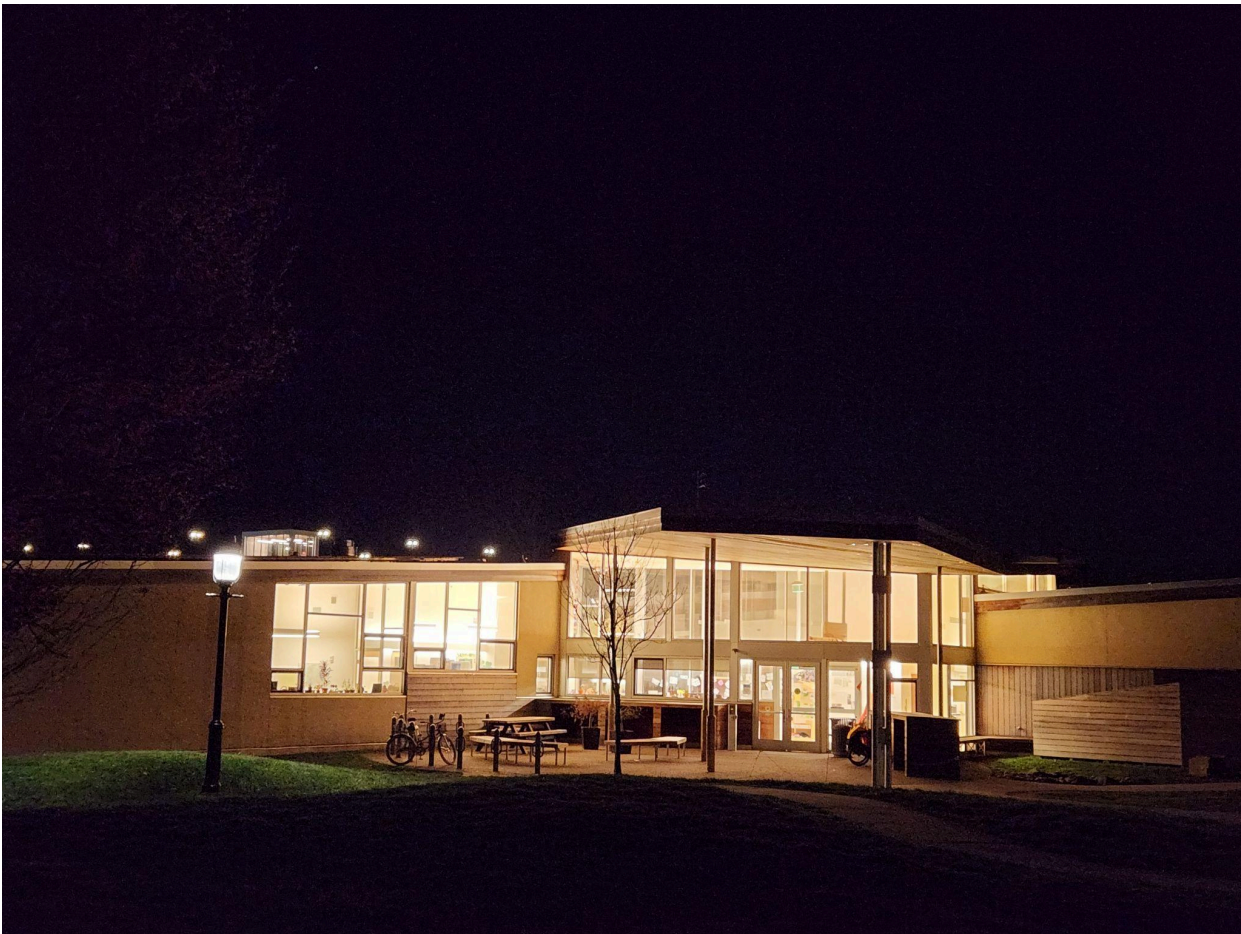
Lights from the Unow nursery school spill onto Broadmead at night. Photo taken at midnight. The lights are so bright that they blind the pedestrians.

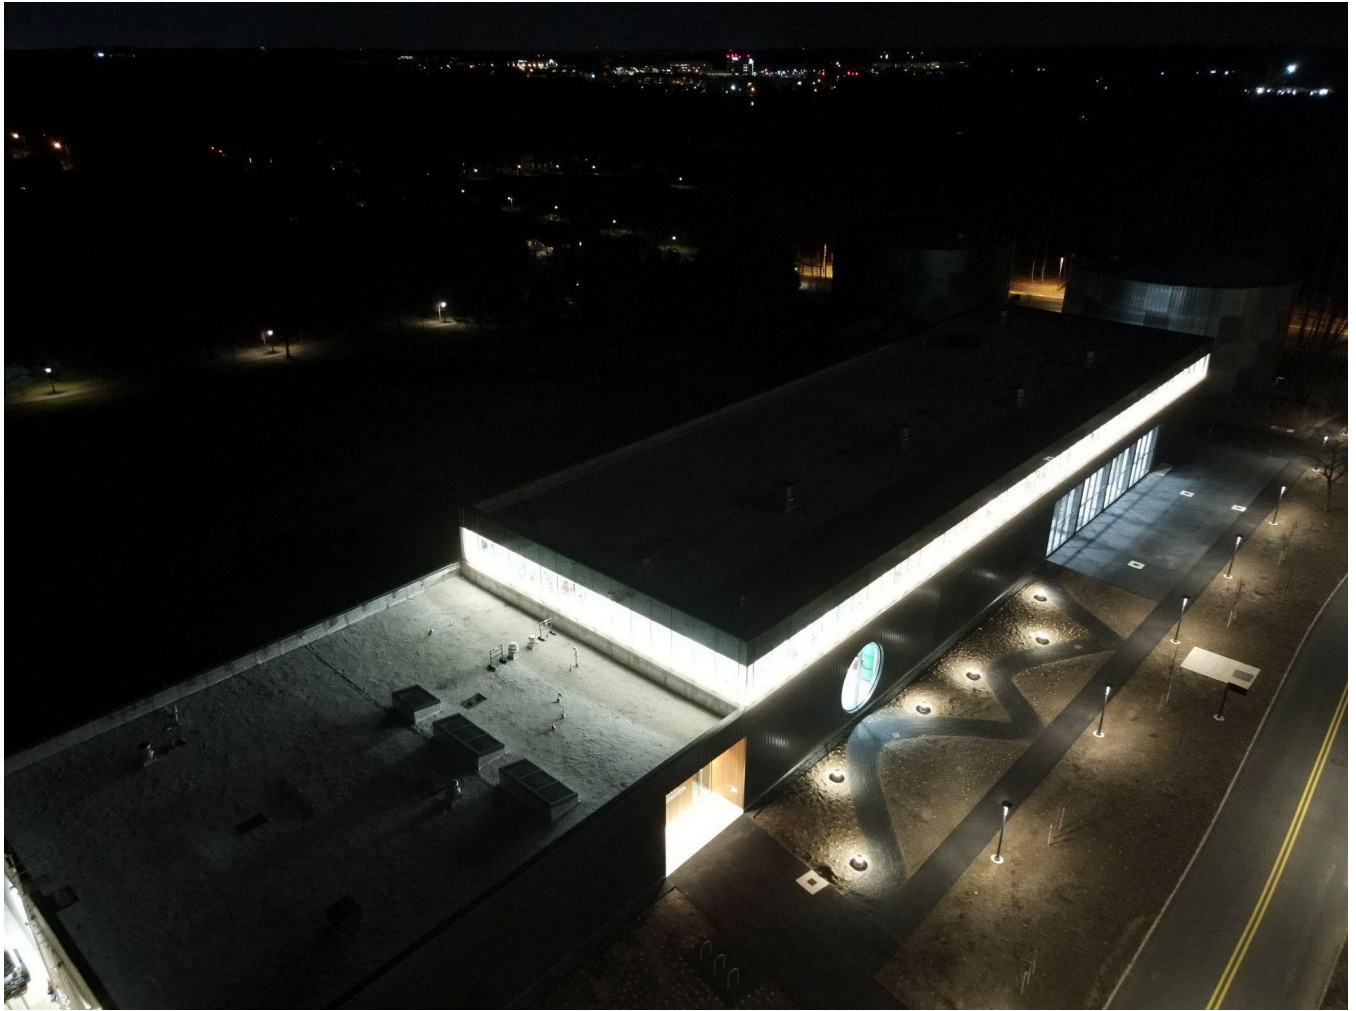
The interior lighting of the geoexchange building is bright, wasteful, and a good fraction goes directly into the sky due to the poor design that did not account for light pollution. Compare the lighting level emanating from the building with that of the Penn globes in the background, or the Faculty drive illumination in the middle/top.

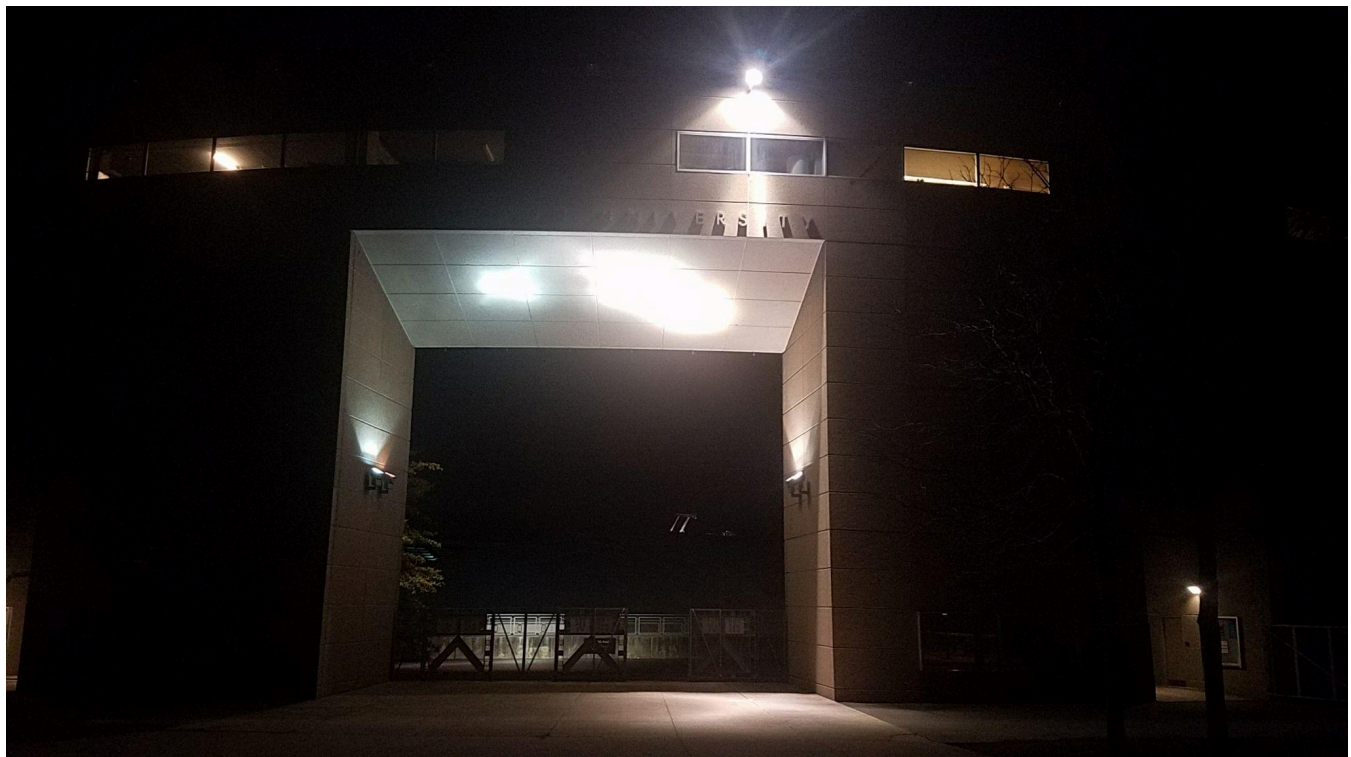
Archway lights of the stadium. The upward-oriented lights are bright, and a fraction of the light misses the building, shining up in the sky.

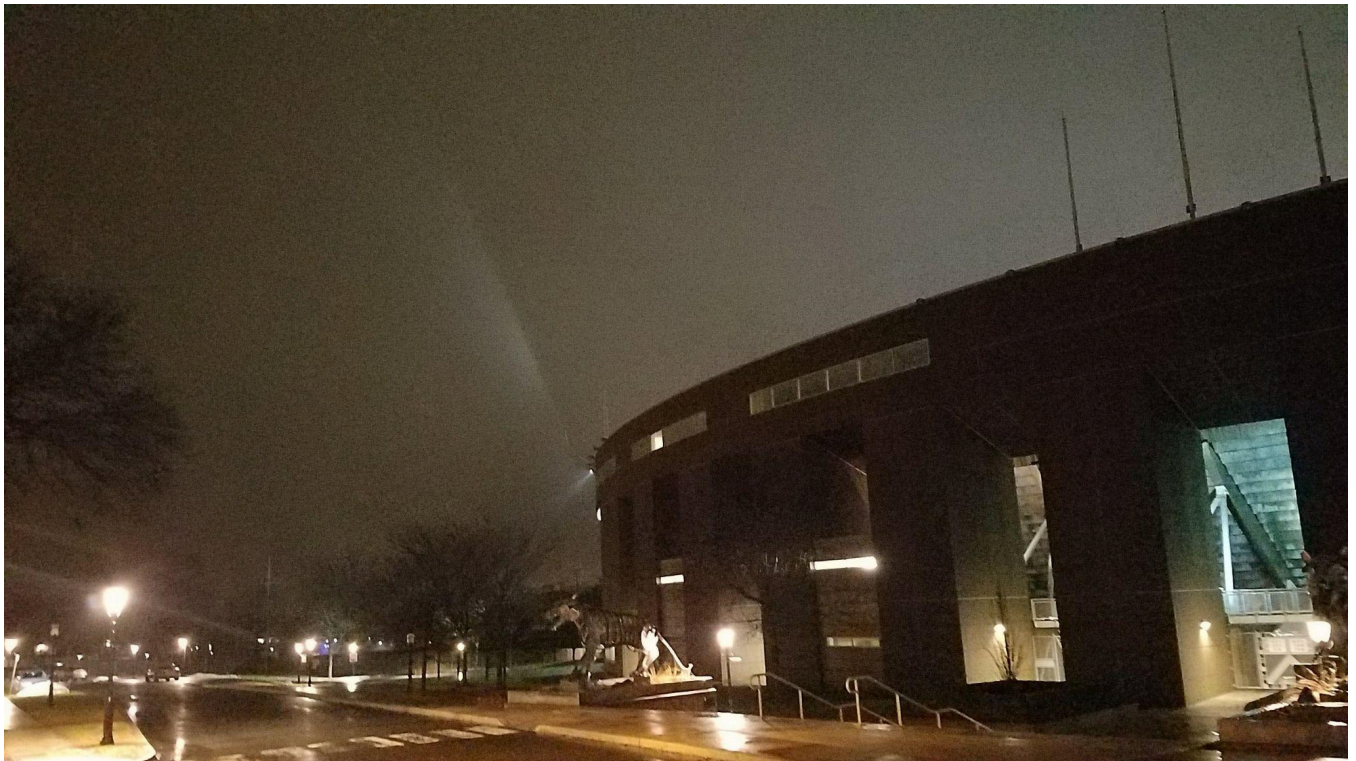
A good demonstration of how the upward-oriented archway lights miss the building. This is the usual side-effect of upward lighting.

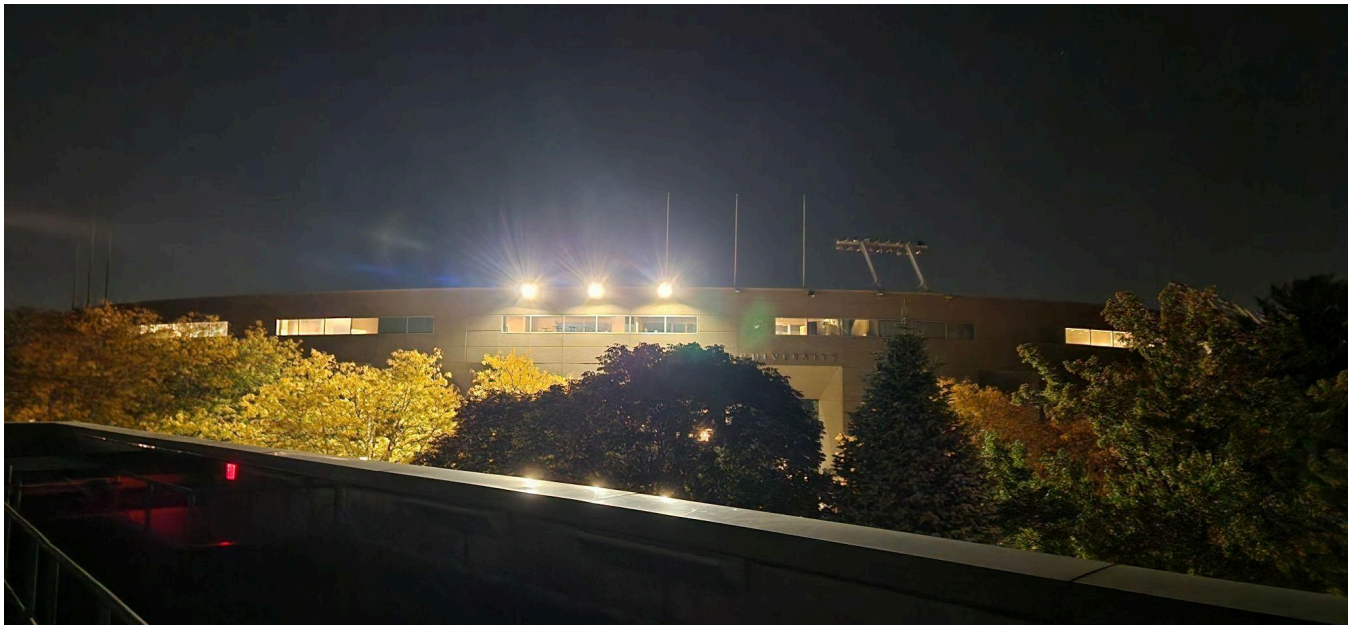
There are only two places along the rim of the stadium with bright, unshielded area lights. One of these places faces Peyton Hall, and has at least 3 very bright floodlights. (Unused) office space in the top of the stadium has the lights permanently on.

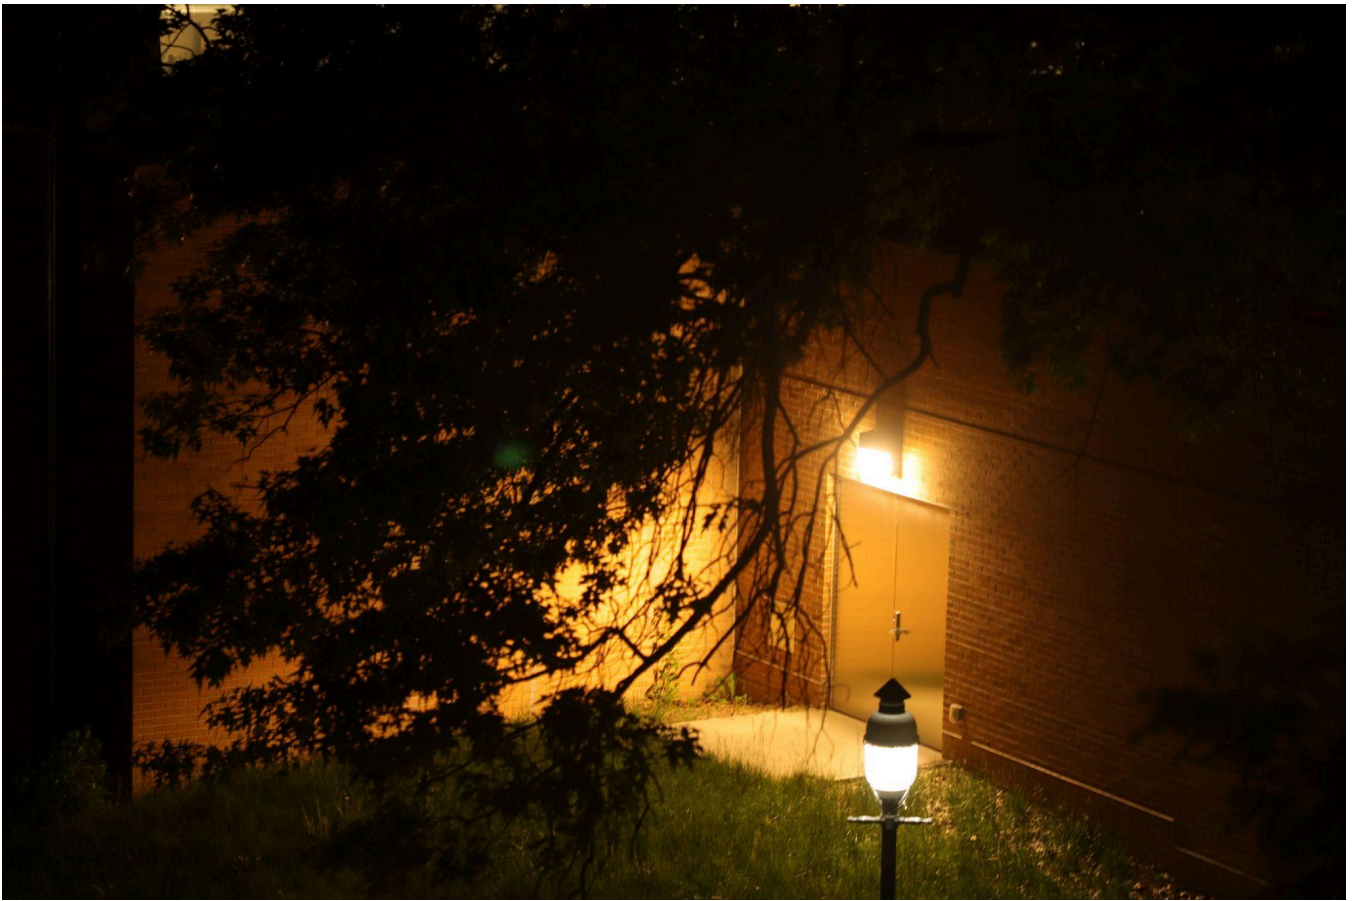
Unshielded area light next to Peyton Hall on the Lewis Library building. The light of this fixture directly shines in the Peyton telescope dome when the dome slit is open. It is also excessively bright, causing glare for pedestrians.

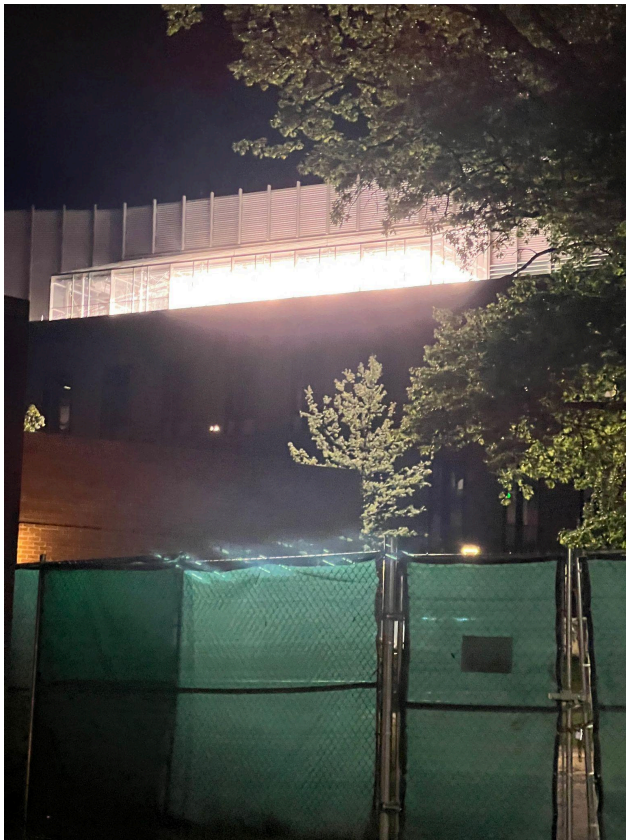
Unshielded, ultrabright greenhouse in the ES+SEAS building, causing glare and massive light pollution.

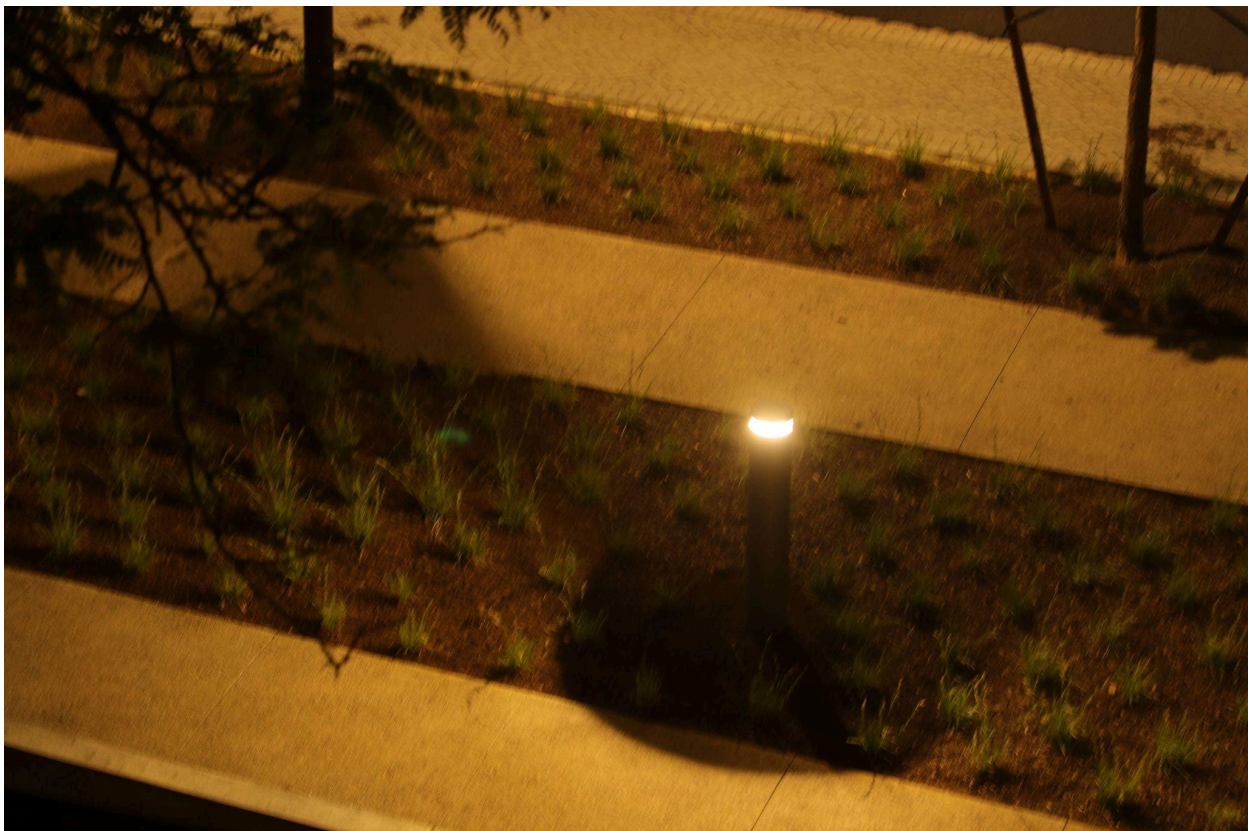
New, unshielded bollards cast light on the roof of Peyton and cause overall glare. Previously used bollards around Peyton BUG ratings with no uplight. Switching to these new ones is a step back.

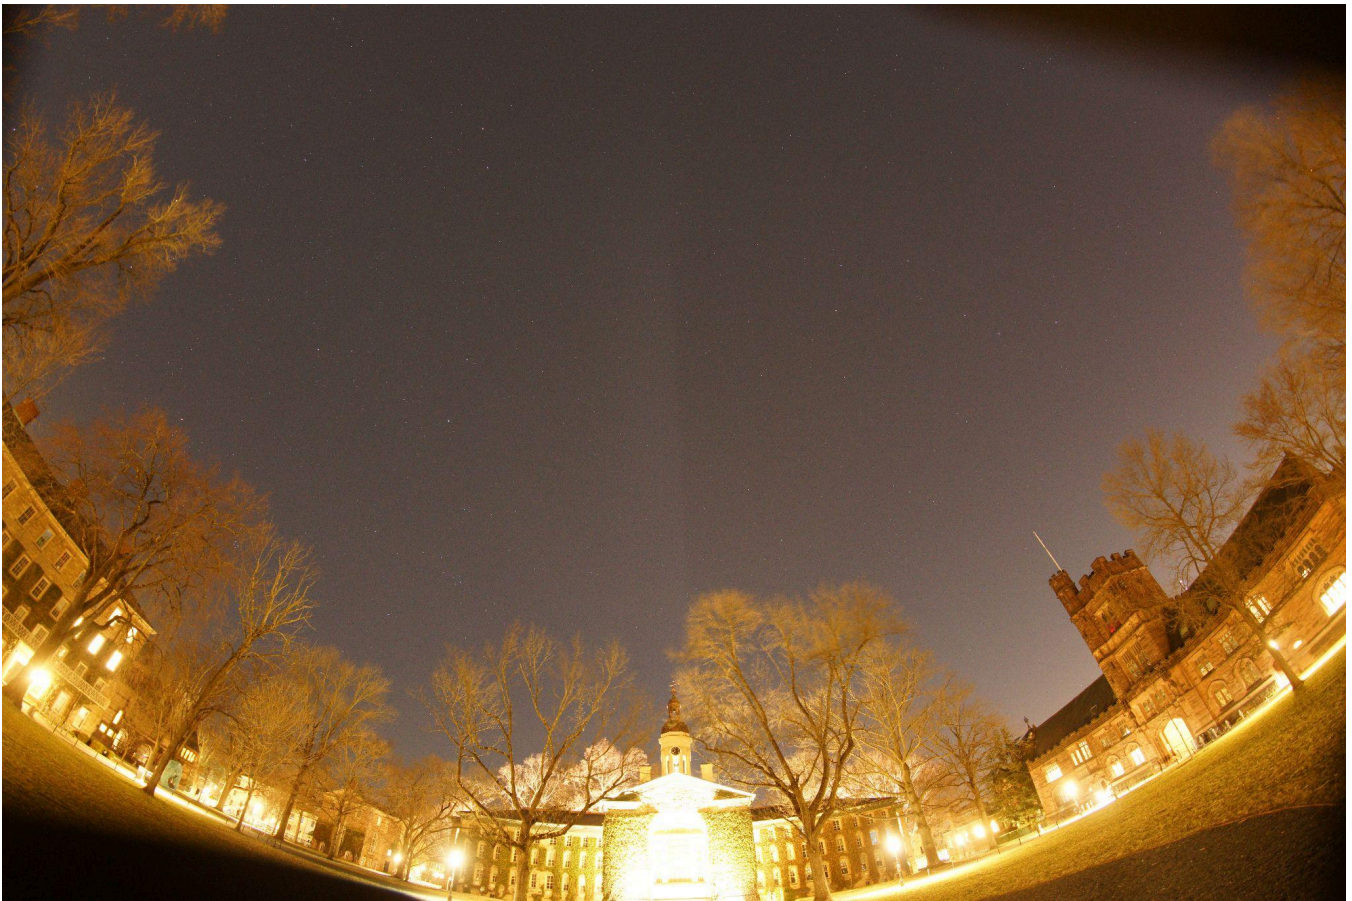
With a little better facade lighting, which is dimmer and downward oriented, we could see a starry sky behind Nassau Hall.

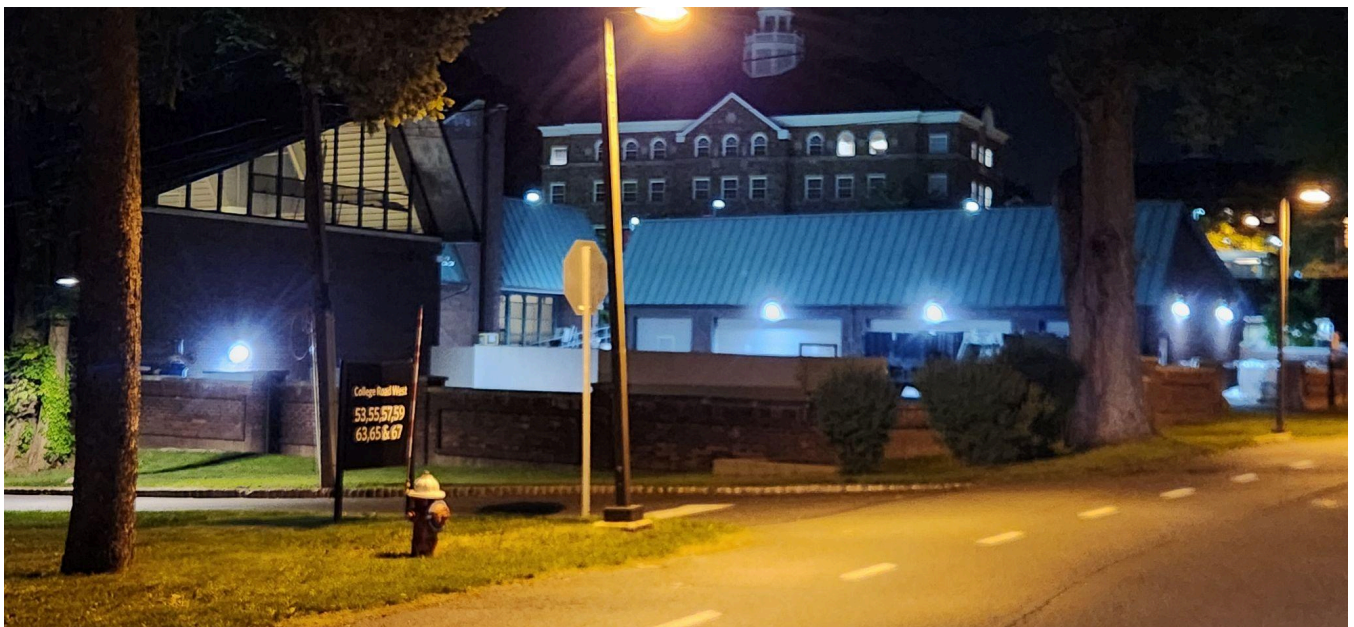
Strong glare from area lights on the facility buildings on College Road. These lights cause glare for pedestrians walking on College Road. to/from the graduate college.

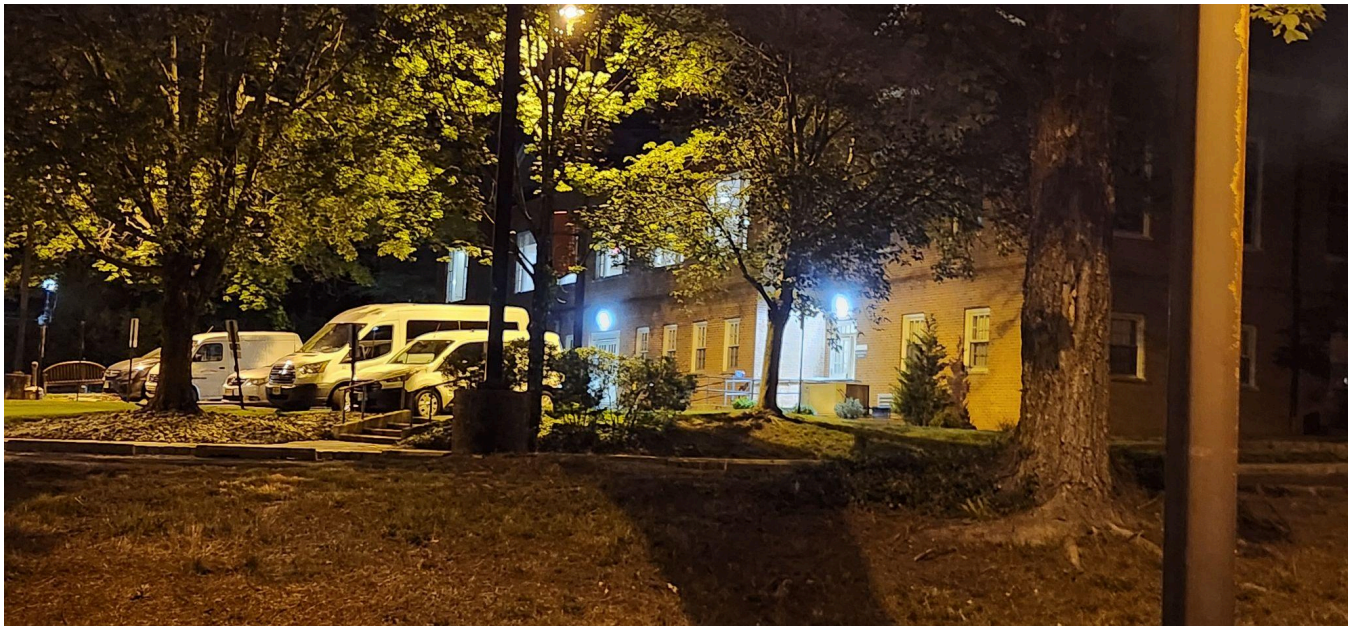
Almost vertically aligned blue LED area lights on College Rd.

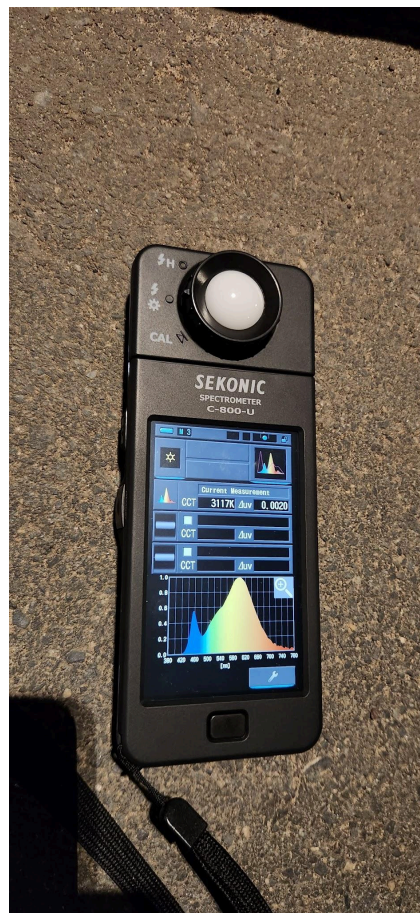
Bega 84* and Bega 99* emission: broad spectrum peaking at an equivalent temperature of 3100K, strong blue peak hiding in the red end.

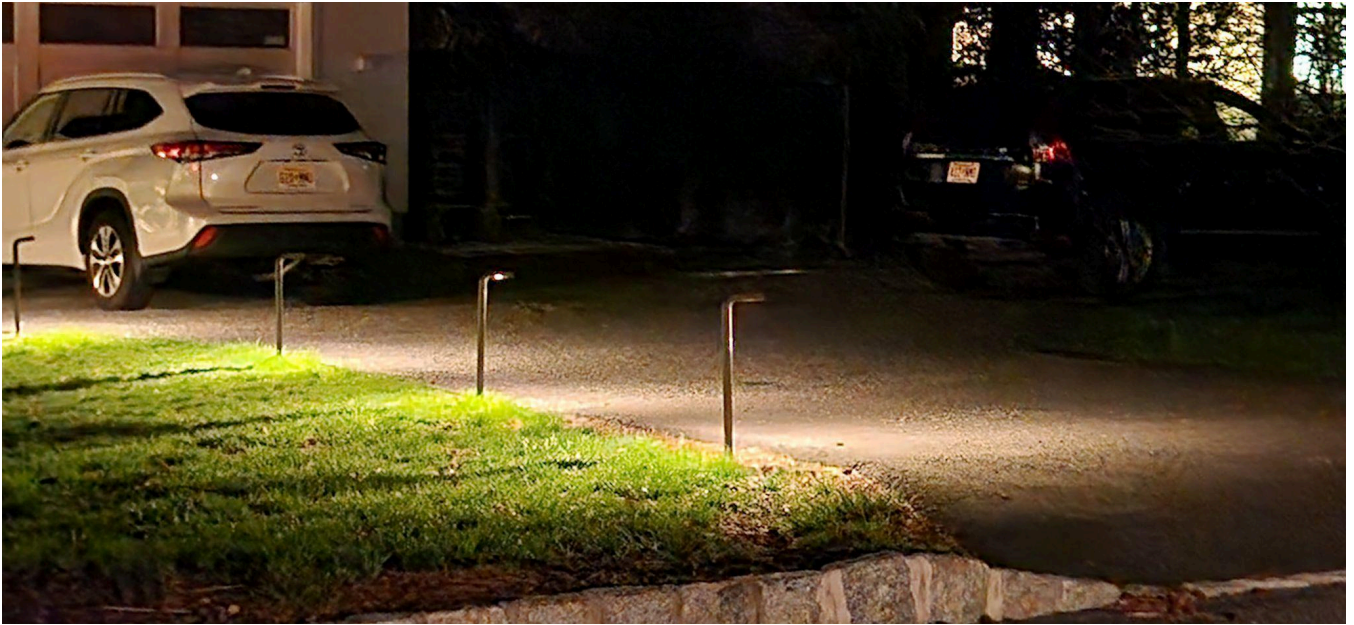
Fully shielded bollards on Prospect Avenue. This might be private property, or property rented from the University.

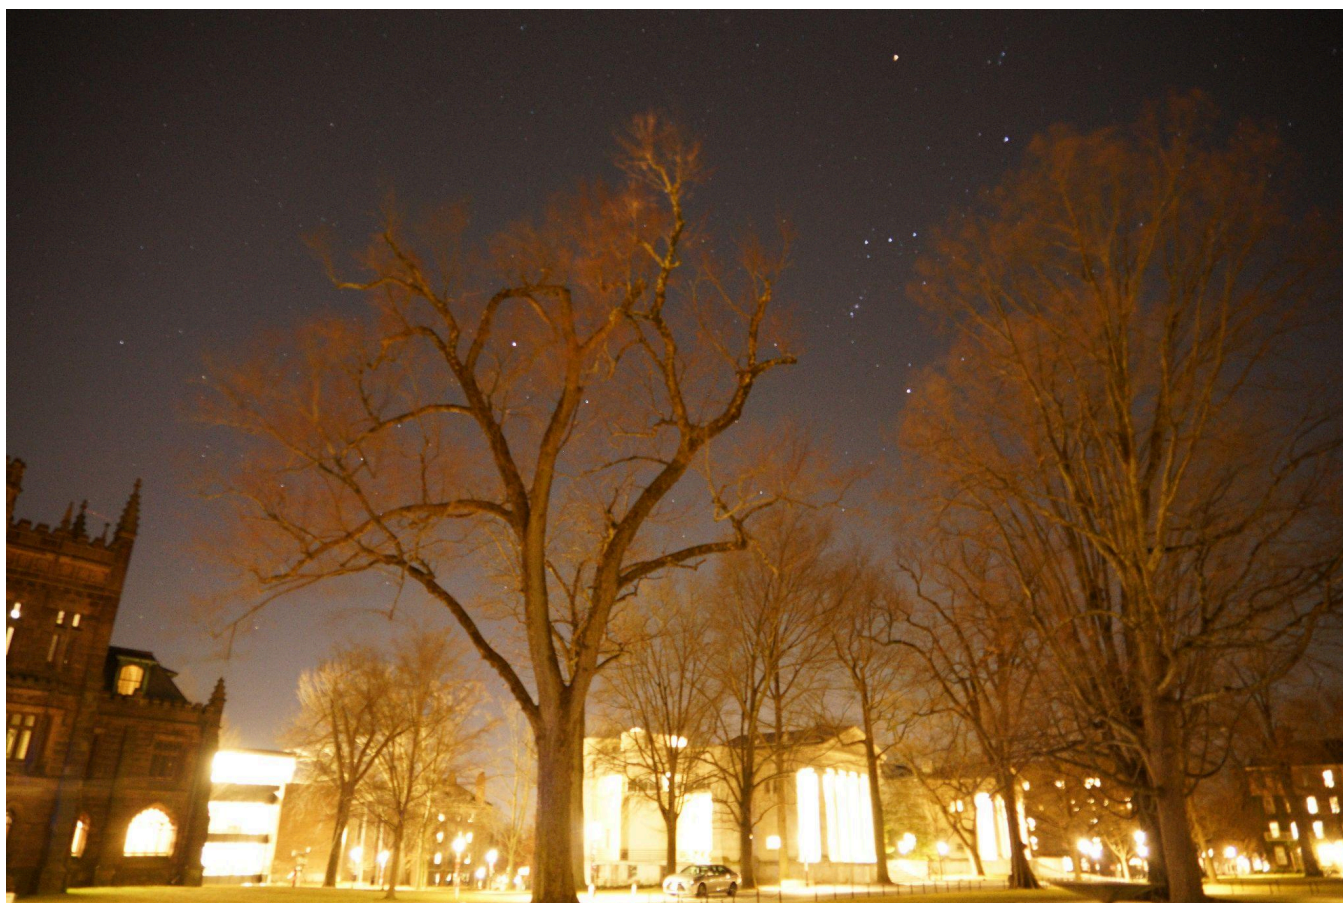
Princeton's campus with Orion in the back. The only reason we can still take photos like that is thanks to no facade lighting of the building (they are naturally lit by the strong reflected stray light from the general lighting).

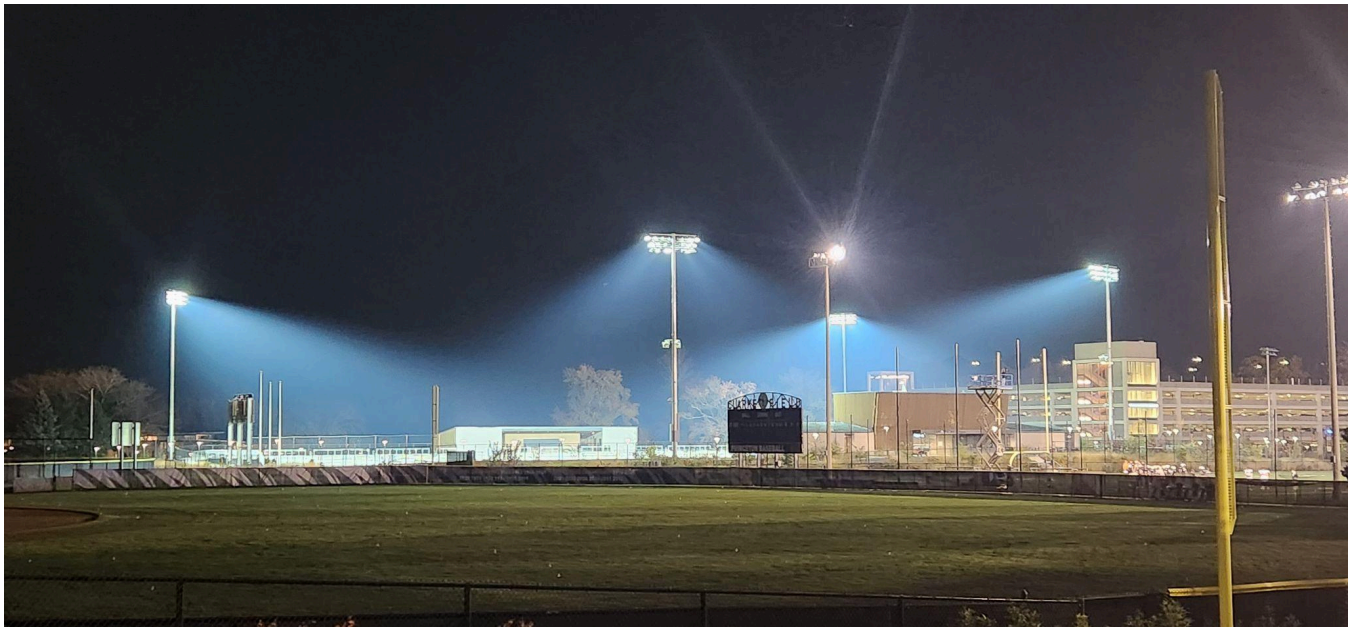
Some of the new sports fields have excellent, well-targeted lighting. This is untrue for the main stadium.

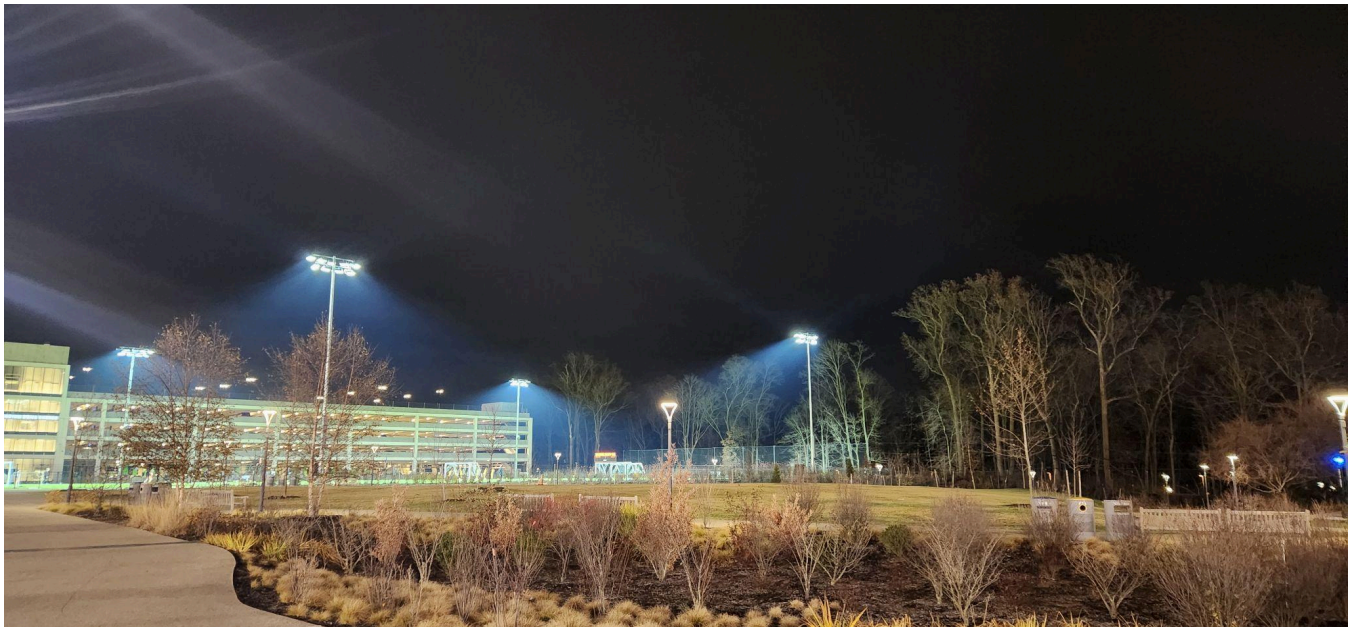
Another example of a well-lit sports field with excellent directional lighting.

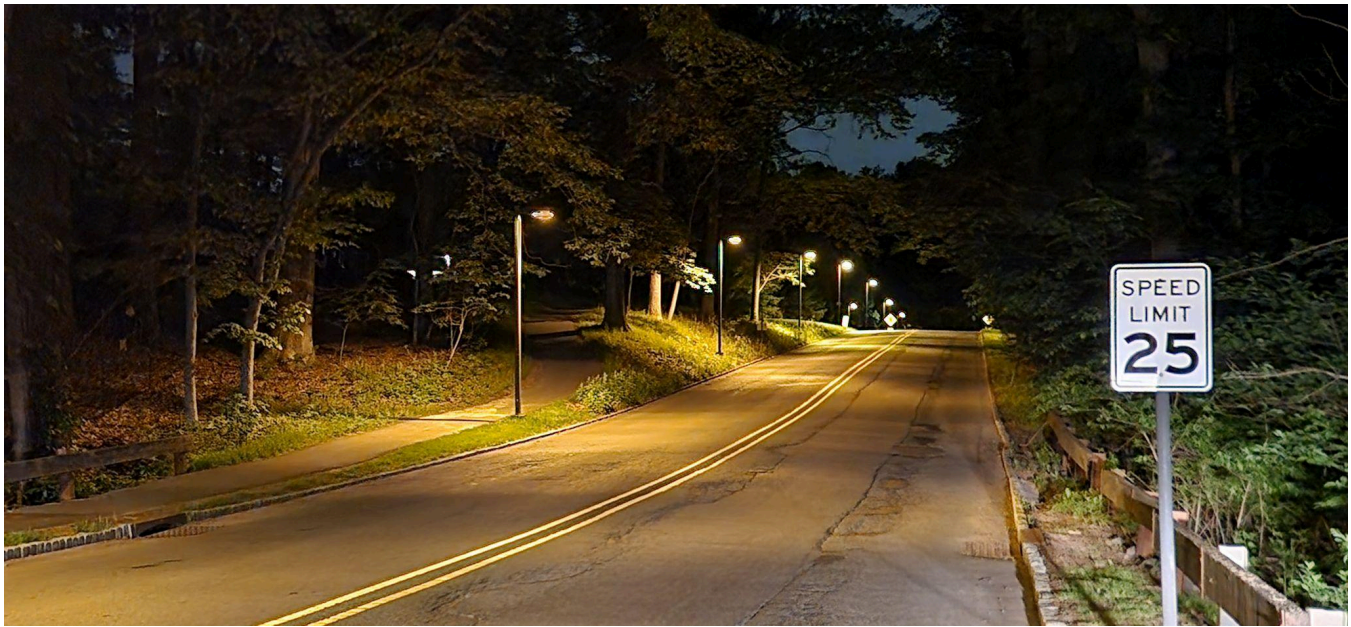
Faculty drive with sodium shoeboxes.

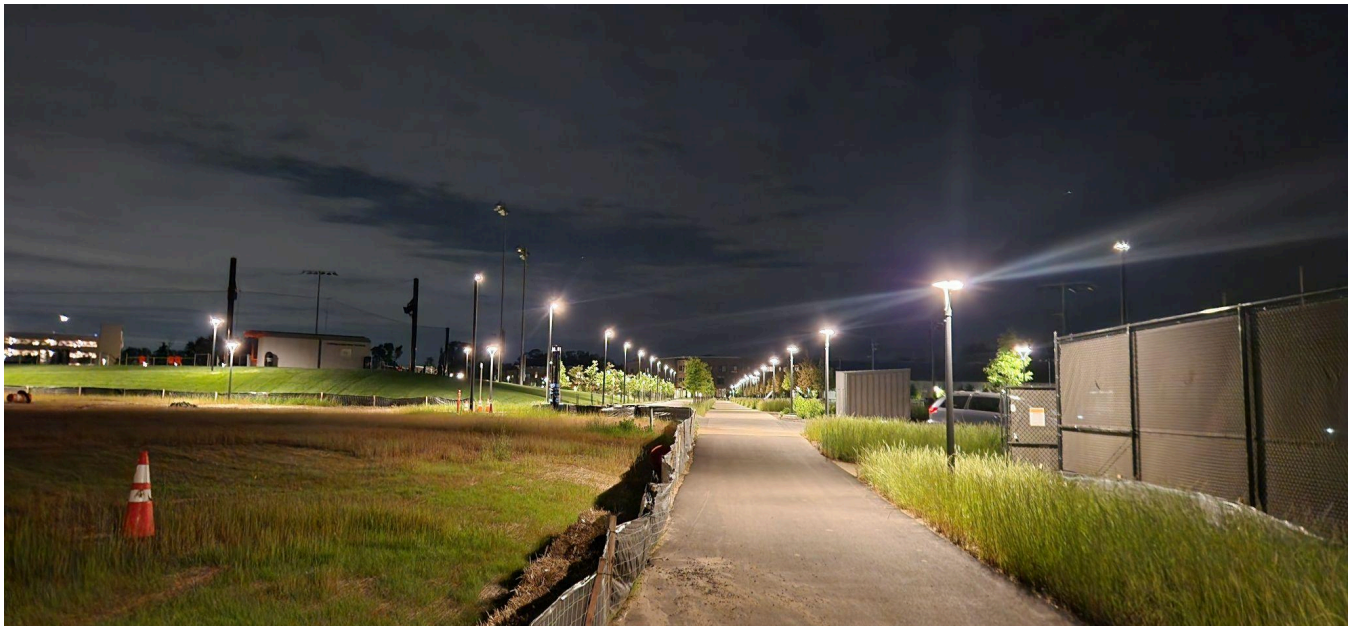
Who would like to take an evening stroll here? Walkway in the middle of the Lake Campus field.

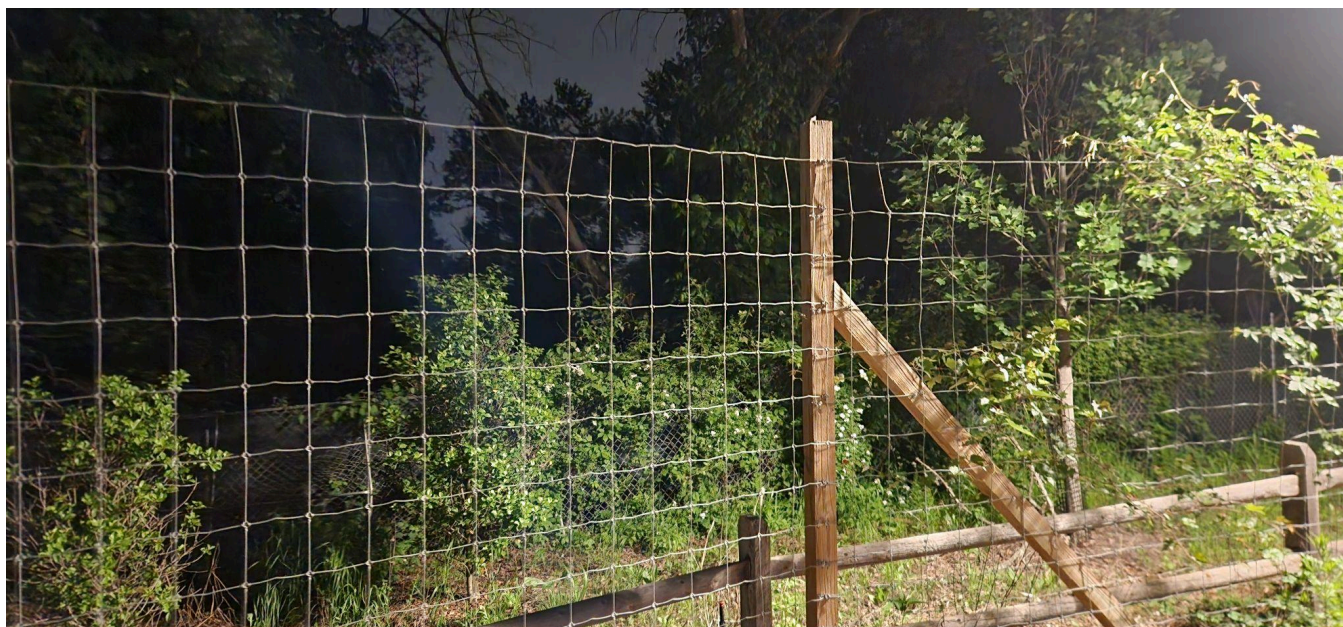
Light trespass into the D&R Park at Lake Campus.

In reality, the implemented values are 3.1 to 3.9 FC under the poles, i.e., about 3-4 times the planned. The light trespass to the nature area is significant (at least 10 times higher than the claimed 0.01 FC). Light spill from the buildings is not indicated in the original design, but is very significant.

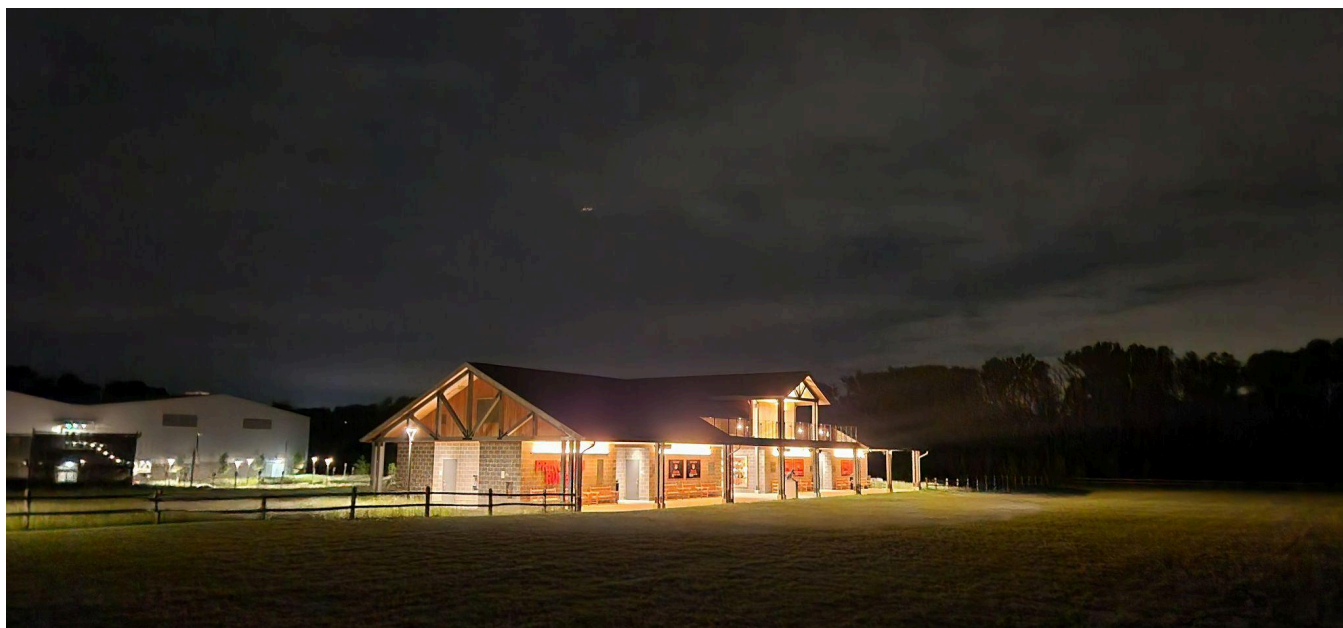
Light trespass from floodlit buildings.
